RFQ NUMBER
 DNRB11006

EXPRESSION OF INTEREST
Canaan Valley Resort State Park
Sleeping Unit Replacements and Other Improvements
DNRB 211006

Canaan Valley Resort State Park and Conference Center is located in Davis, WV and currently hosts many activities within the park property, including overnight accommodations at the lodge. The purpose of this report is to summarize structural deficiencies and provide recommendations for structural repairs and general maintenance items for the 5 overnight sleeping facilities surrounding the main lodge. The 5 facilities are Raven Lodge, Wild Goose Lodge, Deer Lodge, Woodcock Lodge, and Beaver Lodge, and will be referred to as such throughout the entirety of this report. As part of this report, an Order of Magnitude Cost Estimate for Structural Repairs has been prepared as well as an Order of Magnitude Cost Estimate for General Maintenance Items.

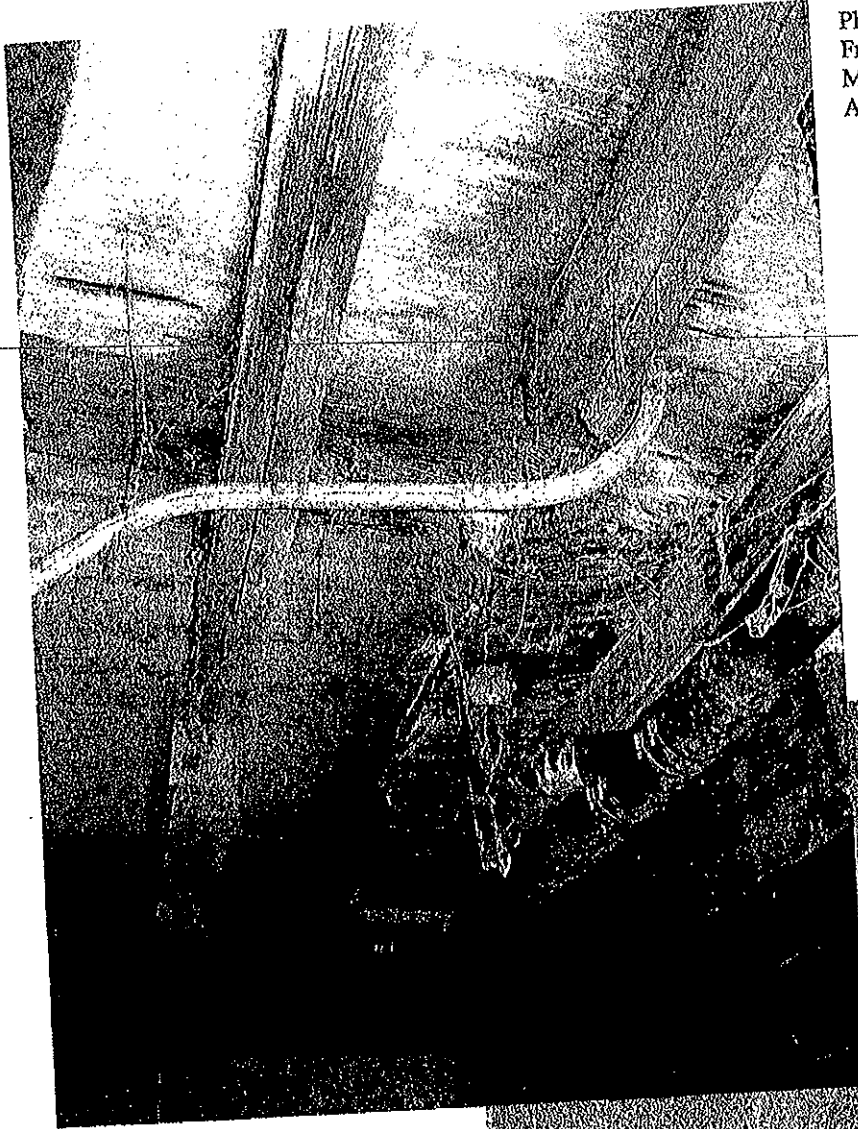
- **Deteriorated/inadequate floor framing under 1st floor mechanical/vending area** (See Photo 13-Appendix A)

Photo 13. Condition of Floor Framing in Raven Lodge under Mechanical Room or Vending Area

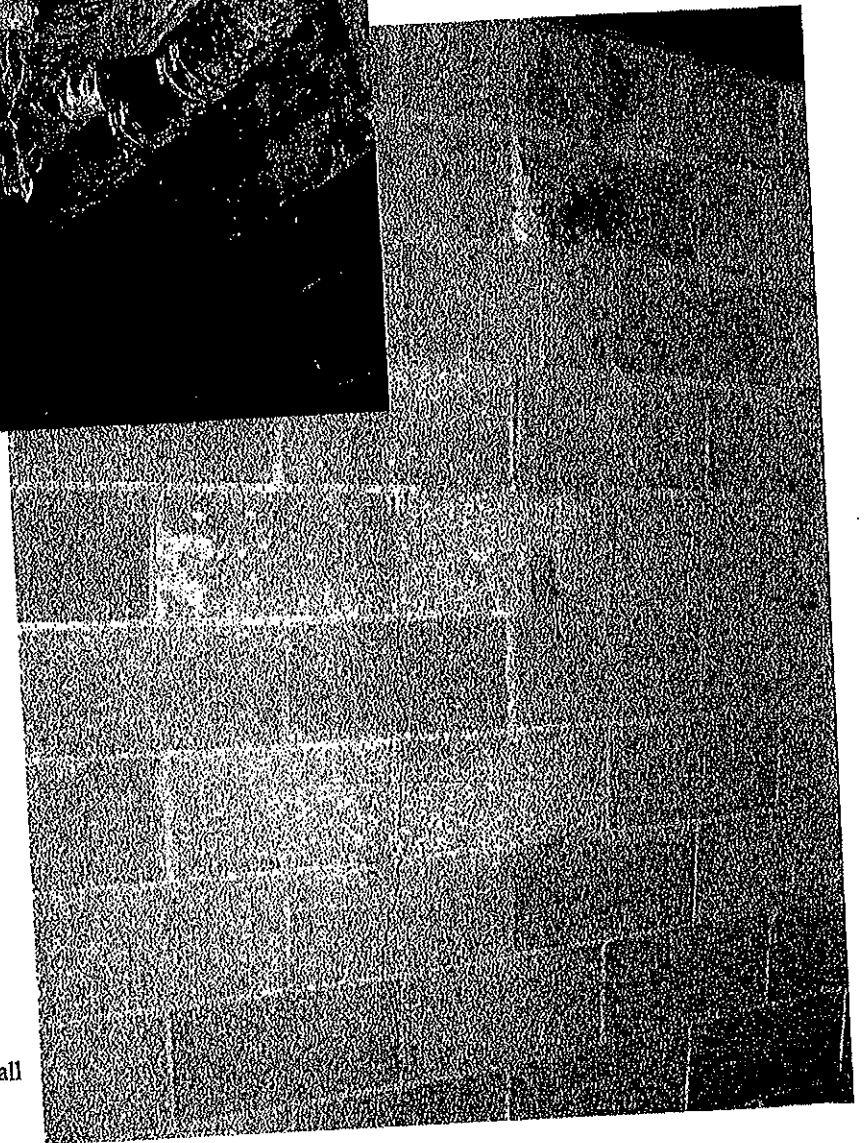
- **The foundation walls and firewall appear to be unreinforced**
- **Cracks at end foundation wall** (See Photo 14-Appendix A)
- **Masonry separation at end foundation wall** (See Photo 15-Appendix A)

Photo 14. Cracked Exterior Block Wall on End of Raven Lodge

The end wall that is cracked should be monitored to determine if the movement has stabilized or if it is still active. Once that determination is made, a repair for this wall can be addressed. The repair of this element is not included in the project estimate at this time.

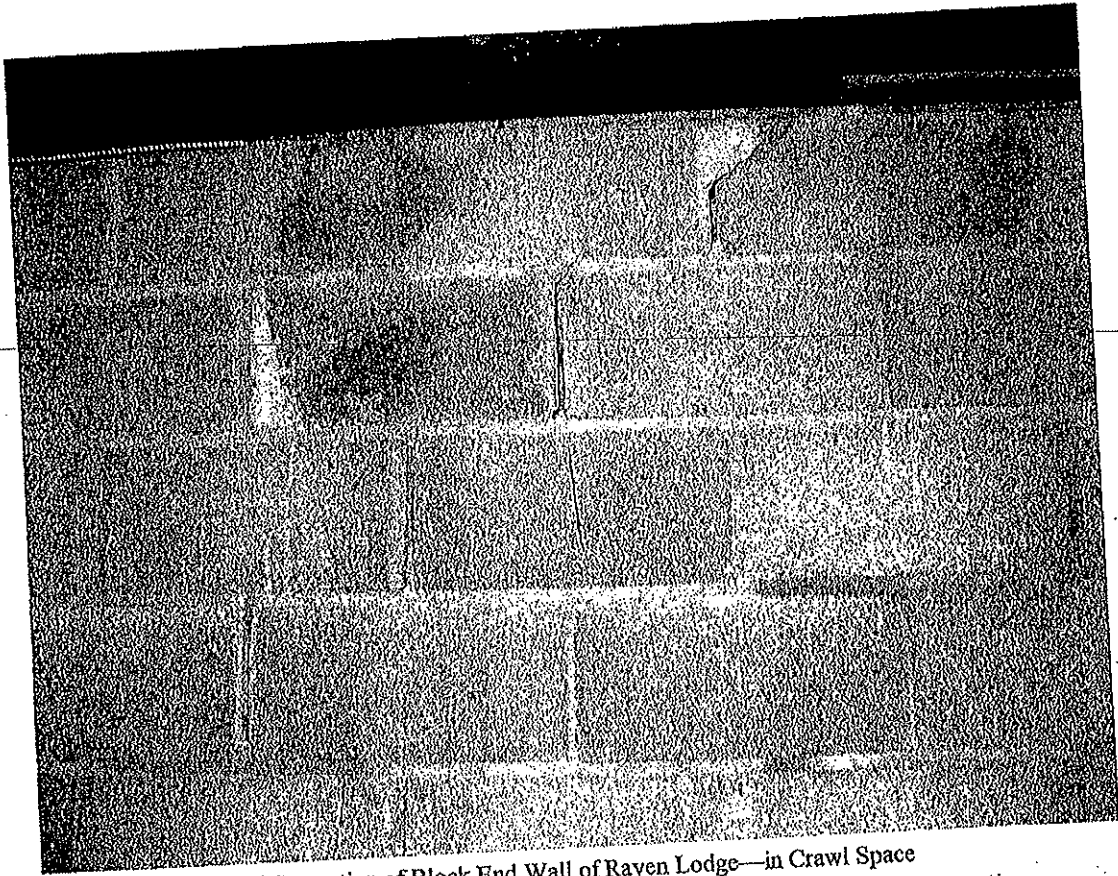
Photo 15. Horizontal Separation of Block End Wall of Raven Lodge—in Crawl Space

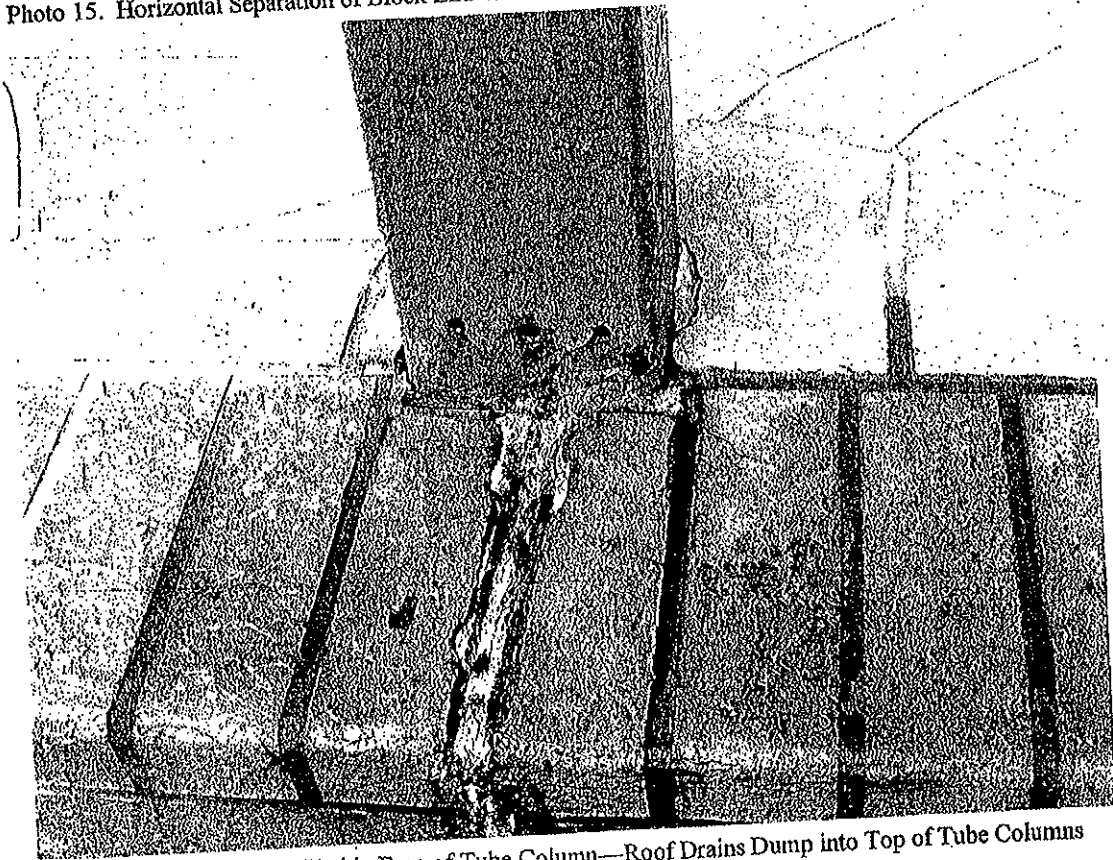
- The balcony structure is aging and showing signs of deterioration
- **The structural steel tube columns are being used as downspouts - holes have been drilled at the bases of certain columns to allow water to pass** (See Photo 16-Appendix A)

Photo 16. New Holes Drilled in Face of Tube Column—Roof Drains Dump into Top of Tube Columns

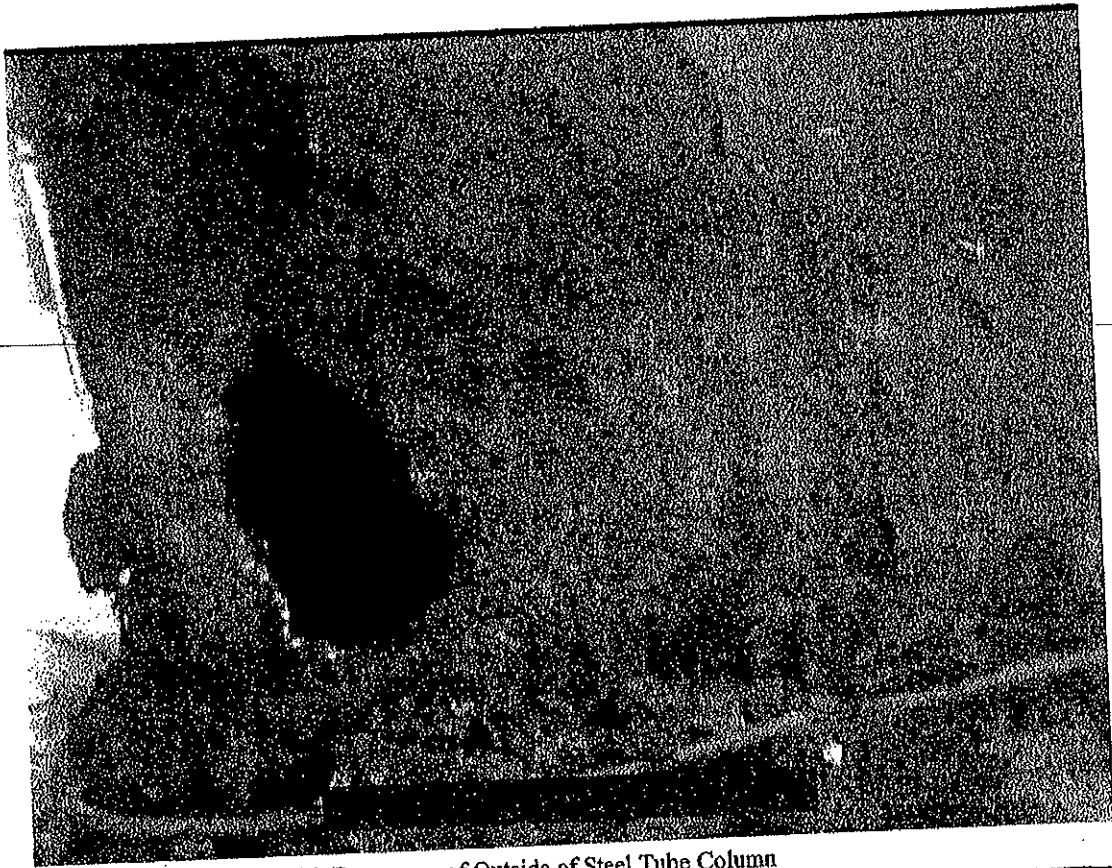
Photo 19. Photo Taken with Borescope of Outside of Steel Tube Column

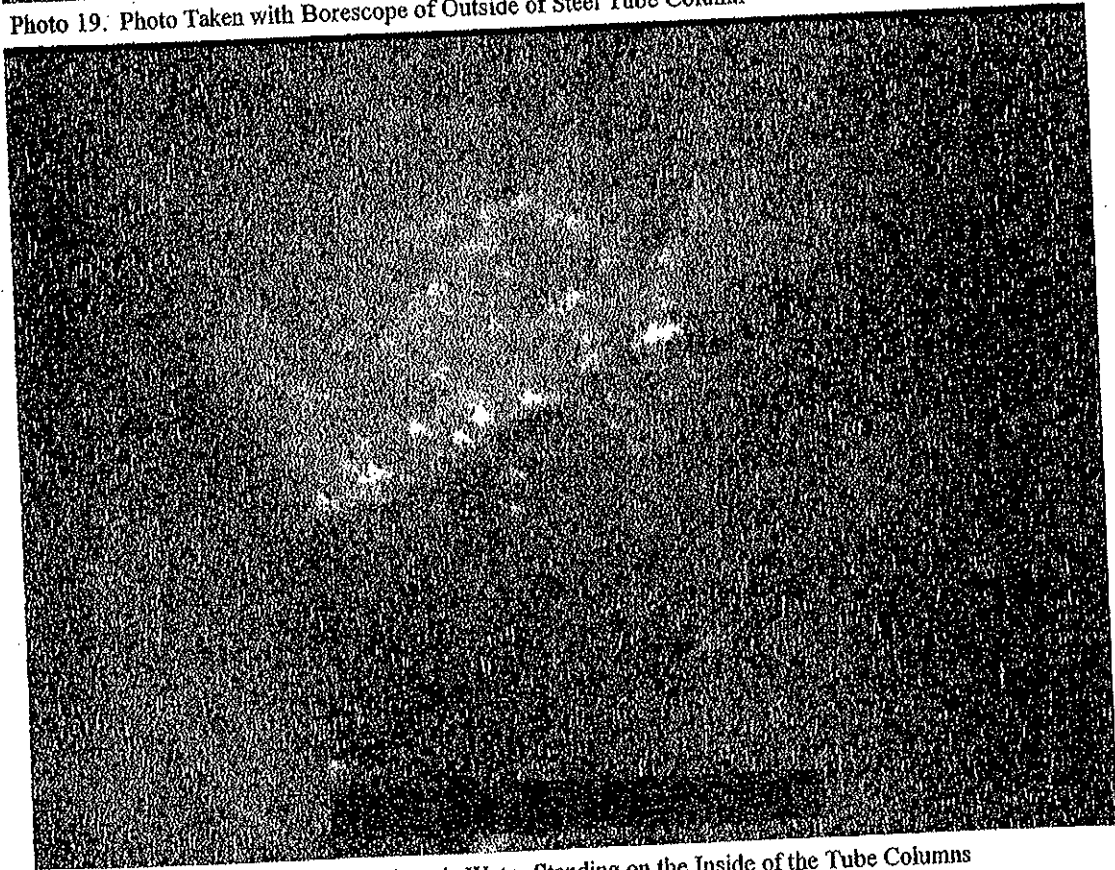
- Staining has occurred on the slabs from the corroding structural steel
- **There is standing water inside some of the columns** (See Photo 20-Appendix A)

Photo 20. Borescope Shows that there is Water Standing on the Inside of the Tube Columns

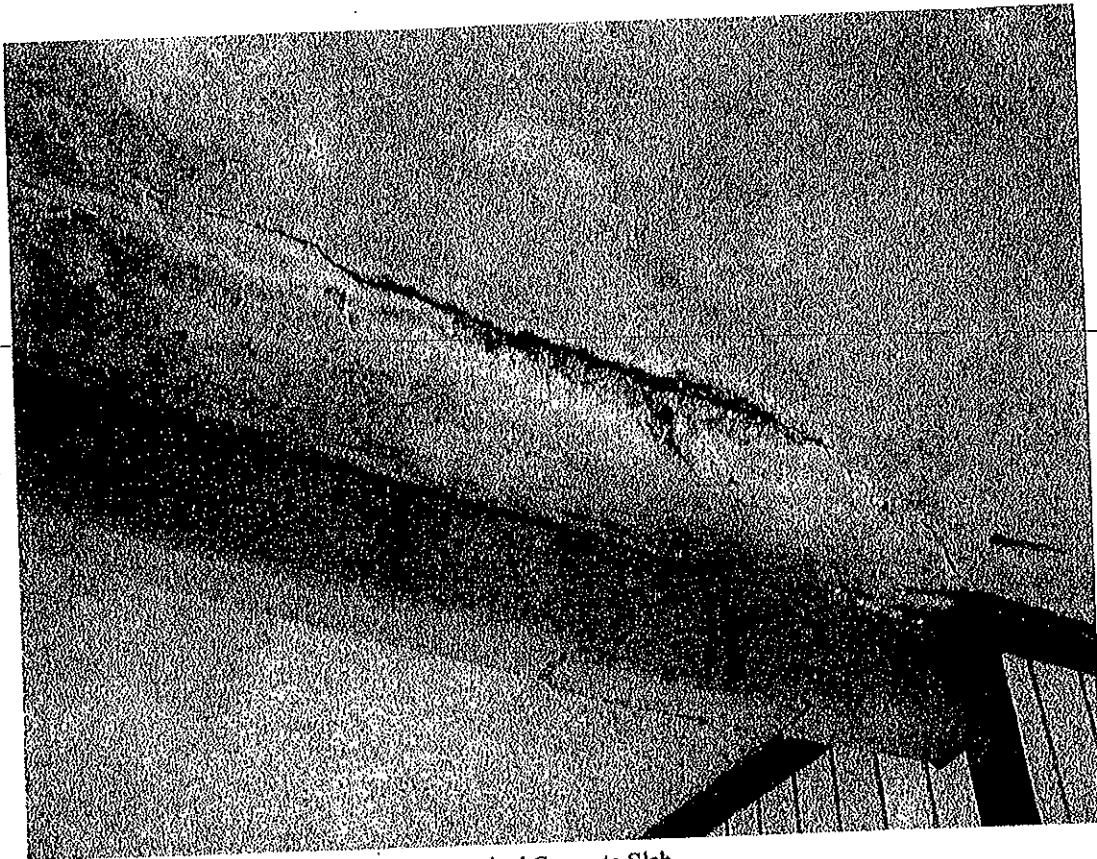
- Structural steel (exterior columns, beams, and stairs) deterioration is prevalent (See Photos 17, 19, 21, 29, and 30-Appendix A)
- Concrete slab deterioration is prevalent. **Cracking has occurred on the topside and underside of most every slab section** (See Photos 25 and 27-Appendix A)

Photo 25. Rusted Reinforcing Steel and Cracked Concrete Slab

There are isolated areas of the concrete slab that require a full depth replacement.

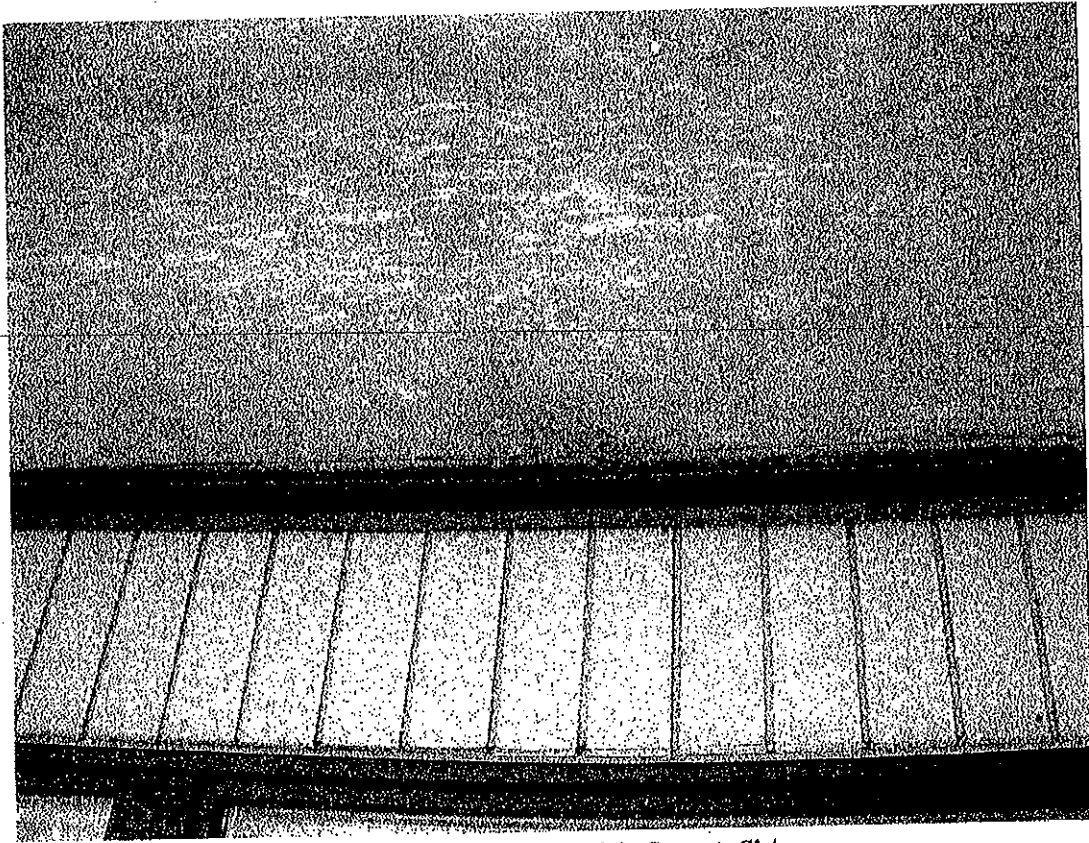
The reinforced deck and structural steel columns and beams can adequately support the prescribed loads, assuming no deterioration and full cross sections of the members. **It should be noted that most of the concrete slab sections were cracked relatively close to the mid-span of the slab.**

Photo 27. Steel Edge Angle at Face of Building and Crack in Concrete Slab

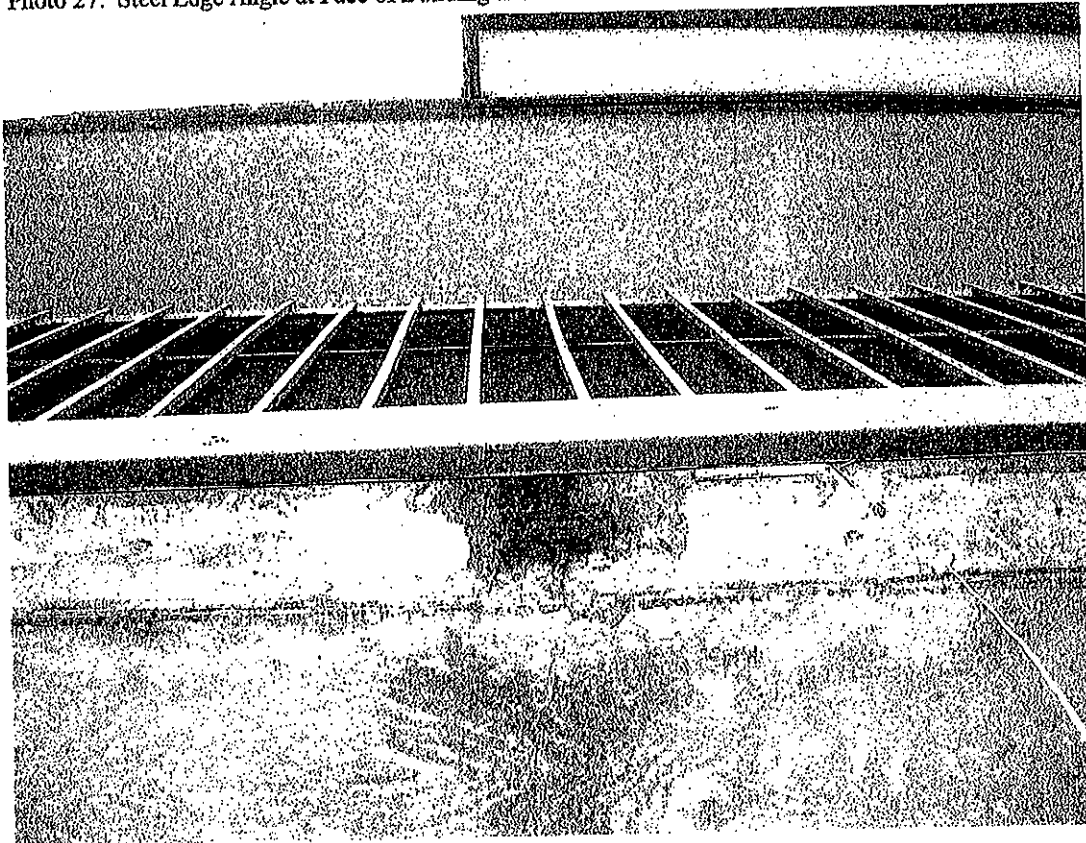
Photo 28. Rusted Connection Anchor Where Edge Angle was Removed

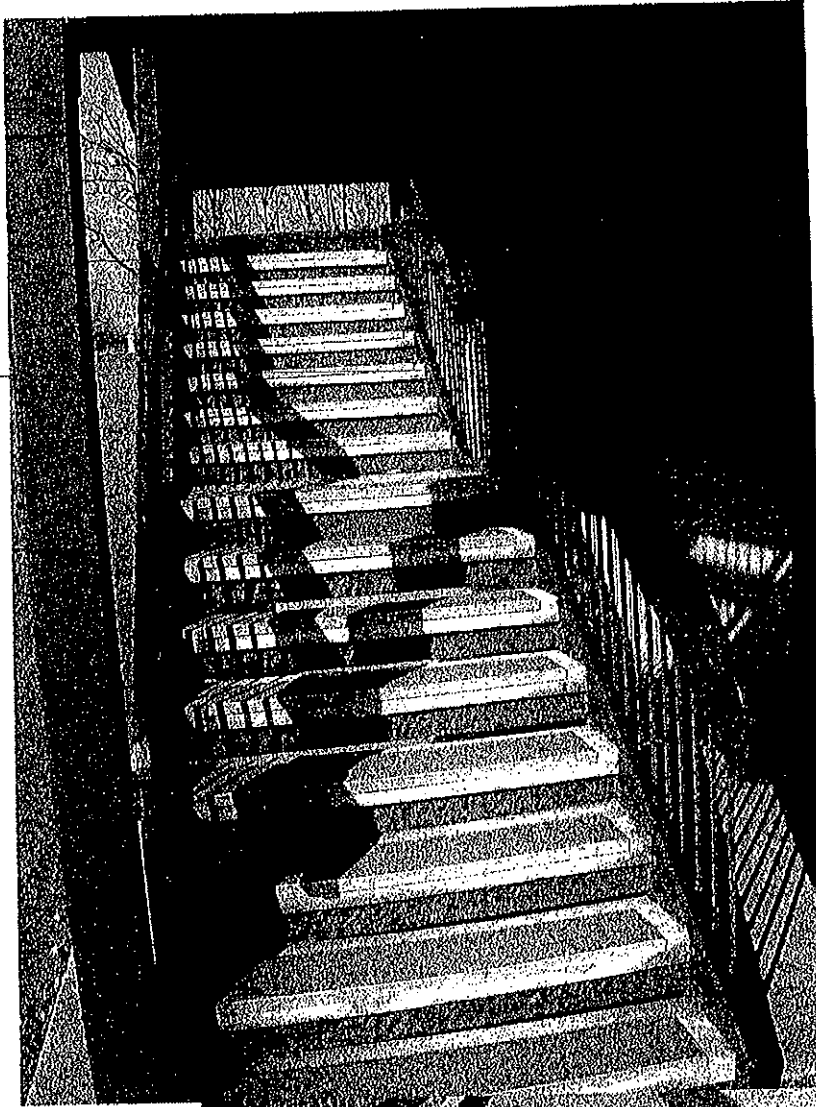
Photo 30. Condition of Steel Framing at Stairs—Some Additional Support Has Been Added to Some of the Stairs

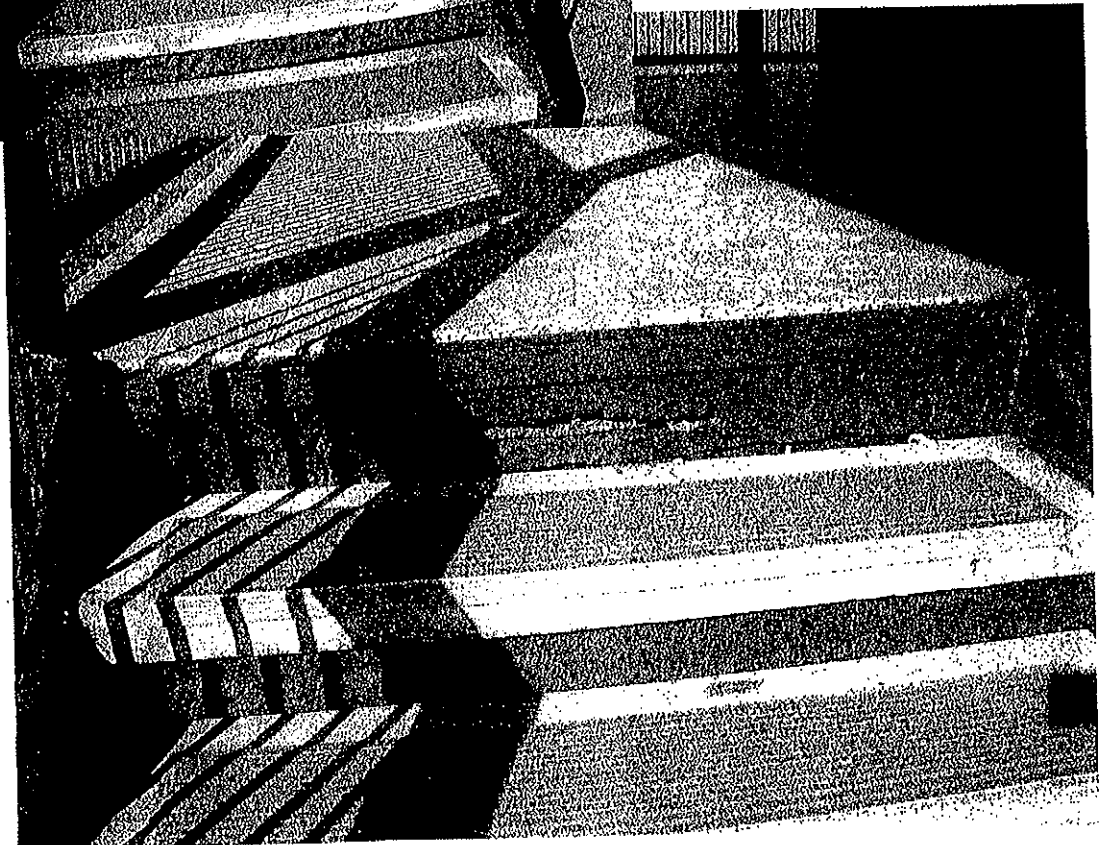
- **The exterior portion of the firewall that extends beyond the face of the building is showing signs of movement and deterioration** (See Photos 31, 33, and 34-Appendix A)

Photo 31. Concrete Block Pier is an Extension of the Firewall Separating the Units in Each Building

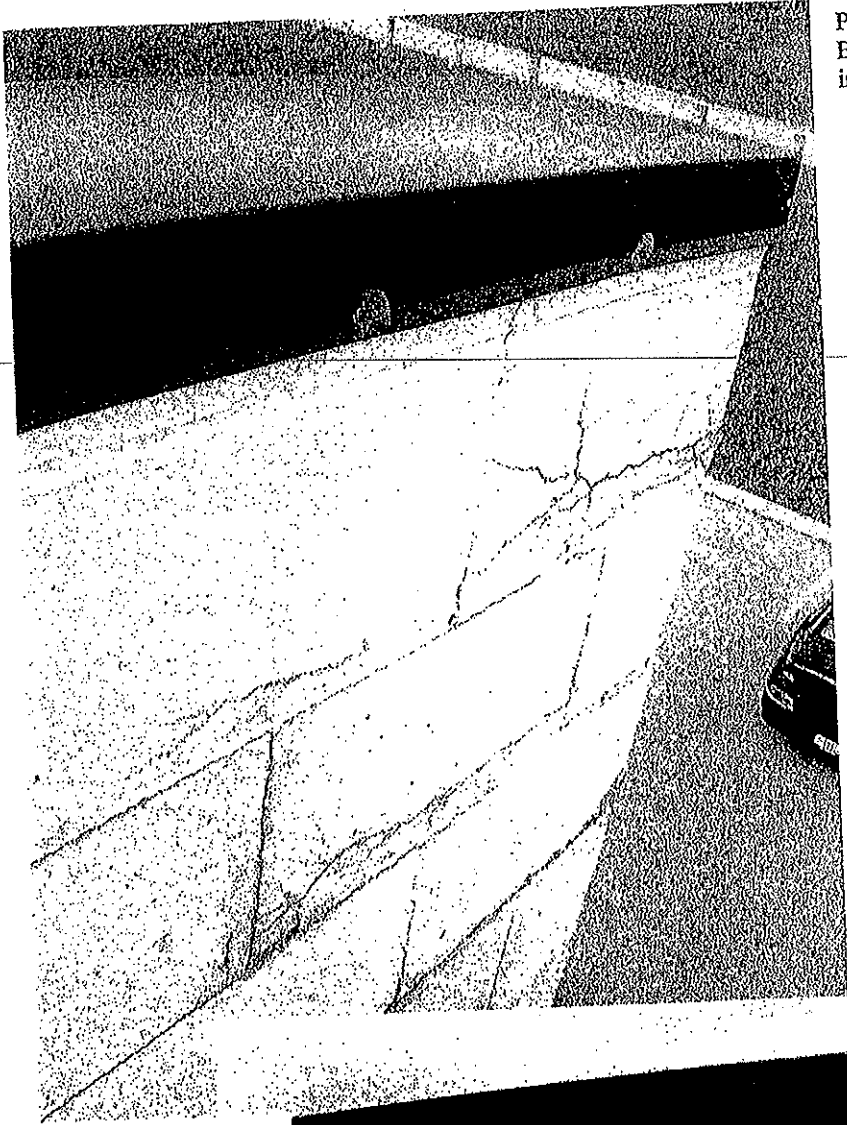
Photo 33. View of Top of Block Firewall Showing Cracking

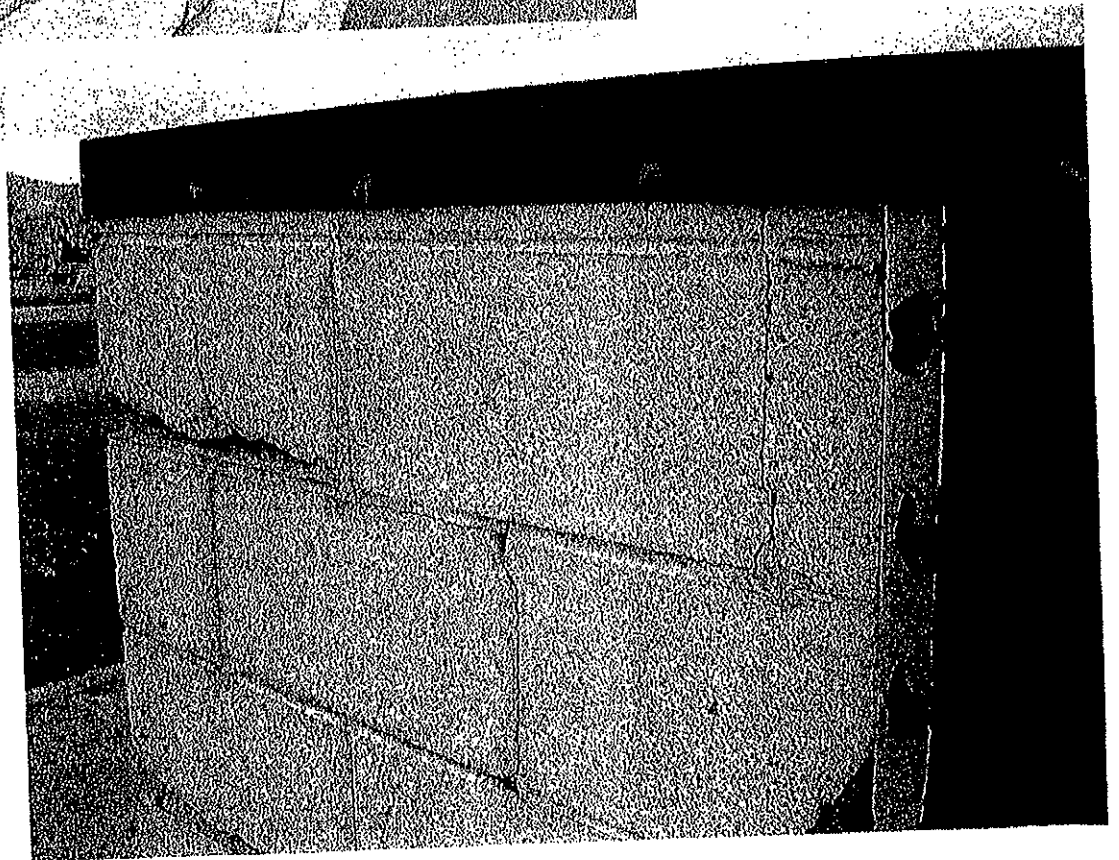
Photo 34. Mortar Joint and Block Cracking at Roof Level

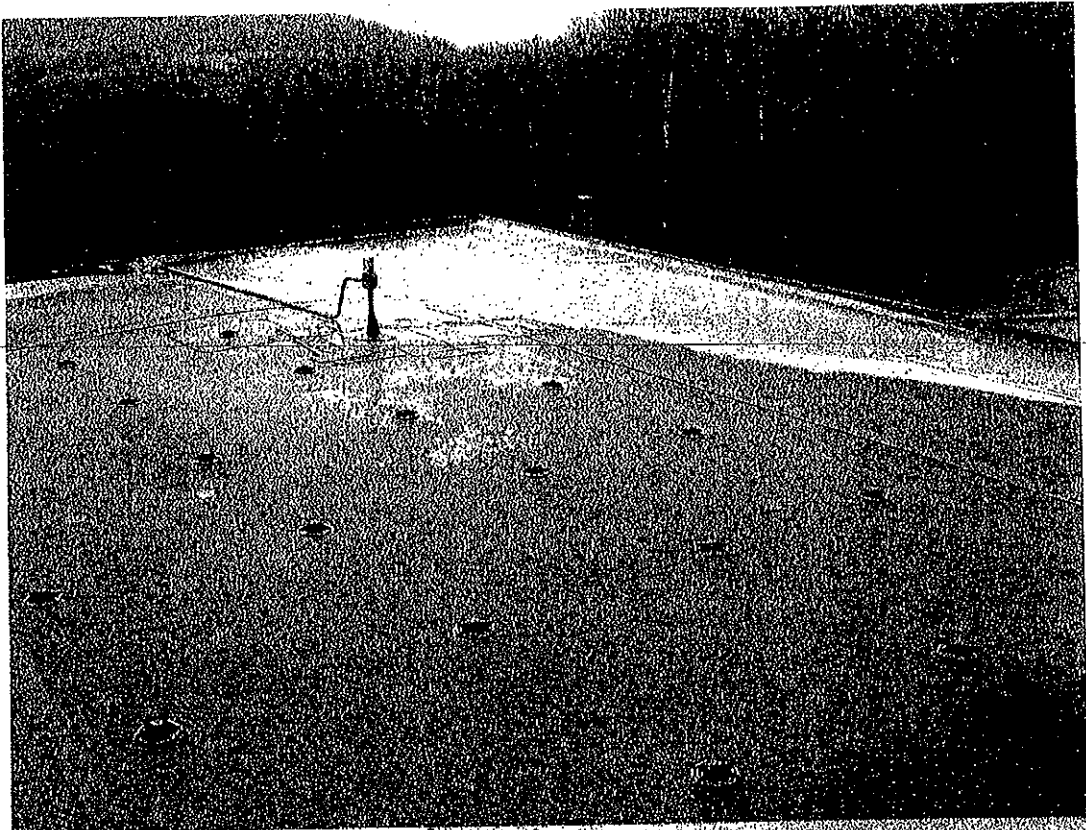
Photo 35. Water Ponding at Corner of Roof

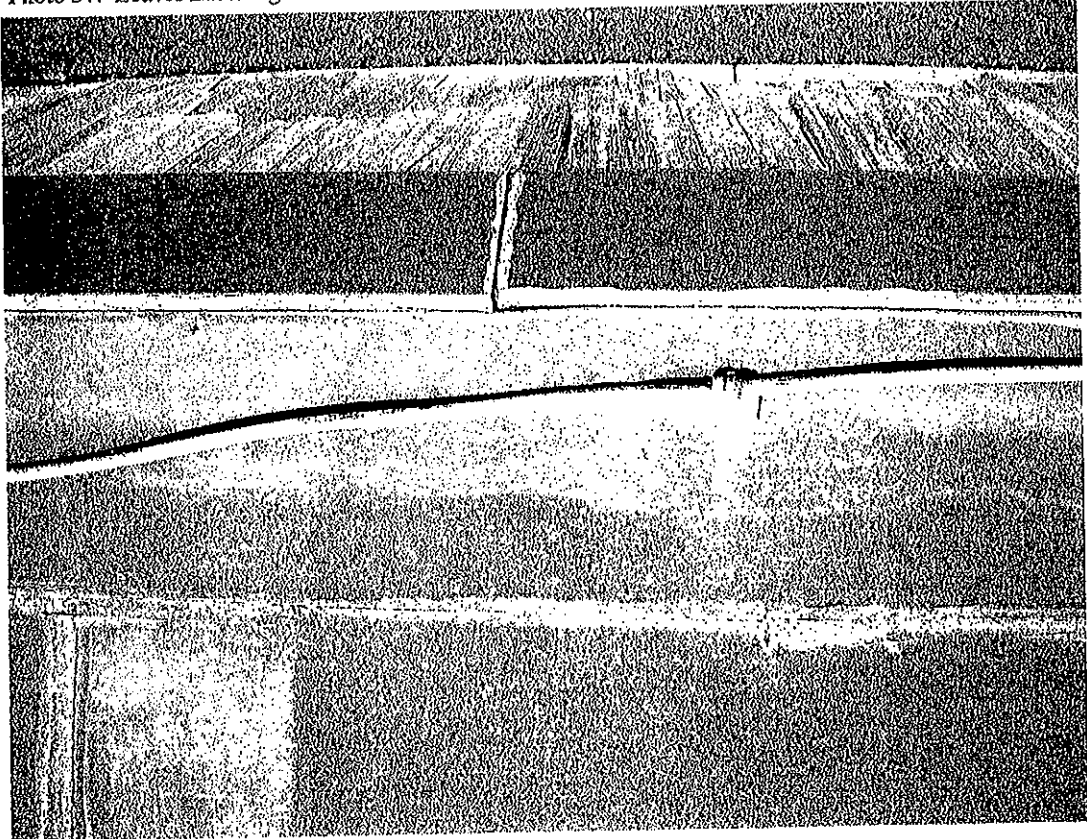
- The existing perimeter joint sealant is inadequate to provide proper protection against moisture penetration
- The cedar shake and flashing for the mansard roof is deteriorated (See Photo 38-Appendix A)

Photo 38. Condition of Flashing at Mansard Roof

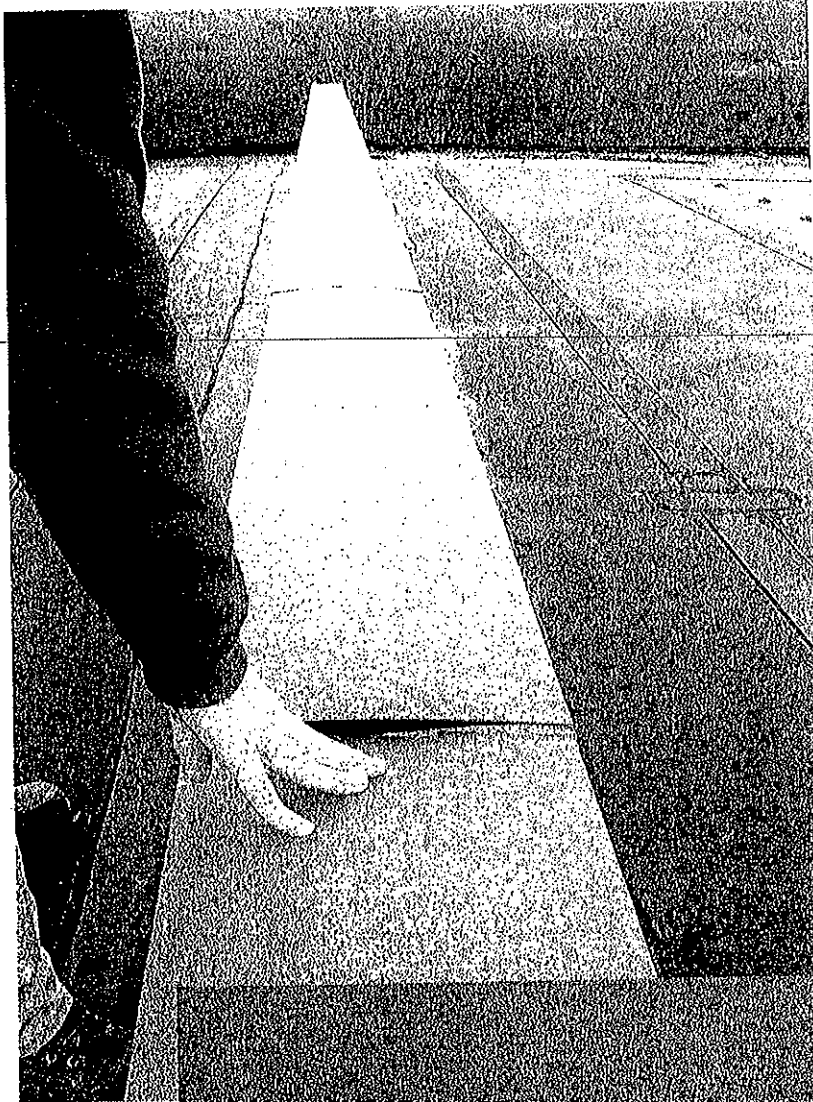
- Open joints in the cap flashing over the block firewall exist (See Photo 39-Appendix A)
- Prior repairs to the roof are showing signs of aging (See Photo 40-Appendix A)
- Peeling paint from the soffit over roof of balcony exists (See Photos 41 and 42-Appendix A)
- The bulkhead was removed at the firewall location after noticing signs of movement (See Photos 43 and 44-Appendix A)

Photo 39. Open Joints in Cap Flashing Over Block Firewall on Raven Lodge

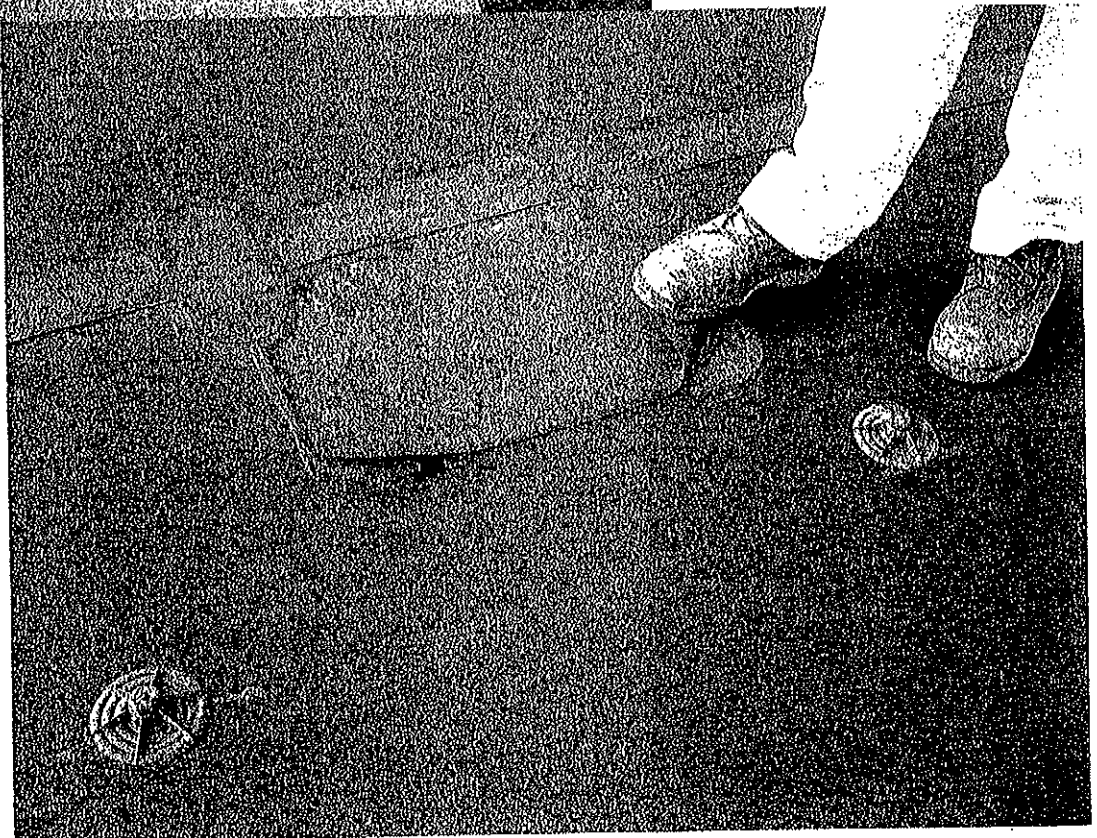
Photo 40. Previous Patches on Roof of Raven Lodge Appear to Be Loose

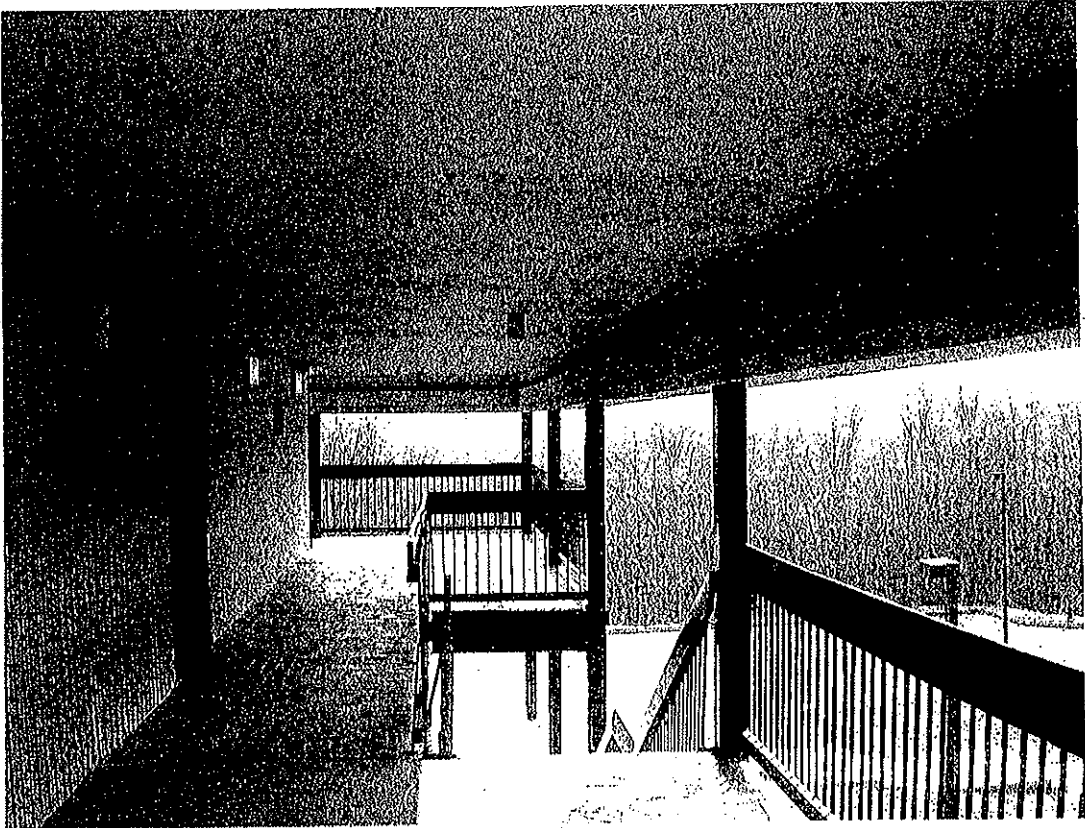
Photo 41. Paint Peeling from Soffit of Roof over Balcony

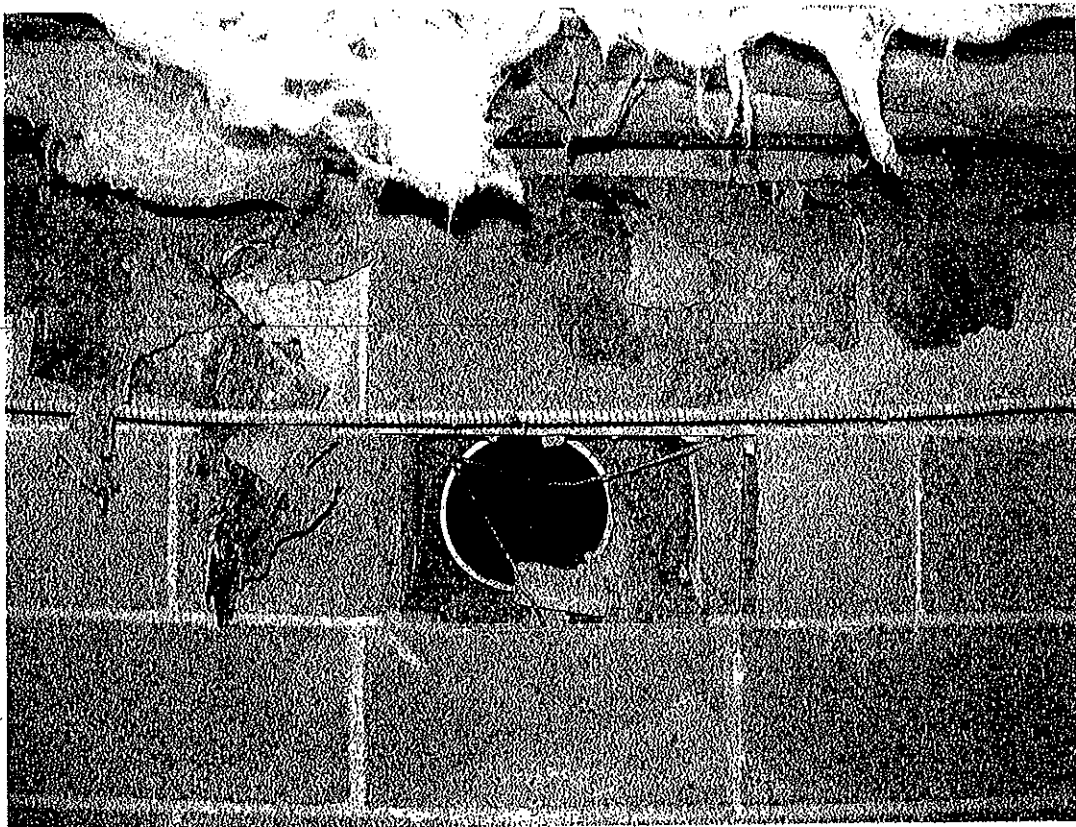
- Missing insulation was observed in numerous locations (See Photo 54-Appendix A)
- **Crawlspace vents are allowing water to enter the crawlspace** (See Photos 51 and 52-Appendix A)

Photo 51. Foundation Vent Pipe through Exterior Wall of Wild Goose Lodge

The existing PVC air vents are permitting water and debris to flow into the crawlspace. Modifications to these functioning air vents would permit water to flow into the existing internal perimeter drainage system while still permitting the passage of air through the crawlspaces. It is recommended to install an 8" PVC "T" onto the existing PVC, with a 4" down leg plumbed to the perforated perimeter pipe. The "T" should not be sealed off on the other end so that air may continue to flow.

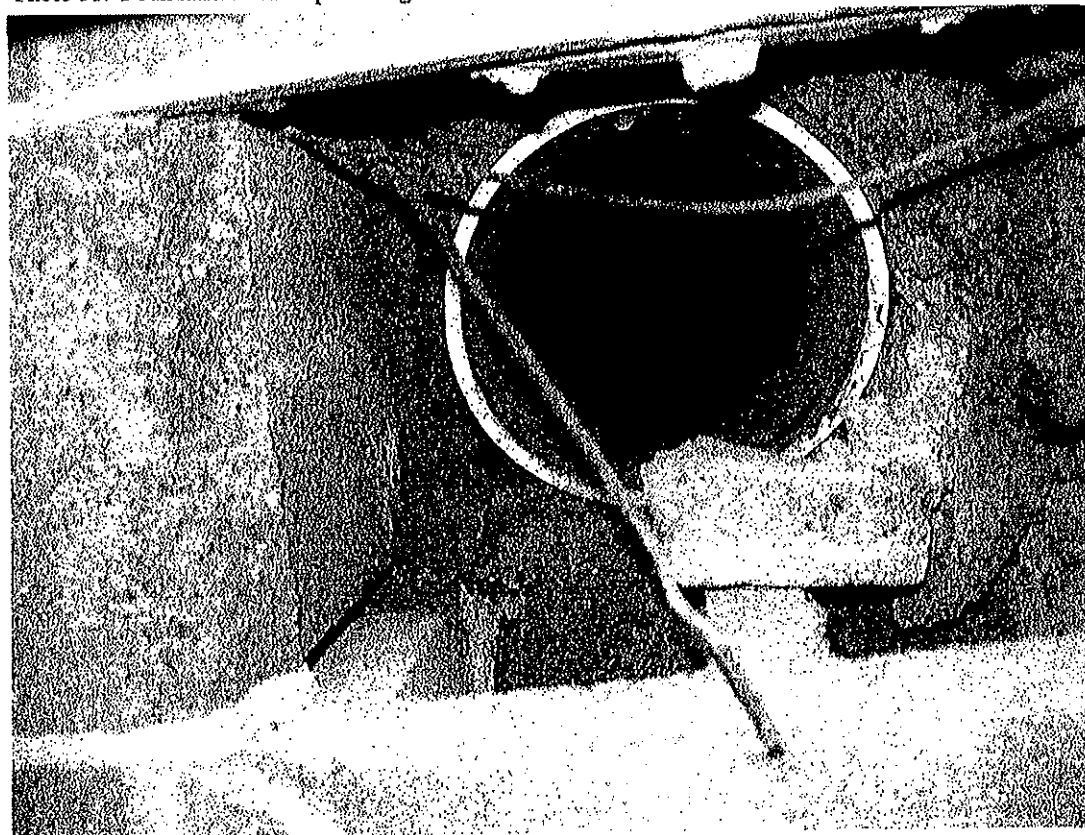
- **Crawlspace vent pipes do not extend through the entire block foundation wall allowing water to dump into the block cores**
- **The depth of the frost wall for the sidewalk and the foundations for the columns supporting the balcony are not below the frost line****

Photo 52. Close-up View of Vent Pipe Showing it Barely Extending in through the Exterior Face of the Foundation Wall

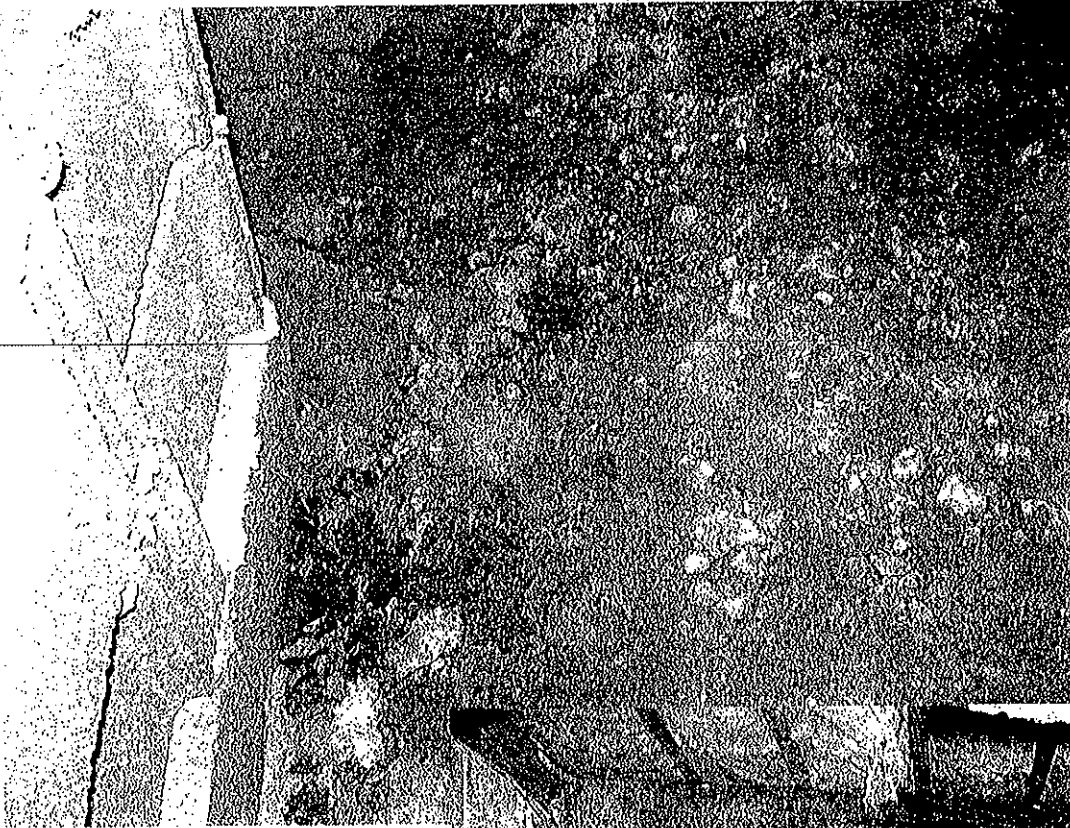
- The crawlspace was noticed to be damp (See Photos 90, 91, and 99-Appendix A)
- **Mold/algae growth in the crawlspace is suspected**
- **The foundation walls and firewall appear to be unreinforced** (See Photo 101-Appendix A)
- **The depth of the frost wall for the sidewalk and the foundations for the columns supporting the balcony are not below the frost line****
- Areas of missing vapor barrier to the bottom side of the first floor framing were noticed (See Photos 90 and 99-Appendix A)
- Missing insulation was observed in numerous locations (See Photos 90 and 99-Appendix A)

Photo 53. Possible Mold or Algae Found in Crawl Space Below Wild Goose Lodge

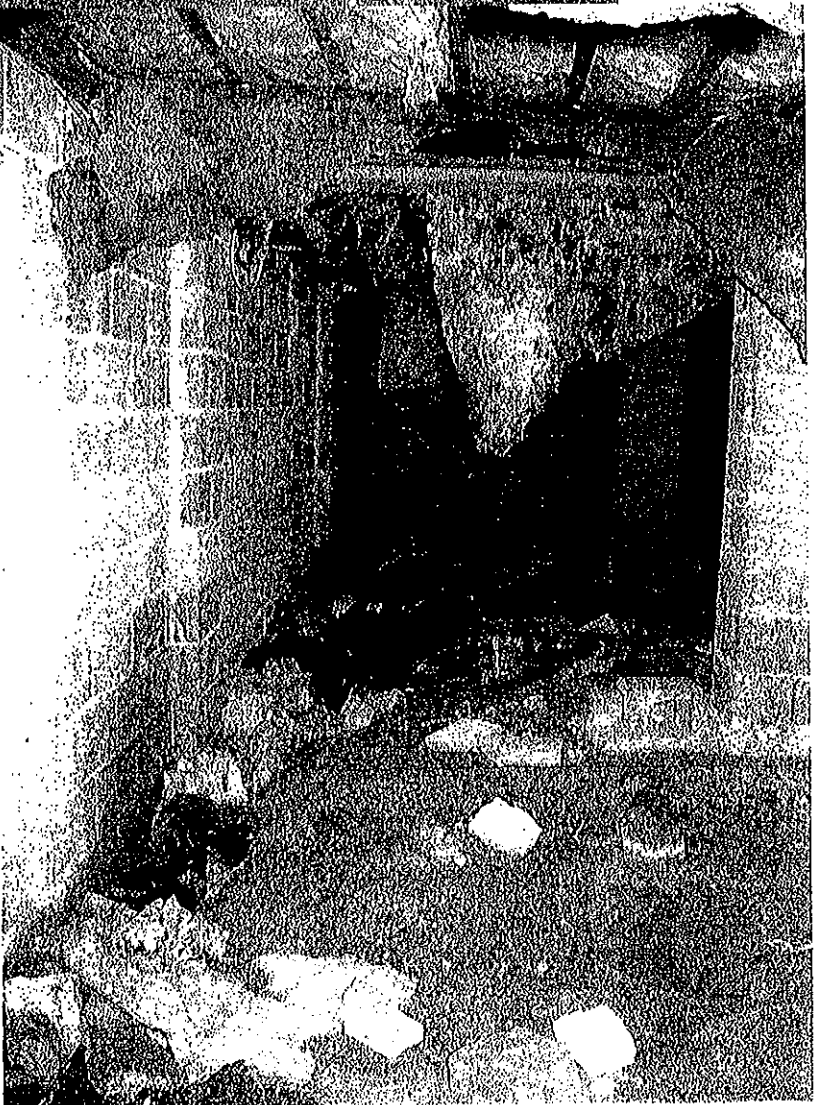
- The crawlspace was noticed to be damp
- Areas of missing vapor barrier to the bottom side of the first floor framing were noticed (See Photo 54-Appendix A)

Photo 54. Condition of Insulation and Vapor Barrier Below Floor Framing as Seen from Within the Crawl Space of Wild Goose Lodge

A vapor barrier is required in isolated locations of the crawlspace. This barrier is applied to the underside of the first floor framing and will minimize moisture damage to the framing.
