RFQ NUMBER
 DNRB11006

EXPRESSION OF INTEREST
Canaan Valley Resort State Park
Sleeping Unit Replacements and Other Improvements
DNRB 211006

Canaan Valley Resort State Park and Conference Center is located in Davis, WV and currently hosts many activities within the park property, including overnight accommodations at the lodge. The purpose of this report is to summarize structural deficiencies and provide recommendations for structural repairs and general maintenance items for the 5 overnight sleeping facilities surrounding the main lodge. The 5 facilities are Raven Lodge, Wild Goose Lodge, Deer Lodge, Woodcock Lodge, and Beaver Lodge, and will be referred to as such throughout the entirety of this report. As part of this report, an Order of Magnitude Cost Estimate for Structural Repairs has been prepared as well as an Order of Magnitude Cost Estimate for General Maintenance Items.

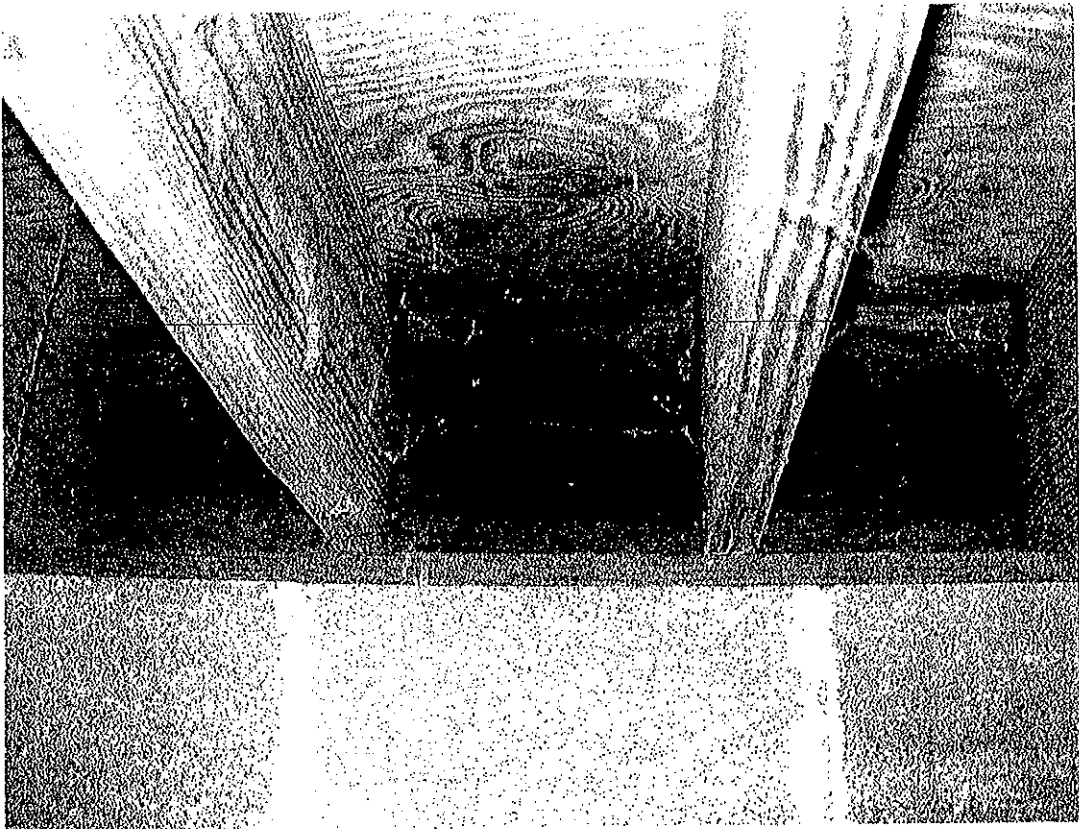
- The wood sill plate and rim joist are showing signs of moisture damage (See Photo 55-Appendix A)
- The floor framing has been modified to allow for the crawlspace entrance (See Photo 56-Appendix A)

Photo 55. Possible Moisture Degradation of Wood Sill Plate

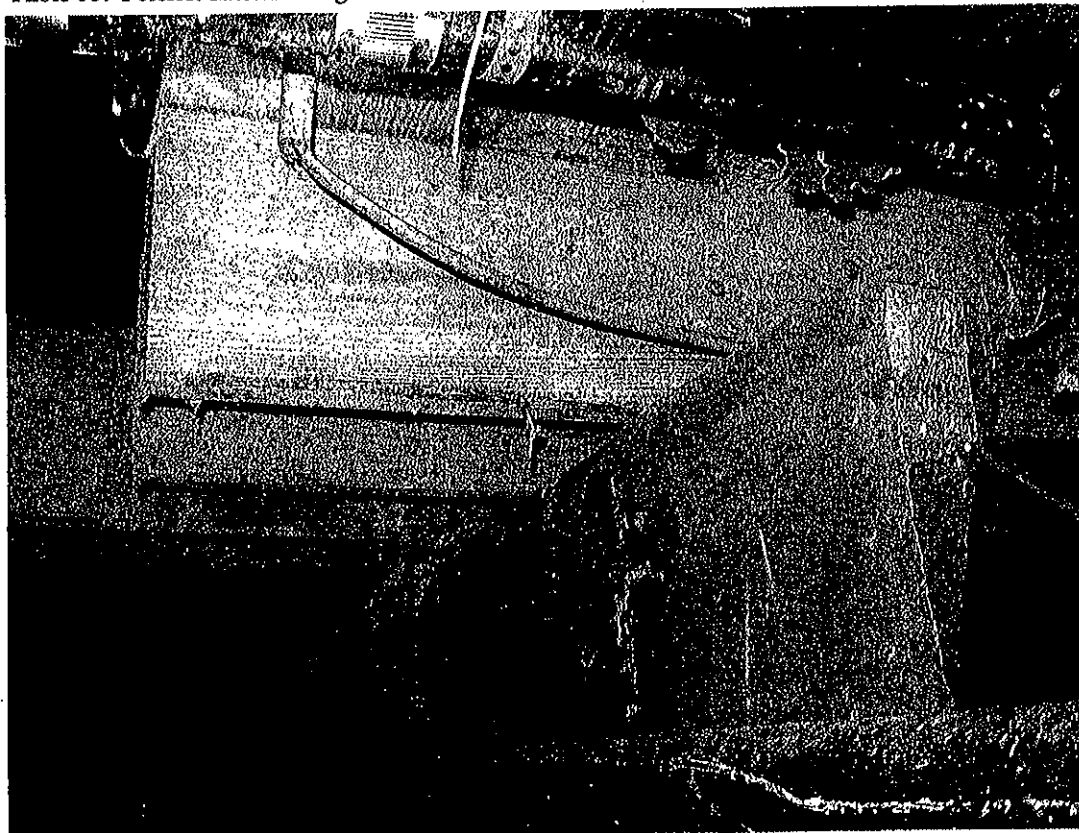
Photo 56. Modified Floor Framing for Crawl Space Access in Wild Goose Lodge

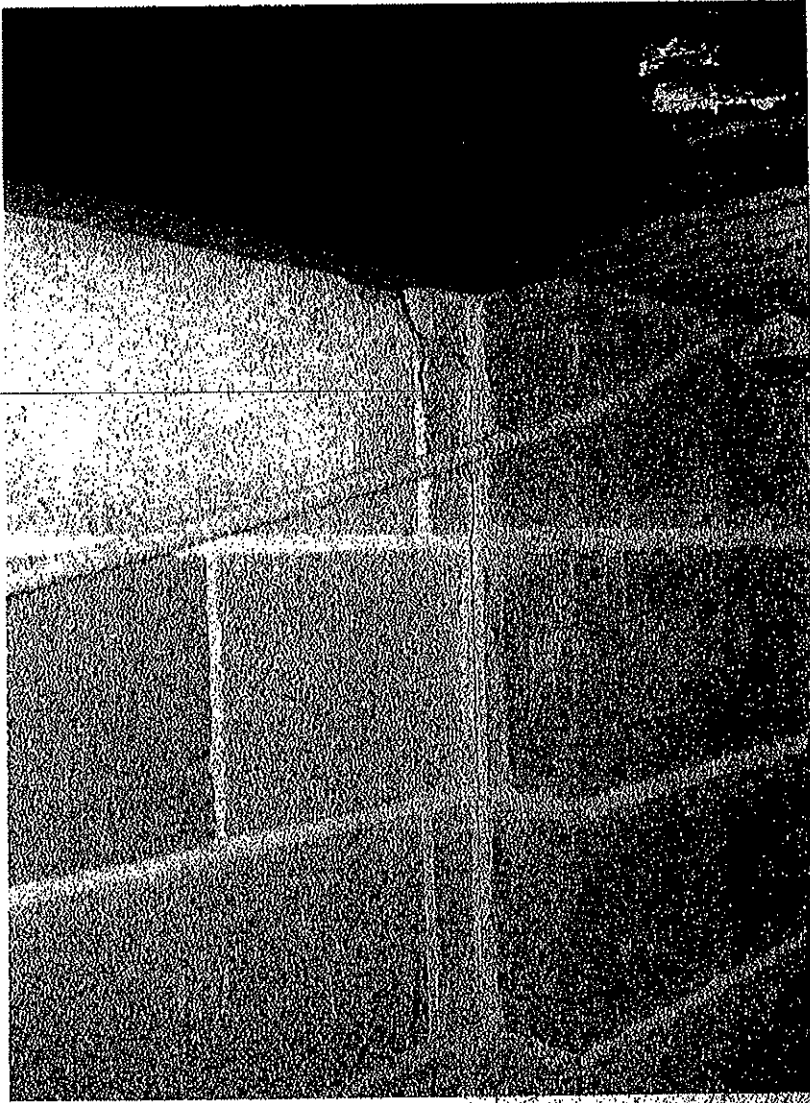
- Local moisture damage to the first floor sheathing exists (See Photo 57-Appendix A)
- **One of the pilasters supporting first floor framing is pulling away from the foundation wall** (See Photo 58-Appendix A)

Photo 58. Block Pilaster Supporting Framing Between Units is Pulling Away from Foundation Wall

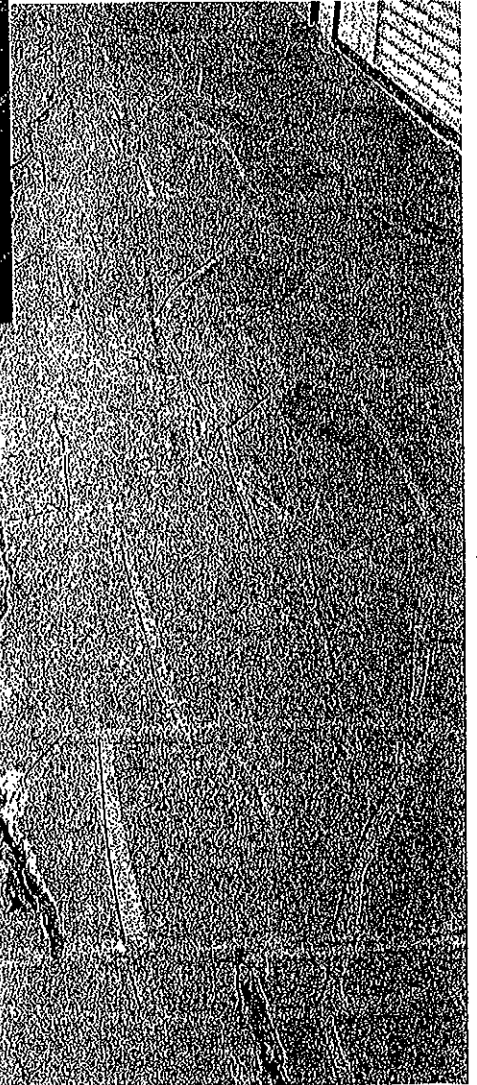
- **One of the pilasters supporting first floor framing is showing evidence of cracking at the exterior foundation wall** (See Photo 59-Appendix A)

Photo 59. Another Pilaster Shows Evidence of Cracking at Exterior Foundation Wall

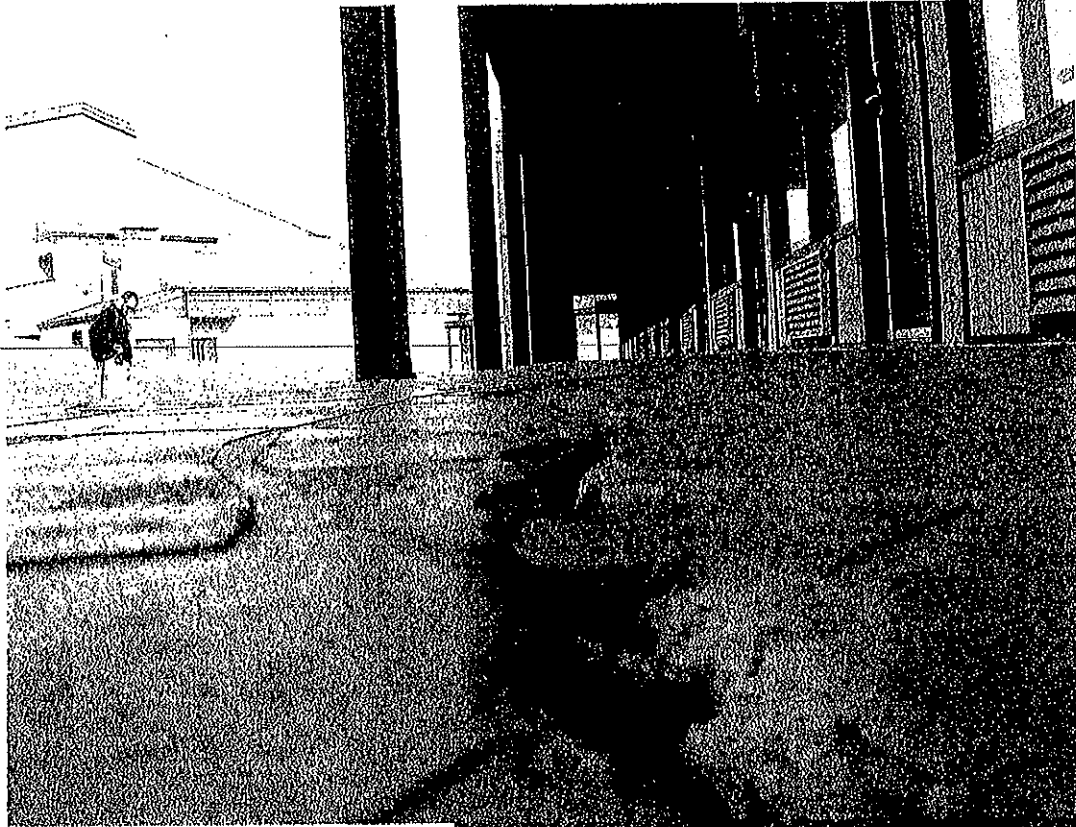
- **The sidewalk slab is cracked and has shifted in elevation (See Photos 60 and 61-Appendix A)**

Photo 60. Cracked Sidewalk Slab at Wild Goose Lodge

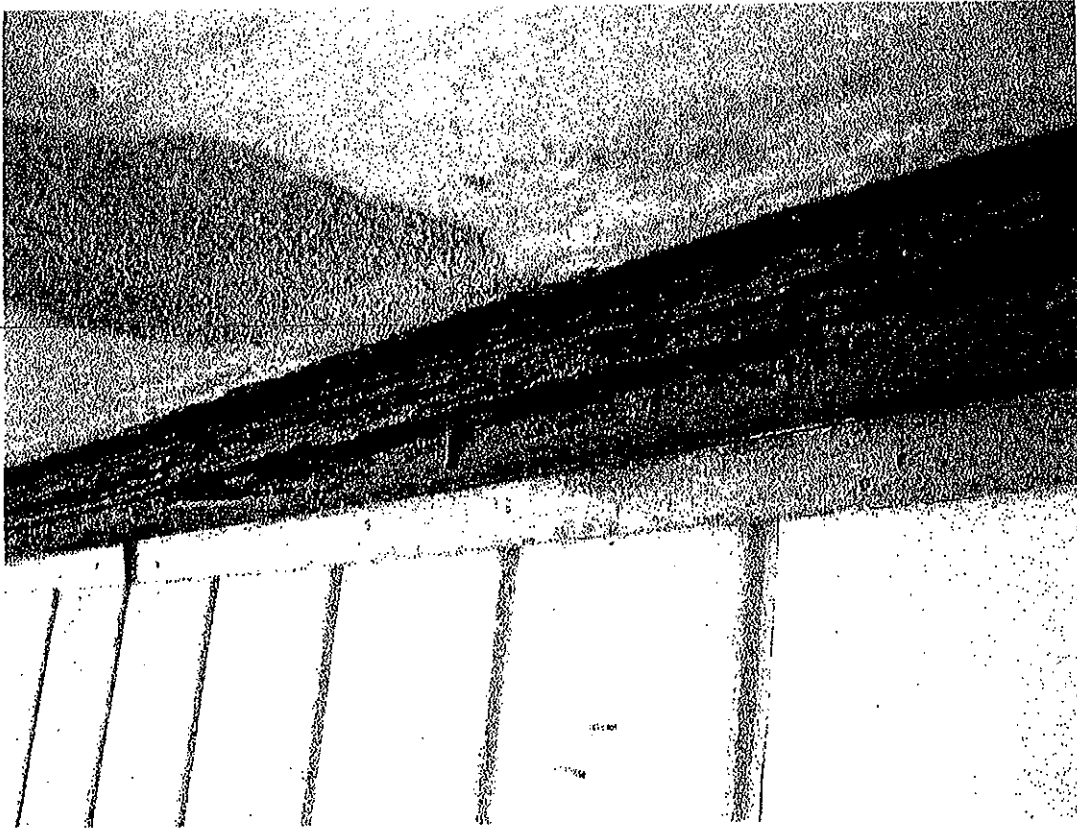
Photo 63. Deteriorated Steel Angle at Face of Building Units

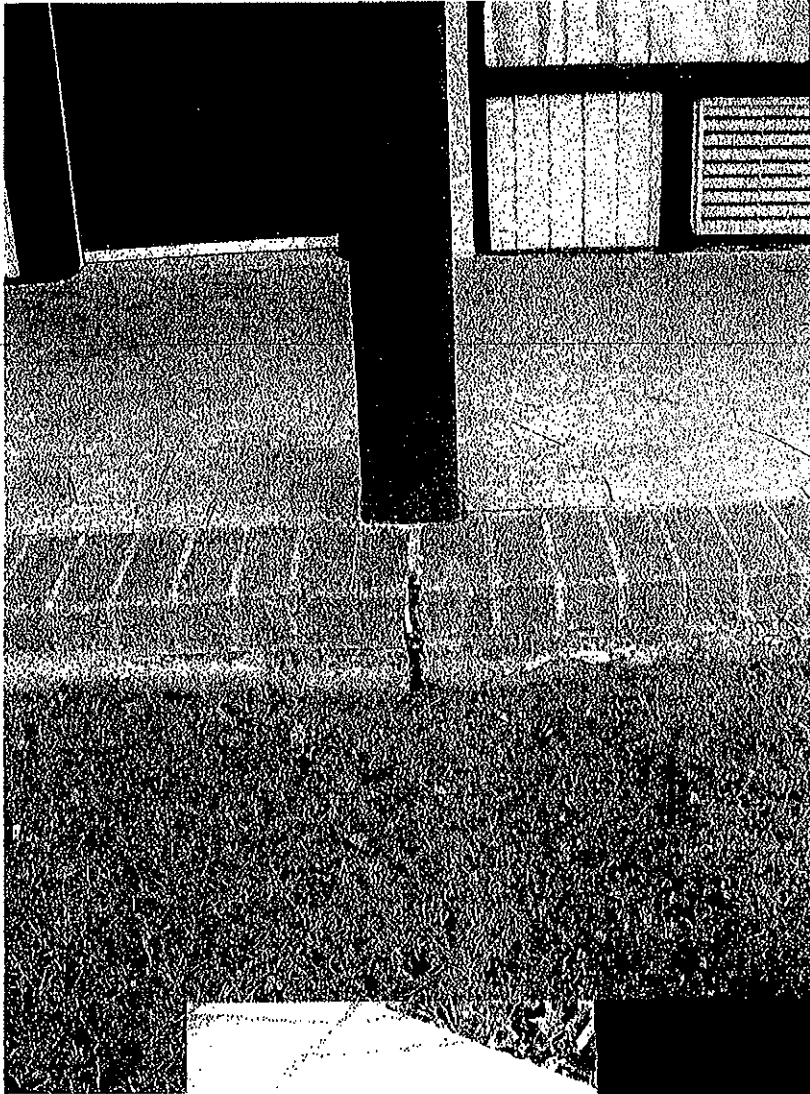
- The balcony structure is aging and showing signs of deterioration
- **The structural steel tube columns are being used as downspouts - holes have been drilled at the bases of certain columns to allow water to pass (See Photo 65-Appendix A)**
- Prior repairs to the beams supporting the concrete deck are evident
- Structural steel angle below the railing has been removed during prior structural repairs
- Structural steel (exterior columns, beams, and stairs) deterioration is prevalent (See Photos 63 and 66-Appendix A)
- Concrete slab deterioration is prevalent. **Cracking has occurred on the topside and underside of most every slab section (See Photo 64-Appendix A)**
- Staining has occurred on the slabs from the corroding structural steel
- **The wood railing is showing signs of deterioration (See Photo 72-Appendix A)**

Photo 65. Hole Drilled in Tube Column/Downspout at Wild Goose Lodge

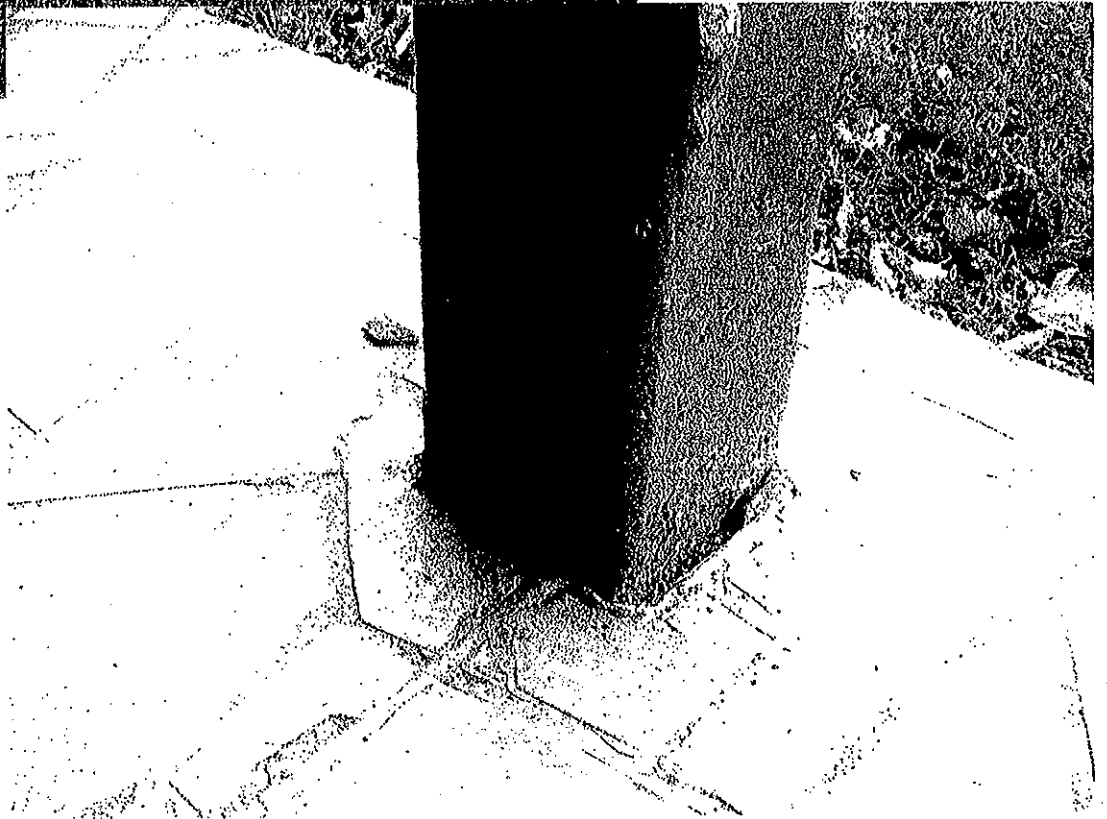
Photo 66. Deteriorated Steel Tube Column at Wild Goose Lodge

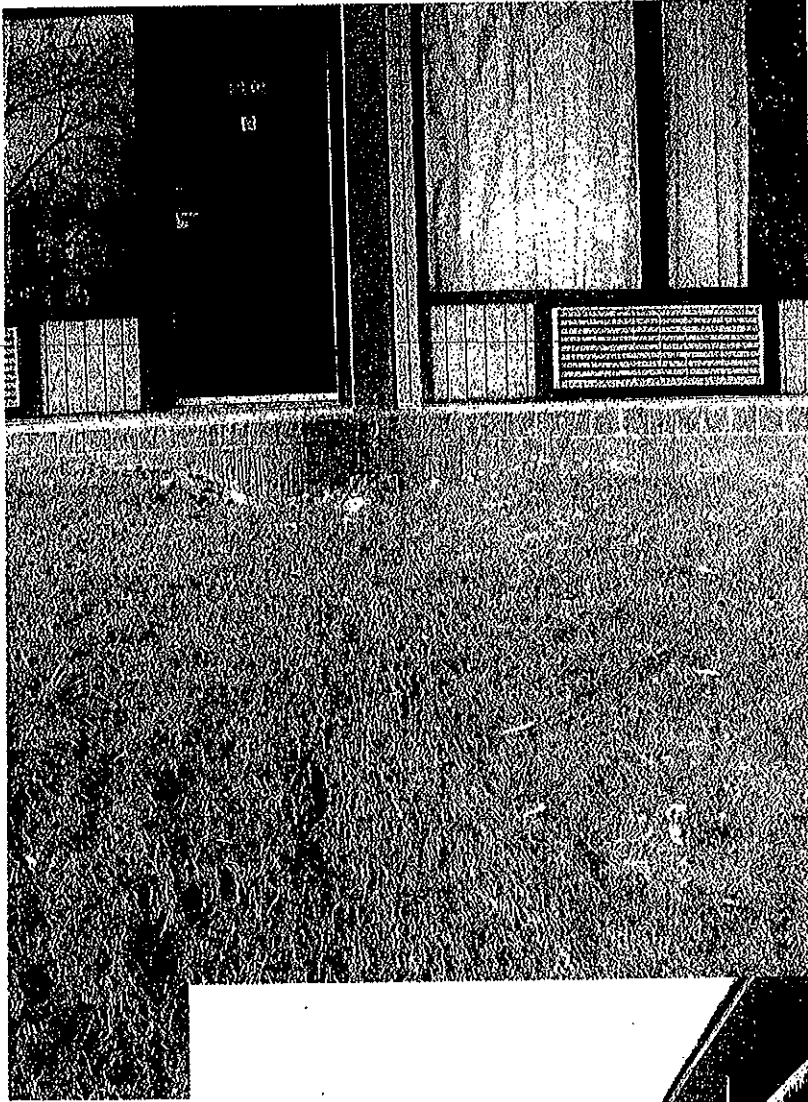
Photo 67. Erosion Due to Downspout/Roof Drain

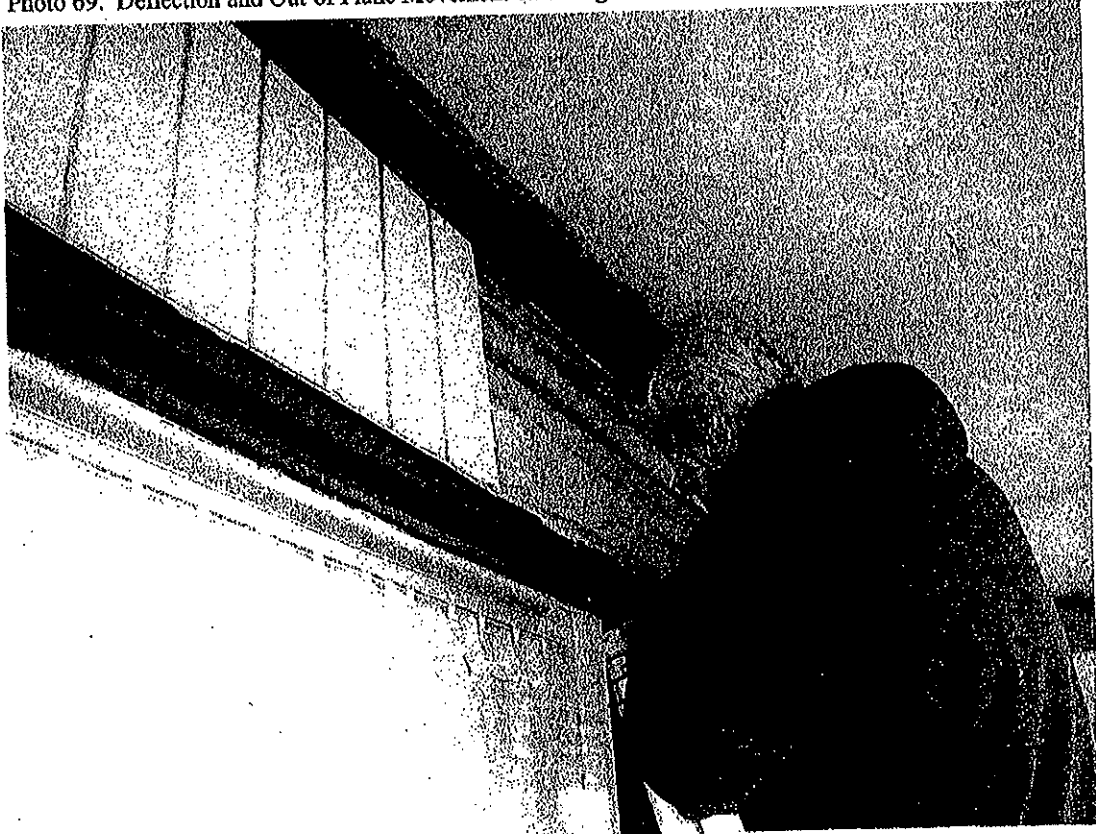
Photo 70. Siding Removal Shows Framing and Moisture Barrier

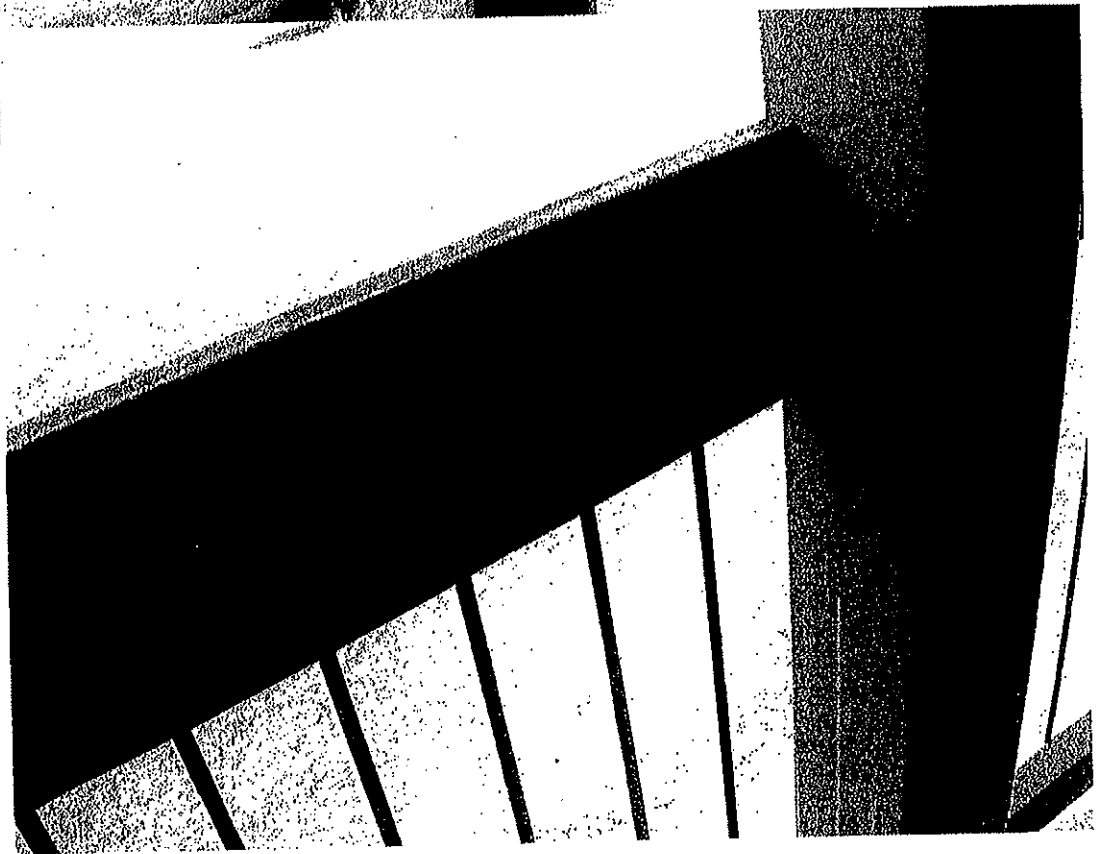
Photo 72. Deteriorated Section of Wood Railing at Balcony

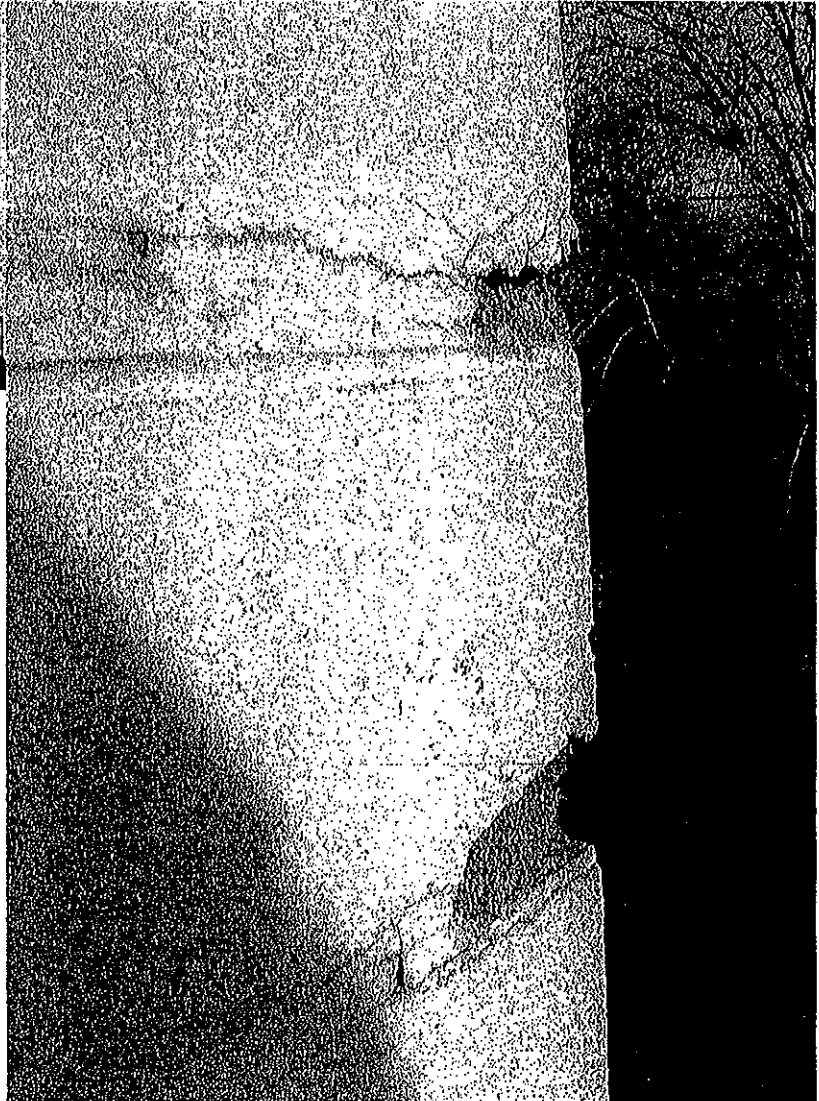
- Supplemental framing has been added below the telephone equipment room (See Photo 49-Appendix A)
- **The foundation walls and firewall appear to be unreinforced** (See Photo 75-Appendix A)

Photo 75. Block was Sounded to Determine if Reinforcing was Installed During Construction

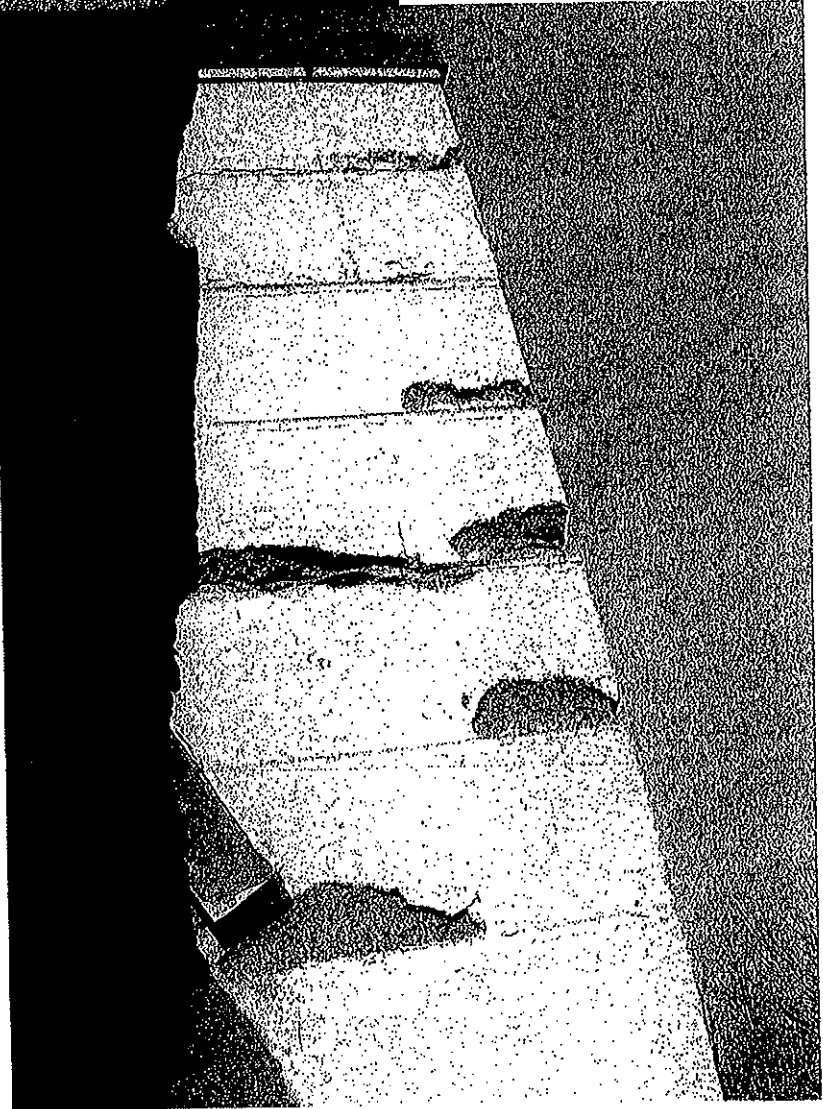
- **The exterior portion of the firewall that extends beyond the face of the building is showing signs of movement and deterioration (See Photos 73, 74, 76, 77, and 78-Appendix A)**
- The structural steel supporting the balcony has caused staining on the T1-11 siding
- Erosion due to the downspout/roof drain is evident (See Photo 67-Appendix A)
- The existing perimeter joint sealant is inadequate to provide proper protection against moisture penetration
- The cedar shake on the mansard roof is deteriorated
- The T1-11 siding is warped at numerous locations (See Photo 62 and 69-Appendix A)
- The outside face of the sleeping room doors are weathered
- **Limited ventilation for the mansard roof exists and is causing the paint to peel at the soffit**

Photo 78. Another View of Deteriorated Block Pier

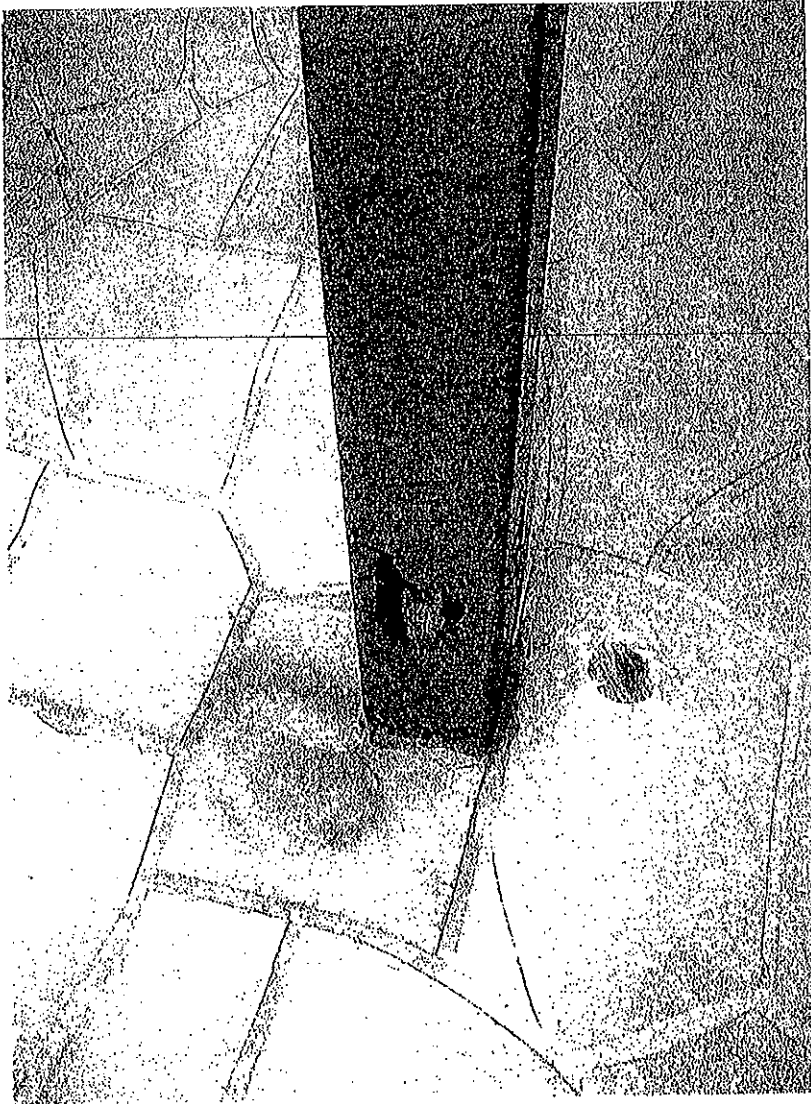
- Peeling paint on the fascia board of the covered walkway between the Main Lodge and Deer Lodge exists (See Photo 83-Appendix A)
- **Steel deterioration exists at one of the tube columns between the Main Lodge and Deer Lodge** (See Photo 85-Appendix A)
- New soffit has been installed between Deer Lodge and Woodcock Lodge (See Photo 88-Appendix A)

Photo 85. One Steel Tube Column is Rusted to the Point that There is a Hole in the Side

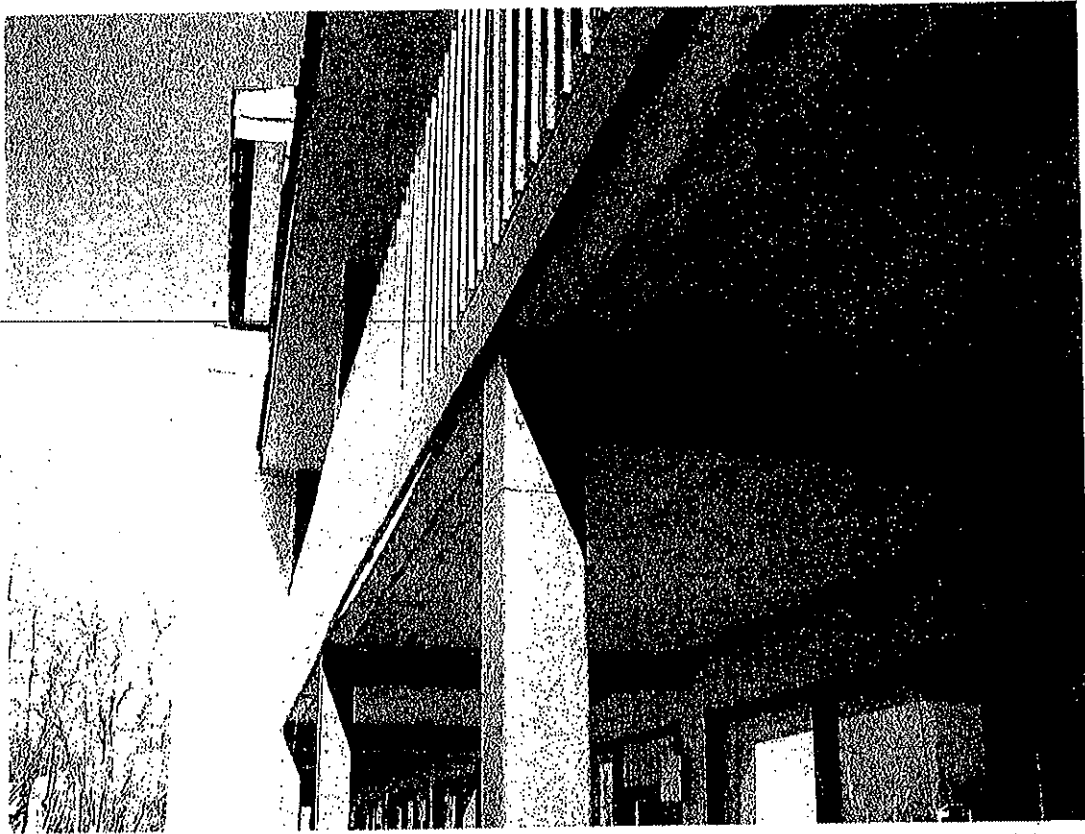
- Structural steel angle below the railing has been removed during prior structural repairs (See Photo 93-Appendix A)
- **Structural steel (exterior columns, beams, angles and stairs) deterioration is prevalent** (See Photos 94 and 107-Appendix A)
- Concrete slab deterioration is prevalent. **Cracking has occurred on the topside and underside of most every slab section** (See Photos 95 and 107-Appendix A)
- Staining has occurred on the slabs from the corroding structural steel

Photo 93. Edge Angle Removed and Wood Band Board Added at Face of Balcony—Note Rust Staining

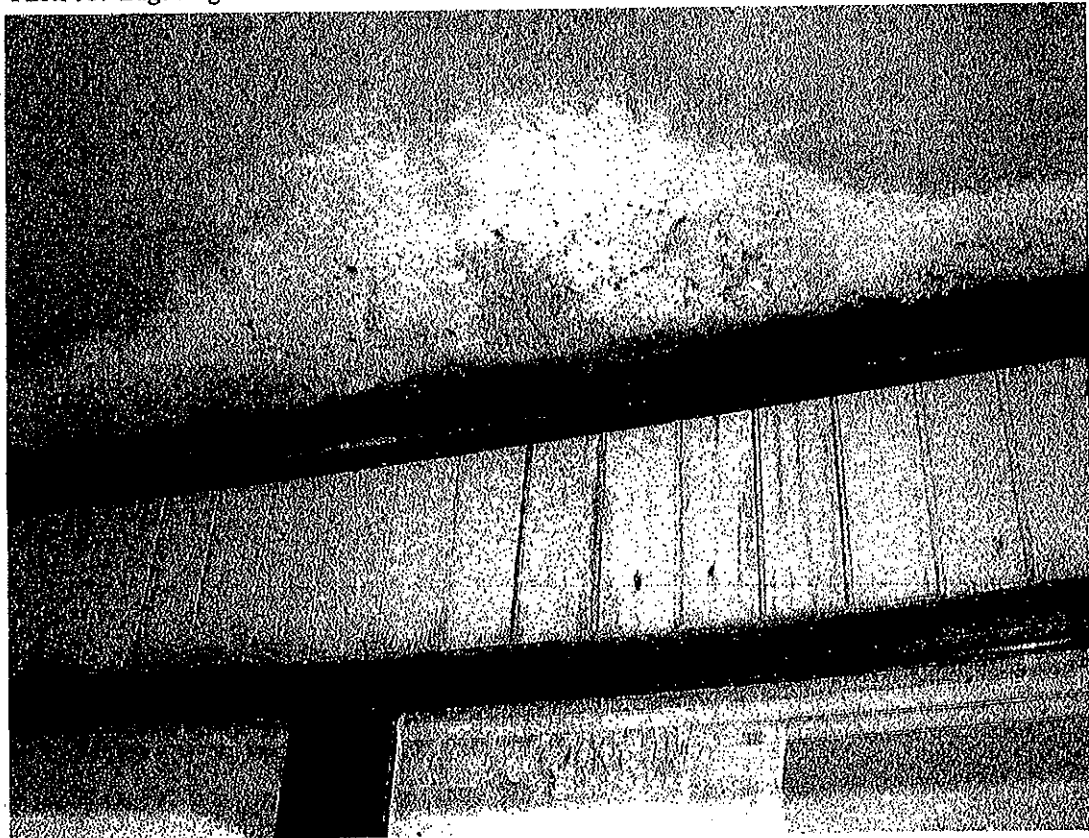
Photo 94. Extreme Delamination of Steel Angle and Rust Staining at Face of Unit at Deer Lodge

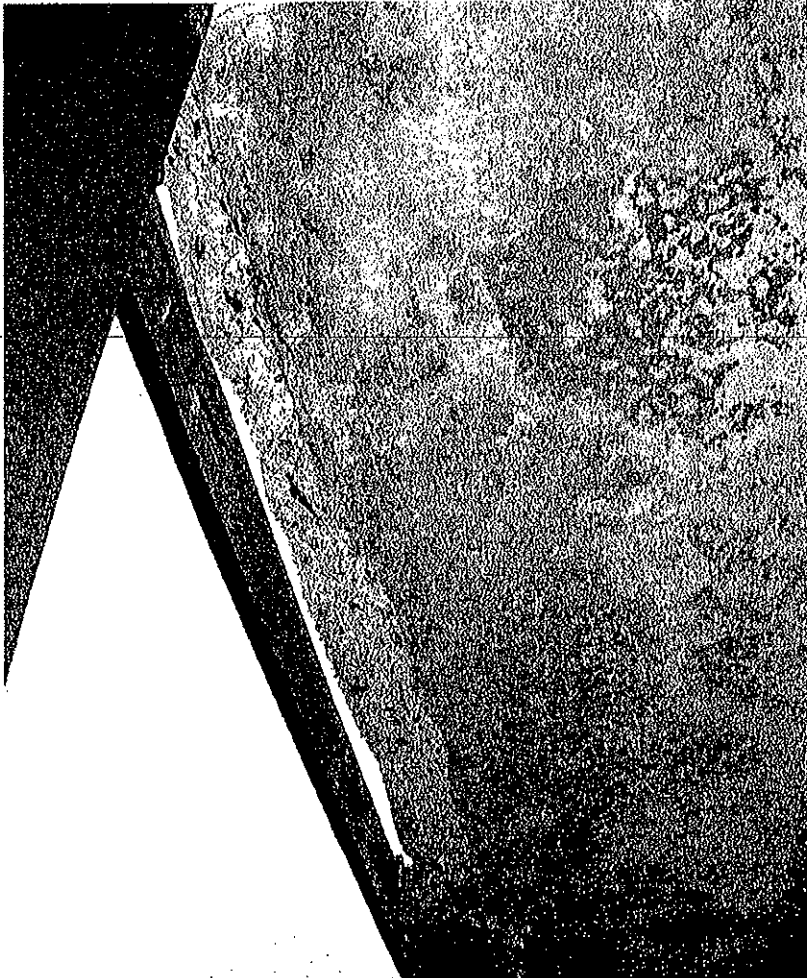
Photo 95. Deteriorated Concrete Balcony Slab at Deer Lodge

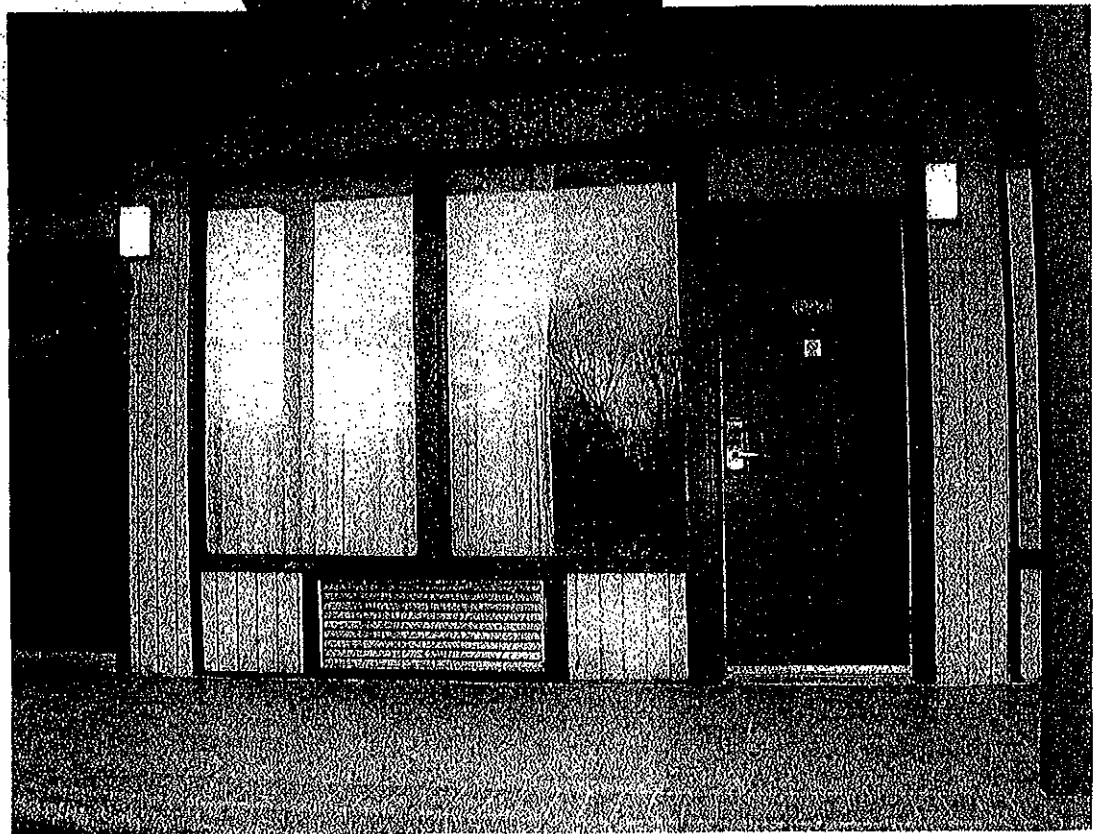
Photo 96. Another View of Extreme Rust Staining at Face of Unit at Deer Lodge

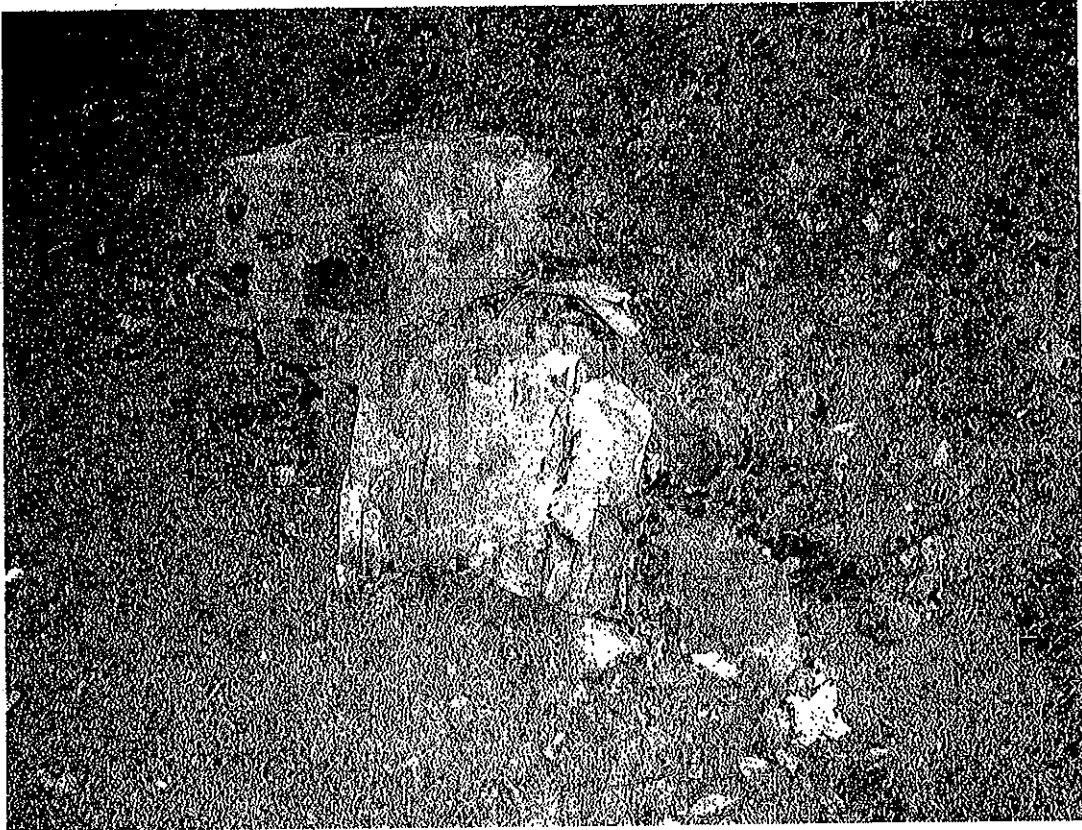
Photo 113. Damaged Headwall at Drainage Pipe
