RFQ NUMBER
DNRB11007

EXPRESSION OF INTEREST Cacapon Resort State Park Dams Engineering Investigation and Certificate of Approval

**PERIODIC DAM INSPECTION (2009)
CACAPON STATE PARK LAKE DAM
(INDIAN RUN DAM - LOWER)
ID # 06503
MORGAN COUNTY, WEST VIRGINIA**

**PERIODIC DAM INSPECTION (2009)
CACAPON STATE PARK RESERVOIR DAM
(UPPER DAM)
ID # 06502
MORGAN COUNTY, WEST VIRGINIA**

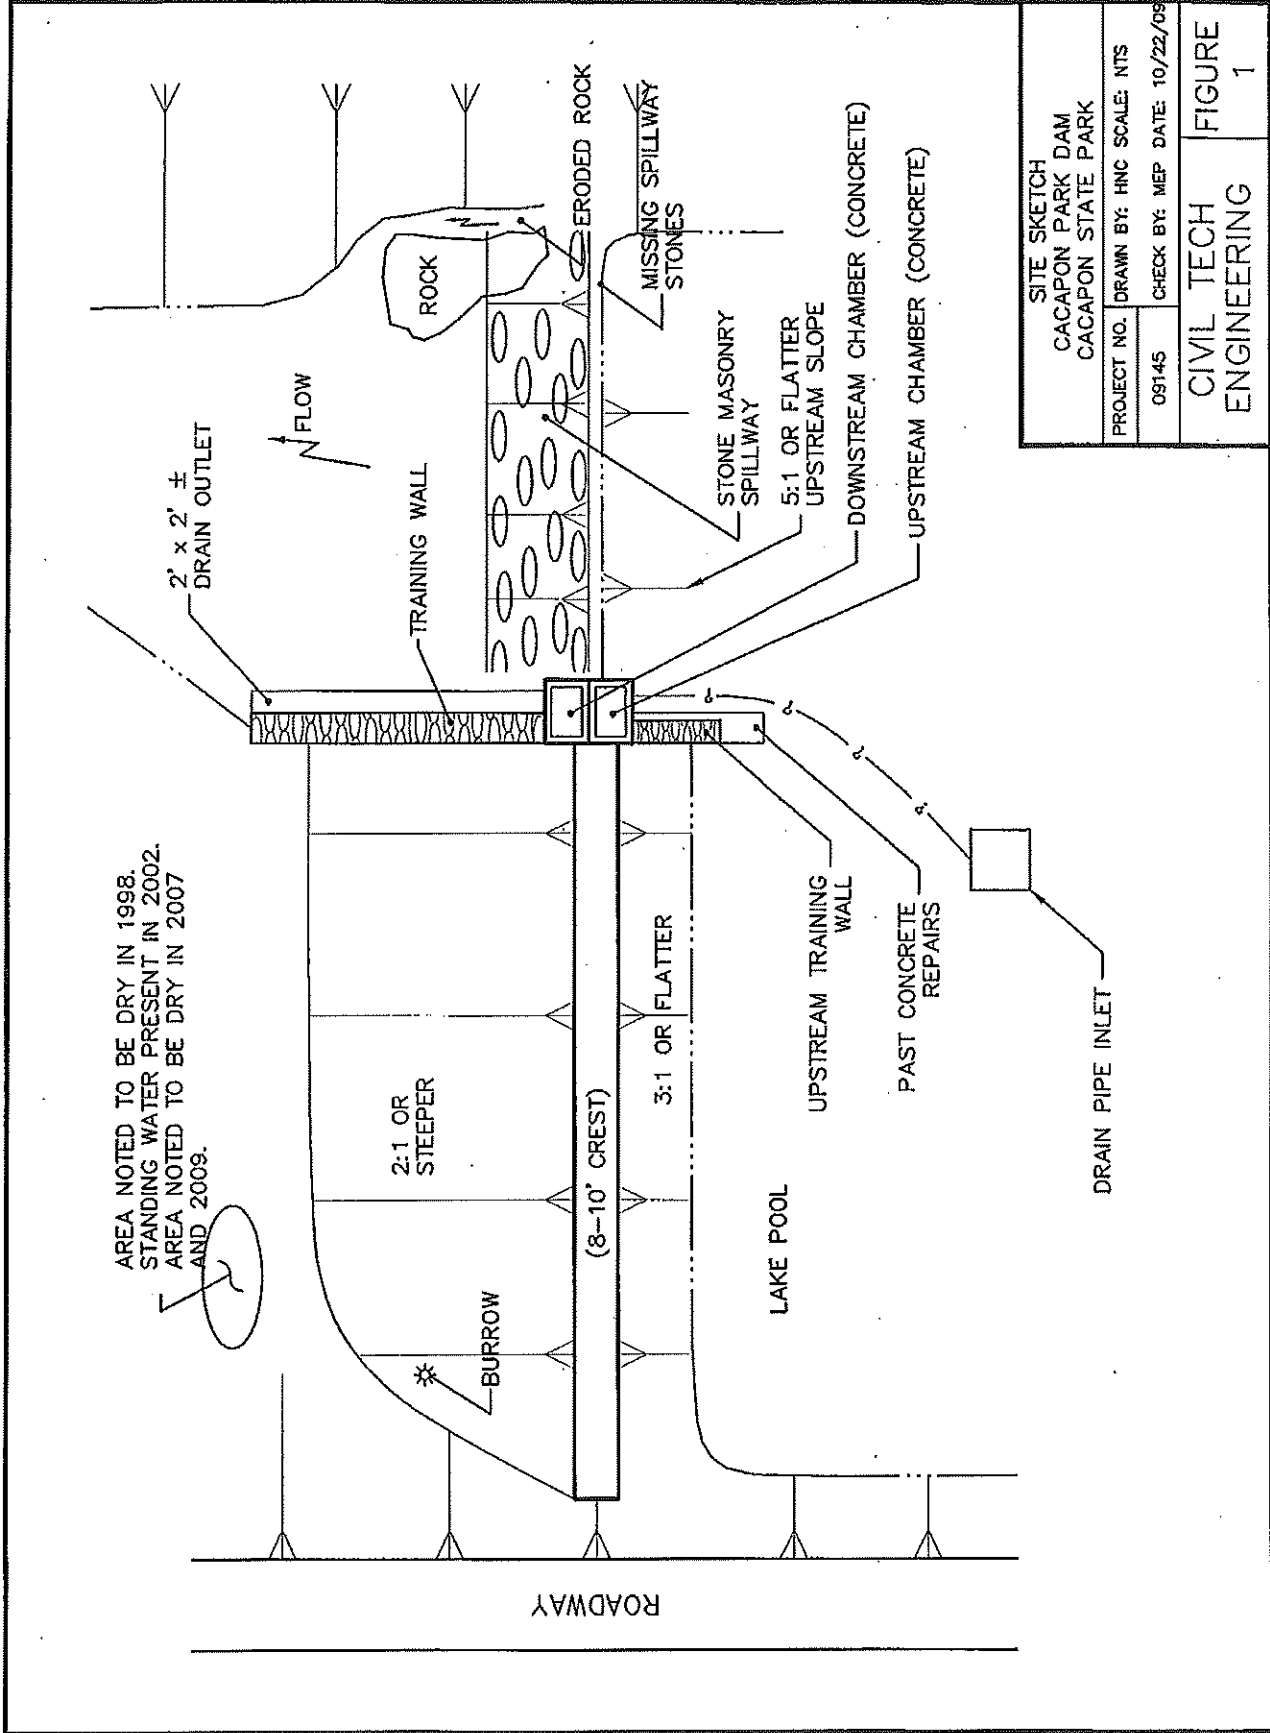
SITE SKETCH CACAPON PARK DAM CACAPON STATE PARK	
PROJECT NO. 09145 DRAWN BY: HNC SCALE: NTS	CHECK BY: MEP DATE: 10/22/09
CIVIL TECH ENGINEERING	
FIGURE 1

4. An animal burrow was observed on the left side of the dam near the toe and left groin area during our inspection performed in 1998. See Figure 1. This burrow was not visible during the 2002 inspection and was observed to be inactive during the recent 2007 inspection. The burrow was not present at the time of this inspection.

5. Similar to our past inspections, no seepage was noted on the slope or at the toe of the dam. Based on our review of past inspection reports, a wet area has been noted to be present downstream of the toe of the dam on the left side as shown on Figure 1. This area was dry during our recent inspection as well as the inspections performed in 2007, 2005, and 1998. However, standing water was present in this area during our 2002 inspection. The reader will note, it was raining during that inspection and this area is poorly drained. Since the area is currently dry and was dry in 2007, 2005, and 1998, it is our opinion the source of this water is surface runoff and poor drainage, not seepage from the dam.

AREA NOTED TO BE DRY IN 1998.
 STANDING WATER PRESENT IN 2002.
 AREA NOTED TO BE DRY IN 2007
 AND 2009.

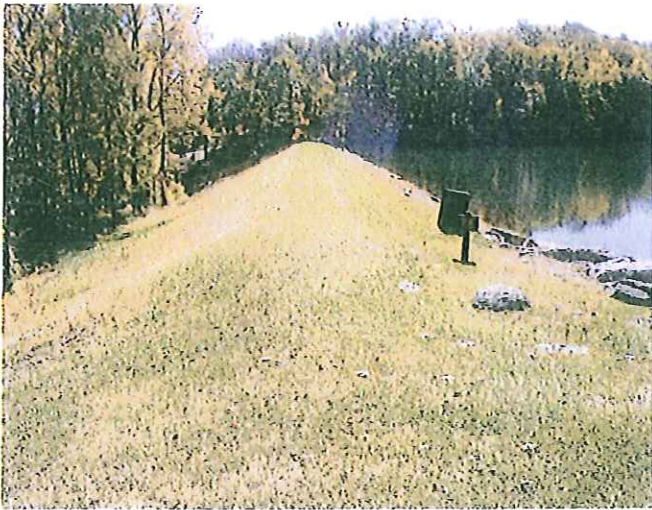
Dam Crest: The dam crest is relatively uniform with no apparent signs of subsidence or erosion. See Photo No.s 1 and 2. The following was noted:

Photo No. 1: Dam crest facing right.

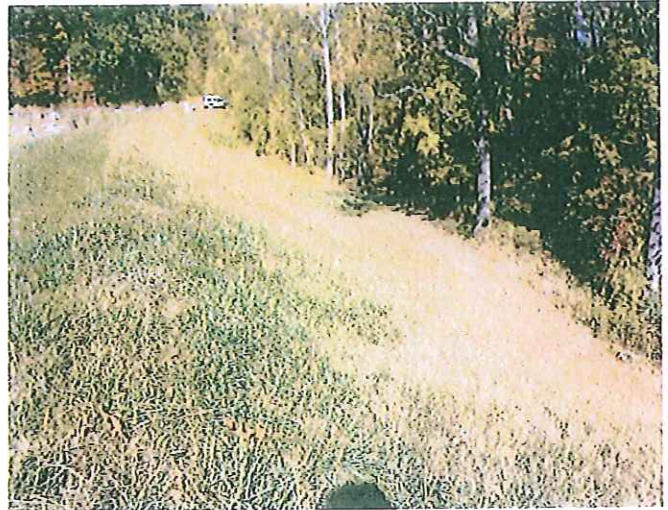
Downstream Slope: The downstream dam embankment is slightly irregular, but did not exhibit any signs of slope instability or seepage. See Photo No.s 3 and 4. The following was noted:

Photo No. 4: Downstream slope facing left.

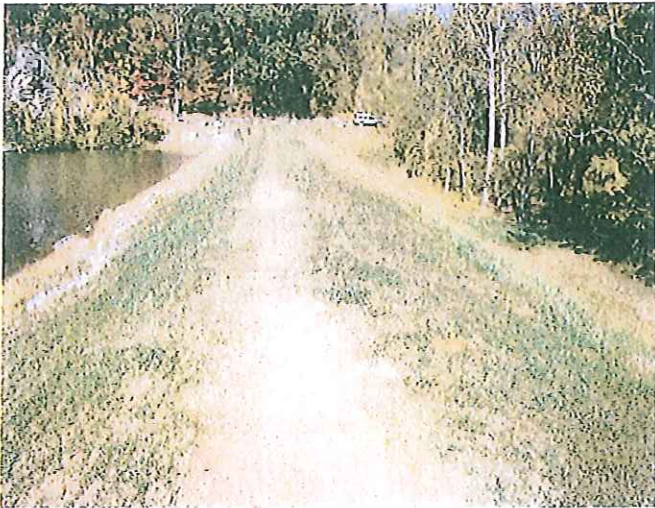
Photo No. 2: Dam crest facing left.

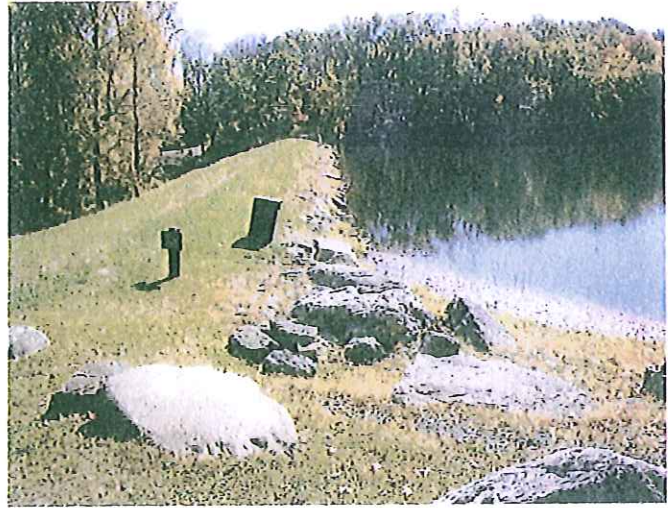
Upstream: The upstream embankment slope was uniformly grass covered and showed no signs of slope instability. See Photograph Nos. 5 and 6 for views of the upstream embankment slope. The following was noted:

Photo No. 5: Upstream slope facing right.

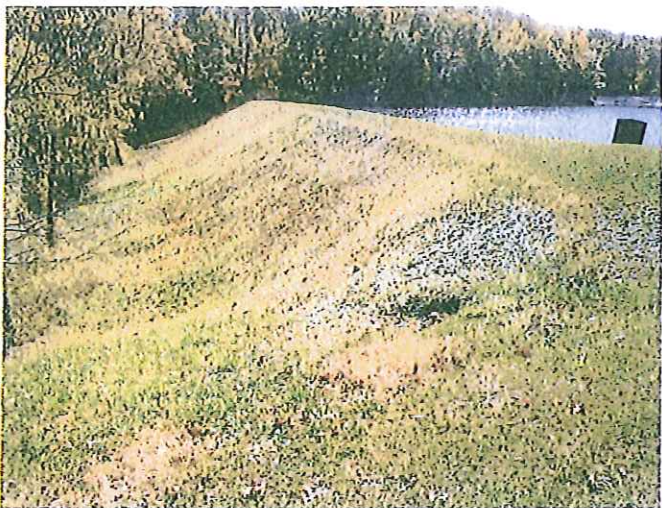
3. Several large tree stumps were present on the downstream slope where trees had been removed in the past. These stumps have generally rotted and are no longer visible. However, depressions in the ground surface can be seen where the stumps were located. These areas should be monitored for seepage in the future. A prominent hole resulting from stump rot is visible in the left groin near the dam crest and can be seen in Photo 3.

Photo No. 3: Downstream slope facing right.

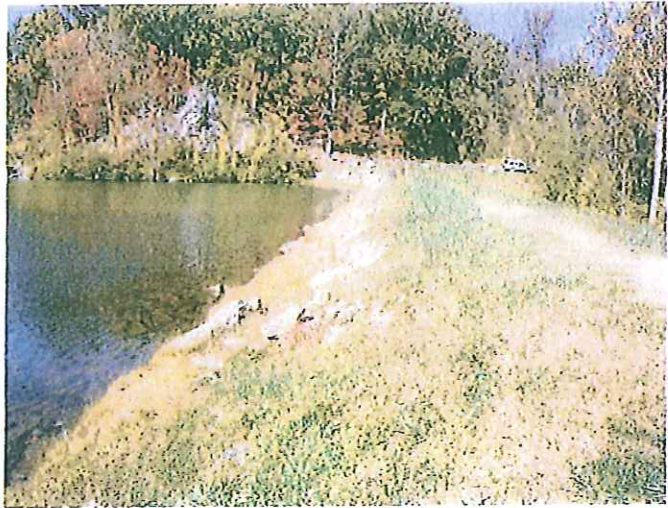
Photo No. 6: Upstream slope facing left.

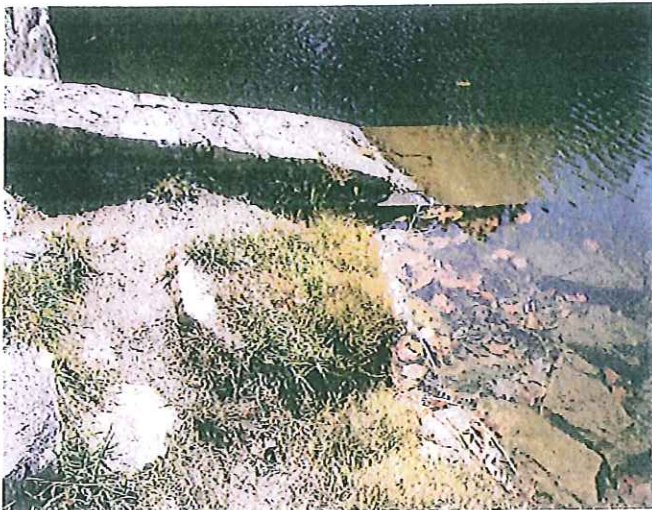
3. In past inspections, several large tree stumps were present on the upstream slope where trees were removed. During our 2002 inspection, it was noted these stumps were beginning to rot and a hole was present in the slope adjacent to a stump located close to the spillway. This stump was removed and the hole was filled following our 2002 inspection. See Photo No. 7.

Photo No. 7: Old stump removed and hole filled near the principal spillway guide wall.

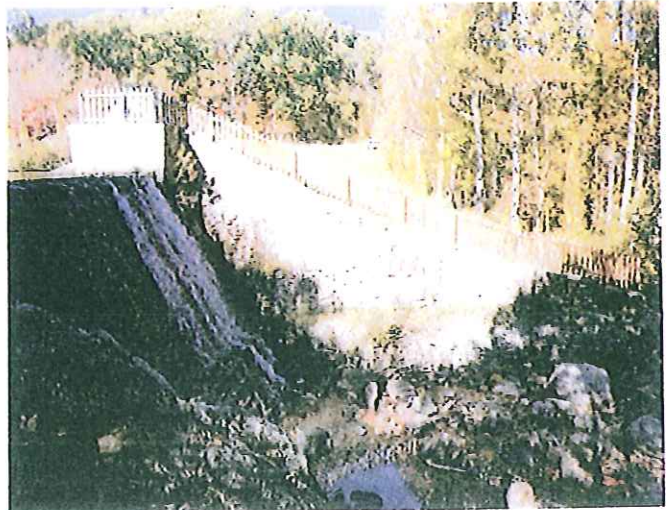
Photo No. 10: Left spillway wall.

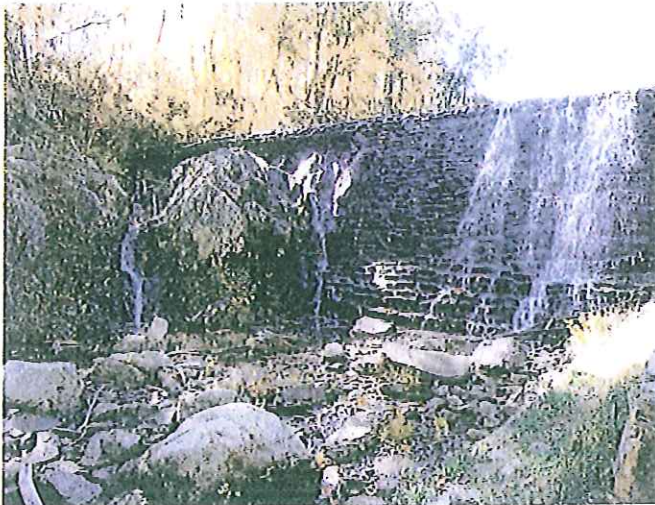
As mentioned previously, normal pool is maintained by a stone masonry spillway located within the right abutment of the dam (right facing downstream). See Figure 1 and Photograph Nos. 8, 9, 15, and 16 for views of the spillway. The following was noted:

Photo No. 8: Principal spillway.

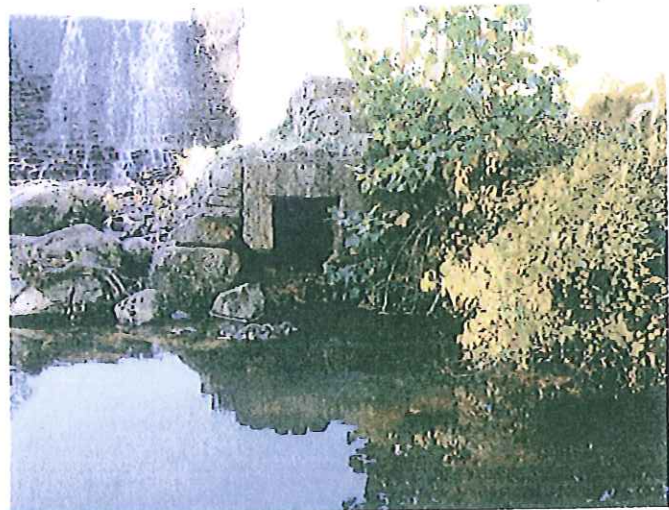
The dam has been constructed with a 2 x 2 ft. concrete box culvert which we believe may serve as a drain pipe for the lake. This box culvert can be seen on Figure 1 and Photo No.11. The following was noted:

Photo No. 11: Box culvert outlet. Flow was observed on this date even though the gate was closed.

1. The seepage occurring within the drain pipe should be monitored for increased flow and/or a change in the flow condition such as muddy flow. If this should occur, immediate investigation and repairs should be implemented.
2. The eroded rock present near the right side of the spillway should be monitored for further erosion. As discussed during our inspection, we believe this area should be filled with concrete and the missing spillway stones replaced to avoid possible loss of pool and more extensive damage.
3. Loose, cracked, and missing mortar in the stone masonry should be repaired as required to maintain the integrity of the riser and left spillway guidewall.

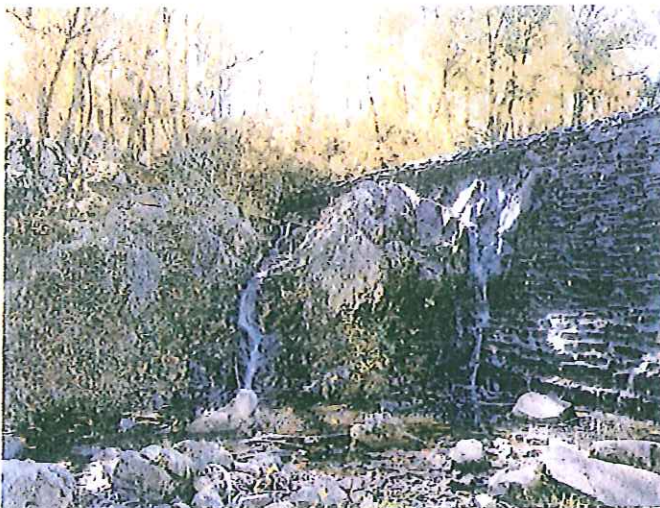
1. The spillway visually appears to be about 50 to 100 ft. wide and has been constructed with an approximate 1/2:1 (H to V) downstream slope and what appears to be about a 5:1 upstream slope. The spillway has been abutted against sandstone rock on the right side and includes a stone masonry guide wall on the left side adjacent to the dam.
2. We understand some of the stones forming the right end of the control section of the spillway were washed out during high flow in 1996. This damage concentrated flow in that area and caused some erosion of the sandstone bedrock downstream of the spillway. The eroded area is shown on Photo No. 9. We understand the stones which were washed

Photo No. 9: Bedrock erosion and old repair along the right end of the principal spillway.

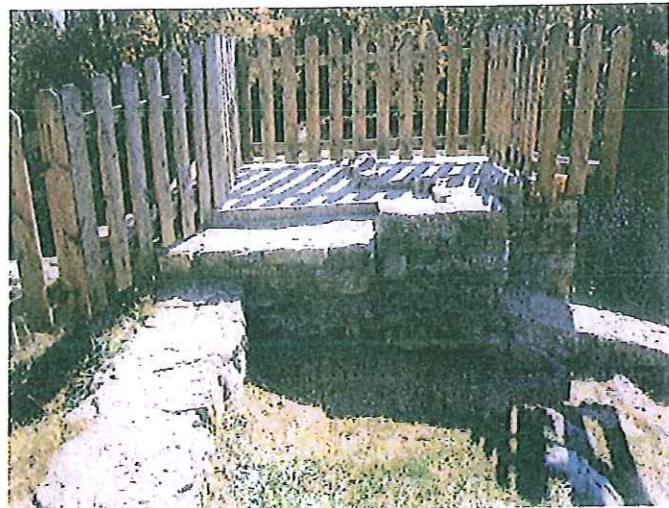
Photo No. 12: The concrete top on the old drain gate well is in good condition. Some of the stone masonry is in need of mortar repair.

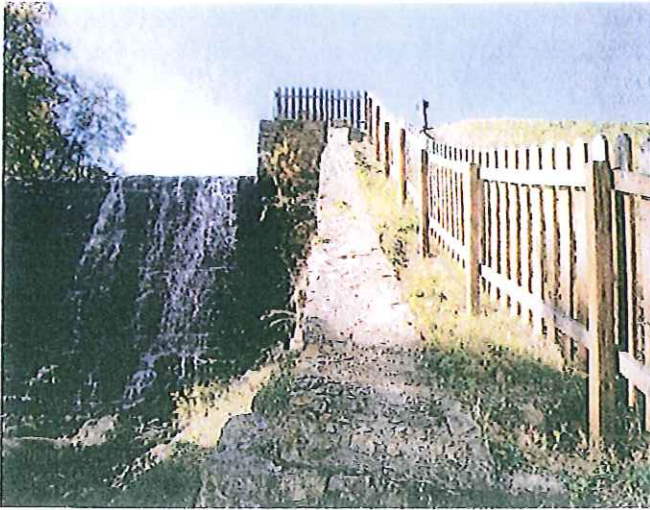
Photo No. 13: Left spillway guidewall facing upstream.

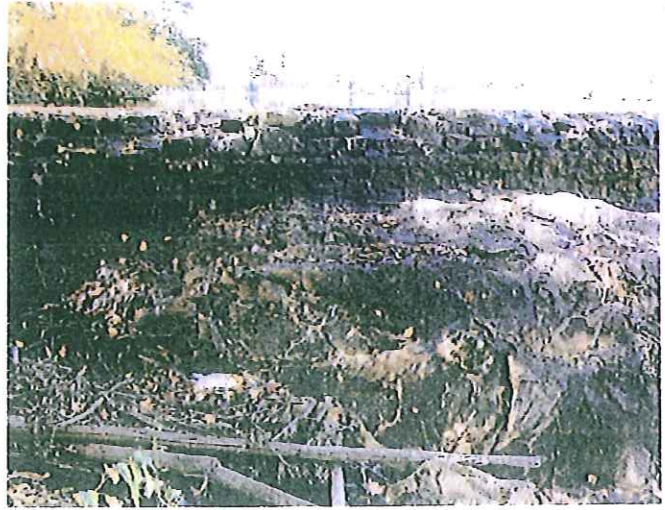
out appear were replaced at that time. However, some of the spillway stones were observed to be missing and erosion of the sandstone bedrock is progressing in this area. See Figure 1 and Photo No.s 15 and 16. As discussed with Mr. Ambrose, the missing stones should be replaced and the bedrock erosion filled with concrete as maintenance. Failure to make these repairs timely could allow the spillway to wash out again and result in the loss of the pool.

Photo No. 16: Missing spillway stones.

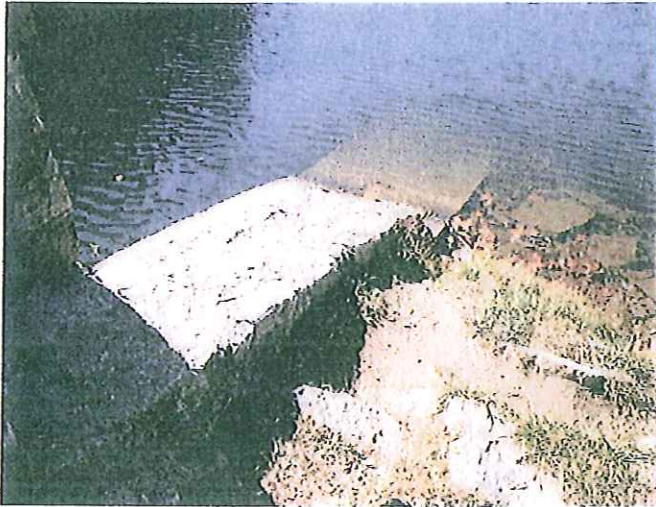
Photo No. 14: Left spillway guidewall.

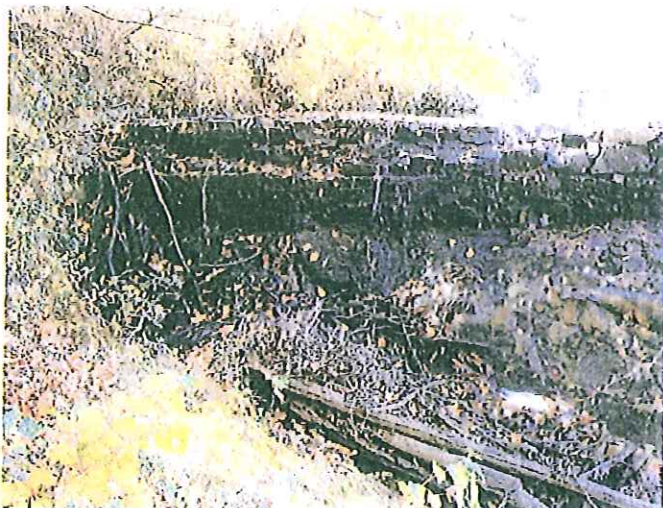
Photo No. 15: Erosion area and missing spillway stones.

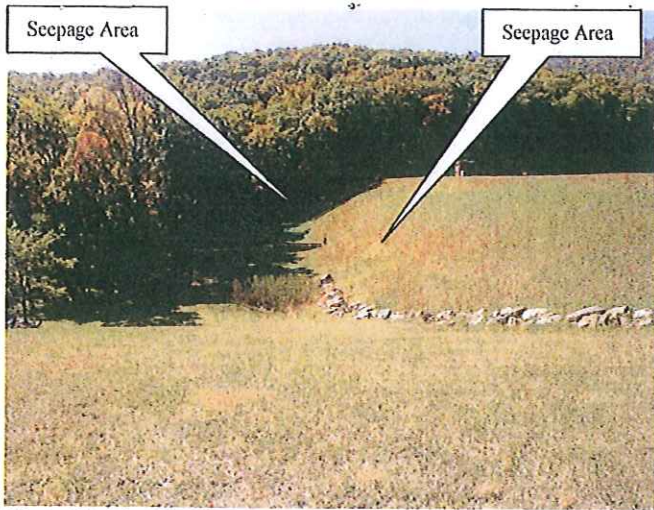
Downstream Slope: The downstream slope is shown on Photo No.s 1 and 2. The following was noted:

3. Seepage areas were noted in the 1998 inspection in the left and right dam groins near the toe of the embankment. The right groin seepage area has been consistently wet with a slight flow of water during all past inspections. A slight flow was also observed during this inspection. The left groin seepage area was flowing in 2002 but was dry during this inspection and has been dry during all other inspections. See Photo Nos. 1 and 4. As during past inspections, flow was clear in these seepage areas.

4. A new seepage area was noted on the face of the dam on the left side during the 2002 inspection which was not noted in 1998. This seepage area was also present during the current inspection. Views of this area are shown on Photo Nos. 1 and 5. Clear standing water was observed in the left seep area at the time of this inspection. However, no flow was observed. The reader will note this area was dry at the time of the last inspection. At the time of the 2007 inspection, the lake pool was approximately 3 ft. lower than the pool observed during this inspection. This increased pool may be responsible for the seepage observed during this inspection and suggests the source of the dam leakage may be positioned between a level which is 5 to 8 ft. below the normal pool. A maintenance person for the park who stopped by during the inspection stated the seep dries up during the summer. We believe the seepage dries up when the pool level drops down to 8 ft. or

Photo No. 1: Downstream slope facing right.

more below normal pool. To confirm this, Park personnel should record the lake level along with seepage observations monthly during routine inspections. Considering the relatively high location of the seepage on the embankment slope, we recommend the seepage be monitored closely for increased flow, muddy flow, etc. especially during higher pool levels. If a high pool level should occur, the owner should observe the seepage rate and condition of the flow on a daily basis while the reservoir is returning to normal and for a period of time after the lake level returns to normal. The seeps should also be monitored closely during storm events which produce an elevated pool. Notes should be made following each inspection along with observations concerning weather and pool level. Should the seepage increase in magnitude or become muddy, this may be an indication of a serious problem. Should this occur, the owner should respond in accordance with the Monitoring and Emergency Action Plan and should contact appropriate authorities including the WVDEP Dam Safety Section immediately.

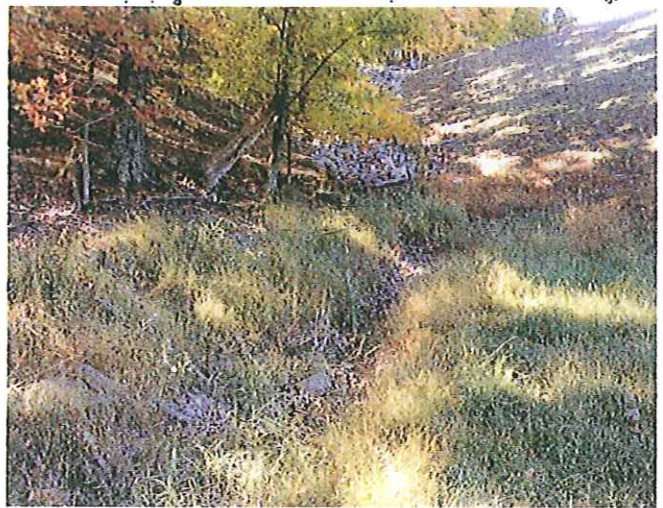
Photo No. 4: Right groin seepage area.

monitored closely for any changes in the magnitude of flow or color. We understand this seepage has been present during past inspections and has not changed significantly since that time. Therefore, this old seepage is considered normal and routine periodic monitoring should be sufficient. **However, as recommended during our 2002 inspection, the seepage observed on the downstream face of the dam is a more serious concern and should be monitored closely.** We are concerned that potential serious conditions could result in the future if this seepage should increase in magnitude or become muddy. Specific recommendations for monitoring are provided herein. However, the actual monitoring schedule and requirements will be dictated by the WVDEP Dam Safety Section. Should seepage flow increase or become muddy, appropriate action should be taken in accordance with the Monitoring and Emergency Action Plan and appropriate authorities including the WVDEP Dam Safety Section should be contacted immediately.

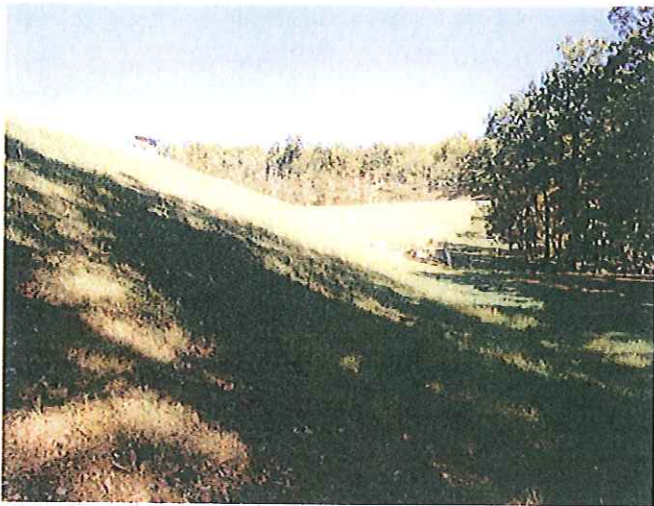
Photo No. 2: Downstream slope facing left.

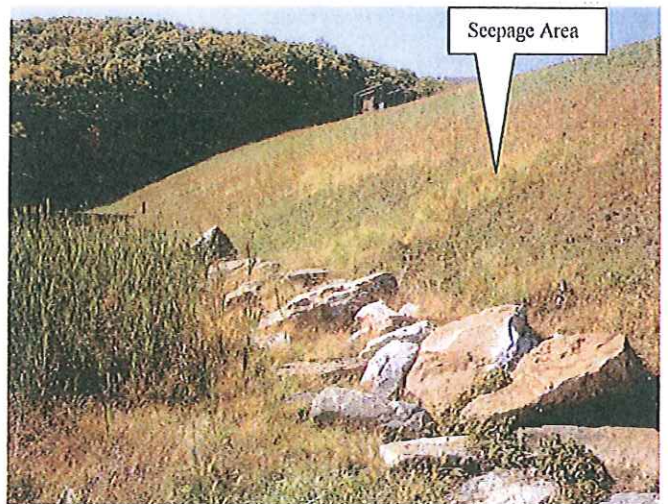
Photo No. 5: Seepage area on the downstream slope near the left groin.

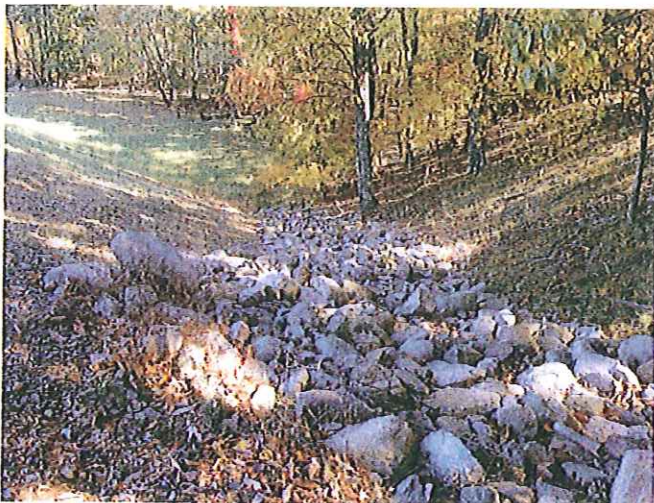
Photo No. 3: New rip rap placed in the right groin where bare soil had been present at the time of our last inspection.

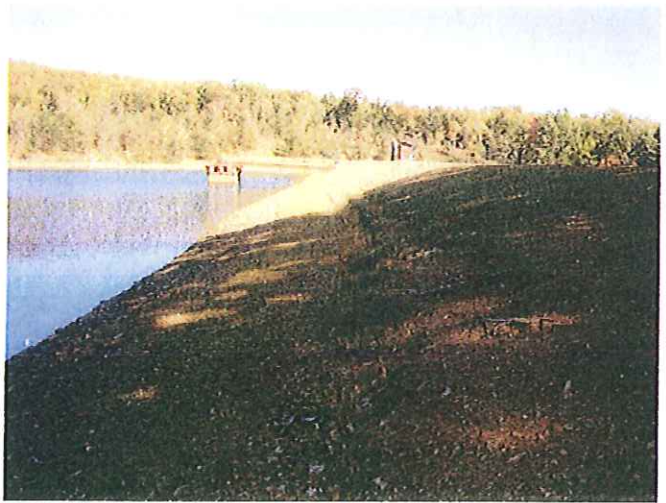
Upstream: The upstream embankment slope is reportedly constructed at an approximate 3:1 (H:V) slope. See Photo No.s 6 thru 8. The following was noted:

Photo No. 6: Upstream slope facing left.

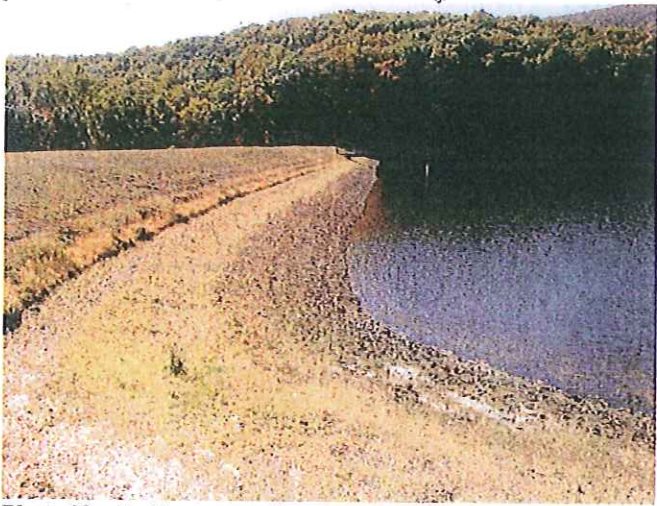
Photo No. 7: Upstream slope facing right.

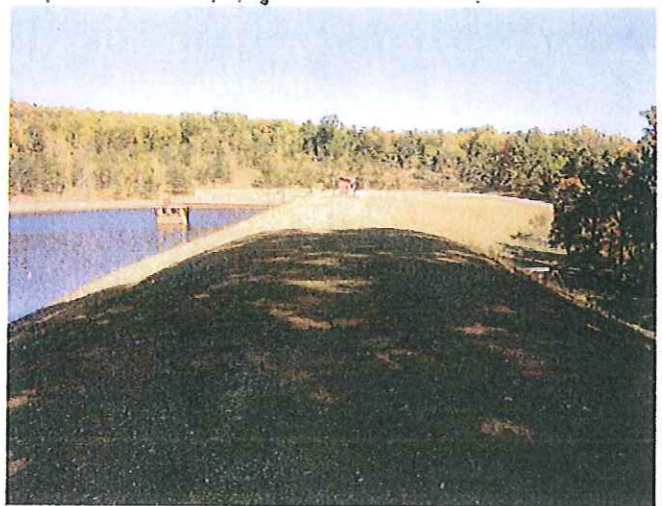
Dam Crest: The dam crest is relatively uniform with no apparent signs of subsidence or significant erosion. See Photo No.s 9 and 10. The following was noted:

Photo No. 10: Dam crest facing left.

3. As noted in our 1998 and 2002 inspections, access to the dam crest area is not restricted by a gate or cable. We recommend access to the crest be restricted from vehicle traffic with a gate or cable.

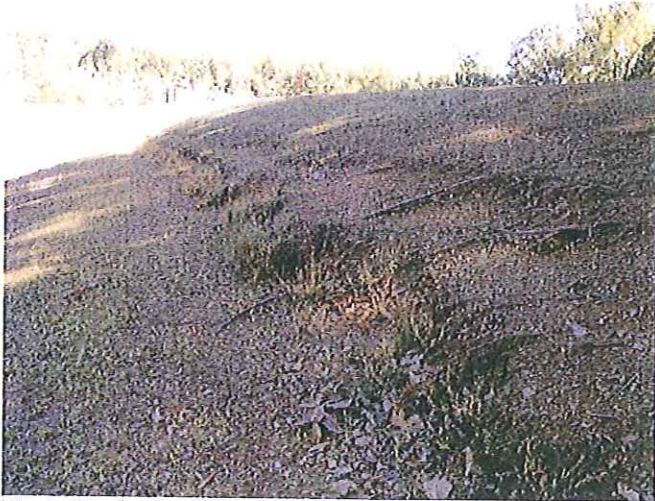
Photo No. 8: Erosion near the right abutment.

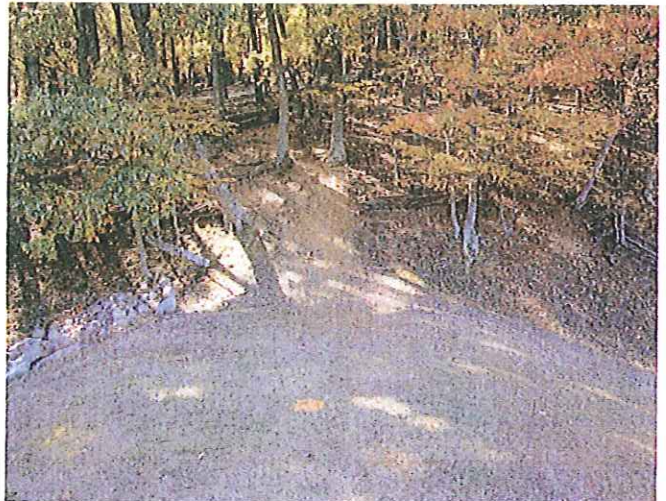
1. Vegetative cover has been established on the dam crest except for the left side of the dam which is open to vehicle traffic and bare. The crest is also bare on the right end adjacent to the natural hillside. Depressions and standing water were noted on the left side of the crest in the 1998 inspection. These depressions were due to minor vehicle rutting. The low areas were filled with crushed stone prior to our 2002 inspection. These areas have remained filled and do not appear to be a concern except for one small area shown on Photo No. 9 where minor rutting has occurred and standing water was present. As noted in 2002, some minor erosion appears to be occurring on the right end of the crest and the adjacent embankment slope due to surface runoff from the adjacent hillside. See Photo No. 11. This erosion does not appear to have progressed since 2002.

Photo No. 11: Erosion on slope to the right of crest.

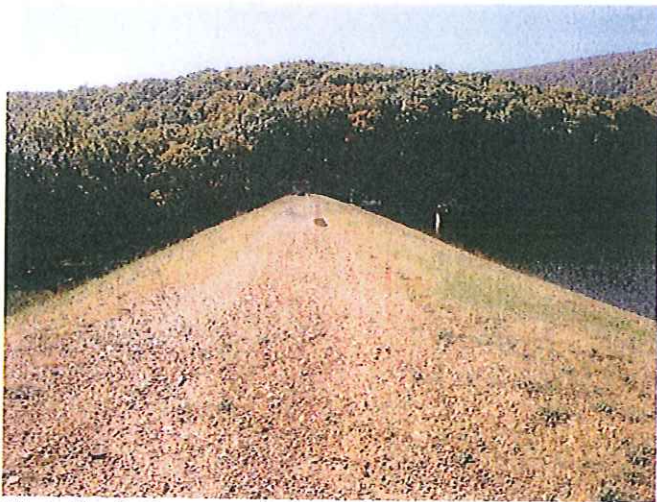
Photo No. 9: Dam crest facing right.

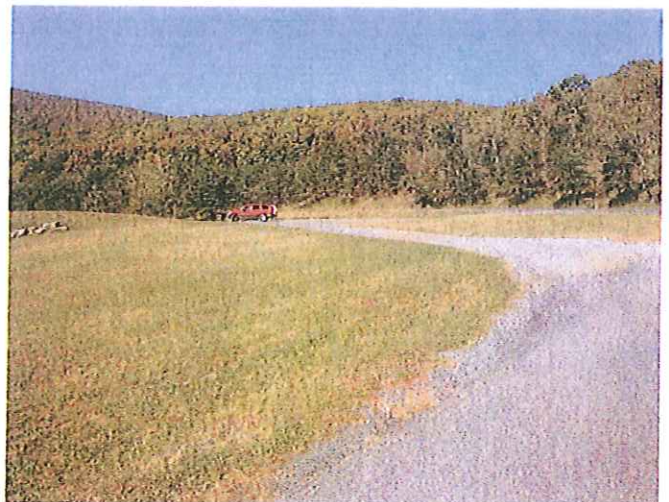
Photo No. 12: Emergency spillway facing upstream.

1. The emergency spillway is directed to flow toward the left groin of the dam. The rip-rap present in this area is not considered adequate to prevent erosion of the dam if the spillway should operate. An engineering evaluation should be performed to determine the frequency of spillway operation and associated depth and velocity of flow. Based on this information, appropriate measures should be implemented to prevent erosion of the dam during spillway operation.
2. The seepage noted within the left and right downstream groin areas of the dam should be

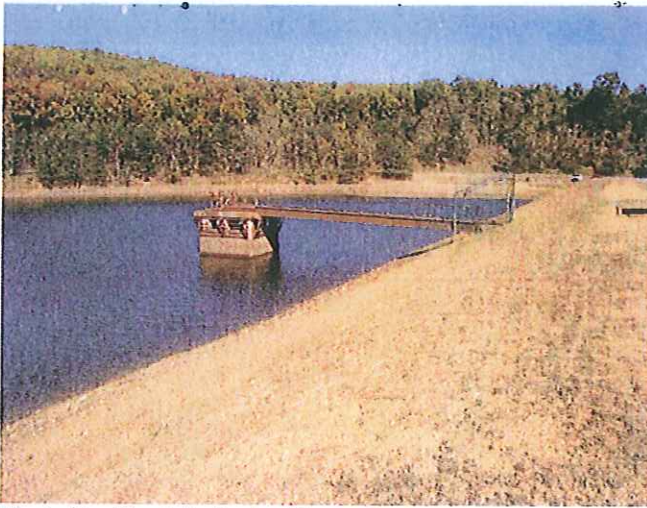
structure. See Photo No.s 13 thru 19. The following was noted:

Photo No. 13: Principal spillway riser.

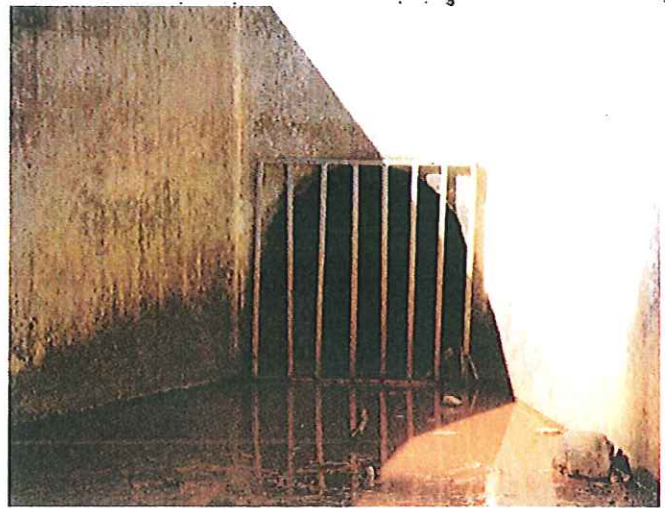
5. The 42 inch drain pipe terminates at the toe of the dam in a concrete outlet structure. The structure appears to be in good condition and there was no evidence of spalling, cracking, or deterioration. See Photo No.s 15 thru 17.

to 1 inch deep and was similar to that observed in 2002, 2005, and 2007. This flow indicates there is a leak in the riser and/or the pipe. To investigate this potential problem further, our engineer and one of Dam Safety's engineers entered the pipe to examine the interior of the same in 1998. We advanced into the pipe a distance of about 80 feet upstream of the outlet. The reader should refer to that report for details concerning that inspection. However, in general, the pipe had deflected at the joints as much as 3 to 12 inches, standing water was present upstream of each joint, and significant leaks were observed. **As discussed in the 1998 report, the condition of this pipe is a serious concern and, as discussed herein, warrants a more detailed inspection and evaluation.**

Photo No. 16: 42" CMP drain pipe outlet. Note small flow.

3. The leakage occurring within the 42 inch diameter principal spillway pipe is a serious concern which could lead to significant damage to the dam and possible dam failure. We suggest plans be implemented as soon as possible to investigate and repair the pipe. In the interim, the pipe should be monitored closely for excessive flow when the pool level is below normal. The flow should be examined to determine if it is muddy which could indicate piping of soil fines from the dam embankment is occurring. Also, the dam embankment should be monitored for any holes or depressions especially along the alignment of the pipe, and the lake should be monitored for swirls or vortexes forming in the vicinity of the pipe alignment. If any of these conditions are noted, appropriate action should be taken in accordance with the Monitoring and Emergency Action Plan and appropriate authorities including the WVDEP Dam Safety Section should be contacted immediately.

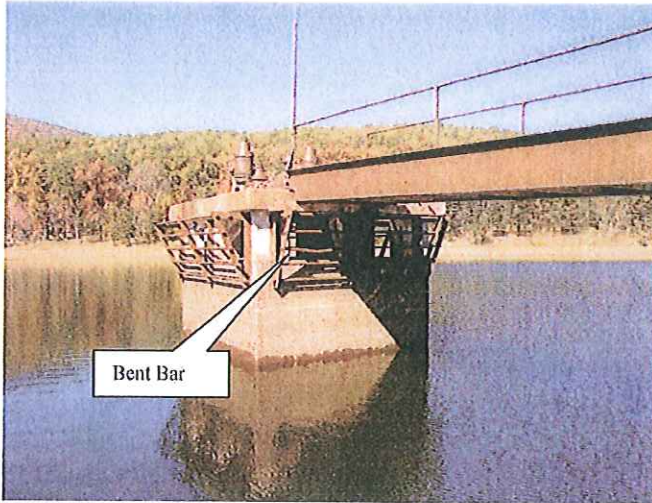
3. A trash rack is provided around the openings to the riser. The portion of the riser which was exposed above the pool level appeared to be in good condition with no cracking, spalling, or other obvious deterioration of the concrete. The trash rack, pumps, piping, and drain gate operators have been painted since our last inspection. However, the bent bar located along the downstream side of the riser has not been repaired. See Photograph No. 14.

Photo No. 14: Riser.

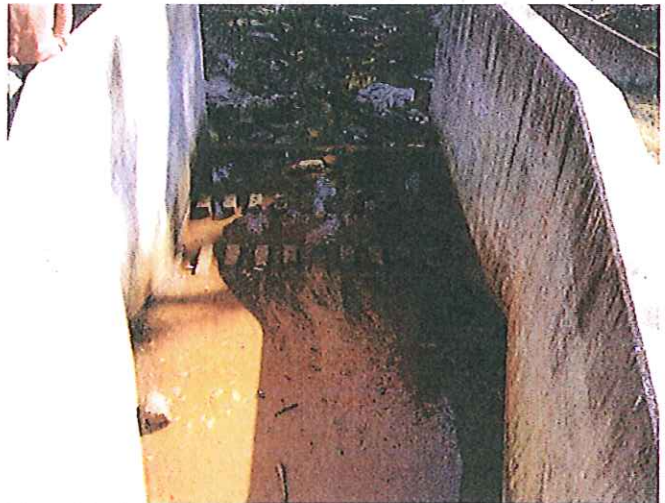
7. The stream channel downstream of the outlet structure is in good condition and does not exhibit evidence of erosion caused by high flow. See Photo No. 17.
8. Underdrain outlet pipes are located within the concrete wingwall on each side of the principal spillway structure. Available information indicates these pipes collect seepage from an underdrain constructed downstream of the clay core. Both pipes were flowing steadily on this date and the flow was noted to be similar to that observed during past inspections. The seepage flow was iron stained and was estimated to be on the order of 1 to 2 gpm. See Photo No.s 18 and 19.

Photo No. 17: Principal spillway stilling basin and stream channel.

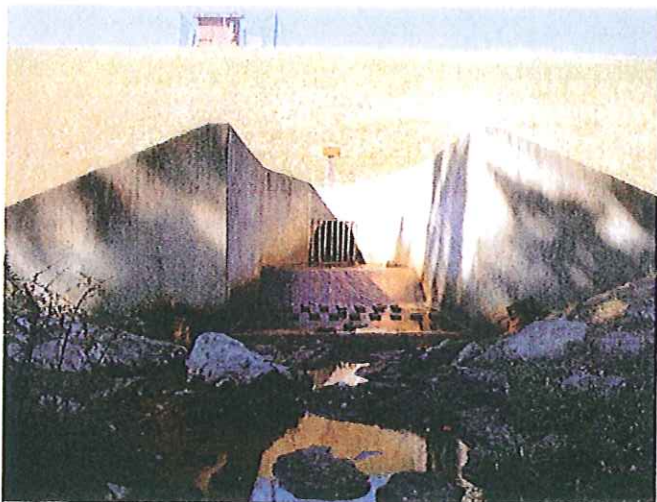
Photo No. 15: Principal spillway outlet structure.

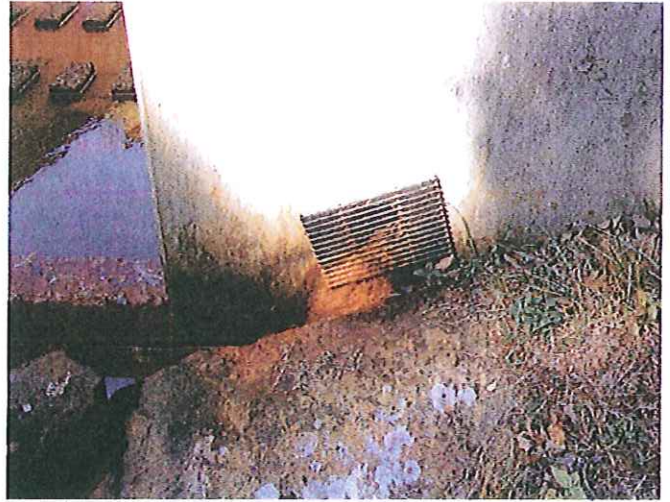
Photo No. 18: Left underdrain outlet.

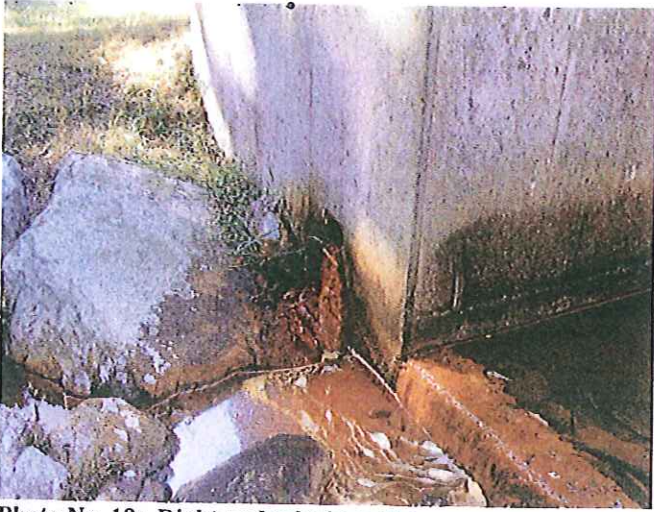
Photo No. 19: Right underdrain outlet.
