REFERENCE EOI #CHA12017 COAL HERITAGE DISCOVERY CENTER

**Patteson Ford Building**  
**Mt. Hope, West Virginia**  
**Building site visit**  
**for**  
**National Coal Heritage Area**  
**Michael Gioulis June 25, 2008**

This report is intended to review the former Patteson Ford Garage in Mt. Hope for the National Coal Heritage Area program. They intend to convert the building to offices and visitor spaces. The review will discuss observed conditions at the building and give recommendations on correcting deficiencies and converting the building to their proposed use.

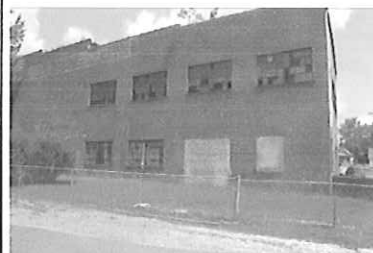
There has been some pointing or brick repairs at the parapet level, as these brick appear lighter than those below. This may be a function of the mortar color.

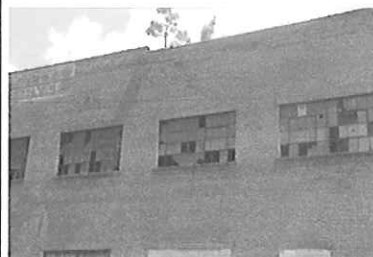
The side elevations are brick as well in a common bond. There are some alterations to the fenestration on the north elevation at the lower level. There has been block infill and the addition of larger garage door openings at this location.

Windows on the side and rear elevation are metal multi-paned industrial units with most of the glazing missing.

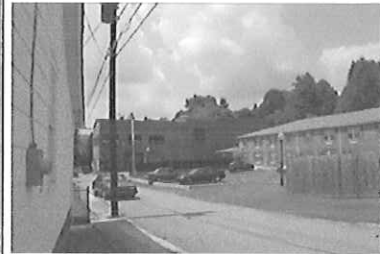
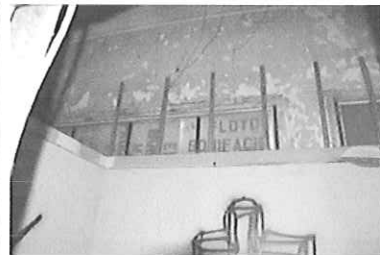
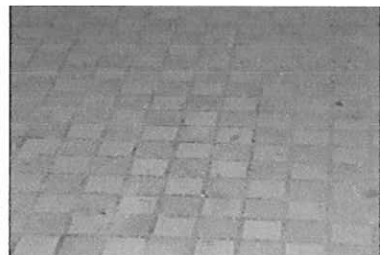
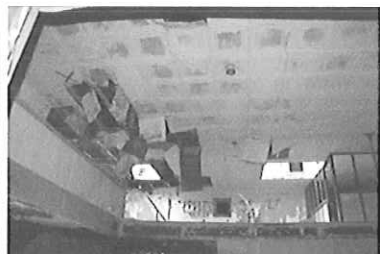
In the mezzanine, there is plaster on the walls, the metal ceiling and vinyl floors. All surfaces are totally deteriorated and will require replacement.

There is a paneled wood balustrade at the edge of the mezzanine remaining in some locations and this can be used to replicate it for the rehabilitation.

The mezzanine is suspended from the roof trusses with rods and pin connectors to the trusses. All connectors and structural systems must be evaluated. There are some unsecured pins visible.

There is a skylight in the center of the back section of the mezzanine.

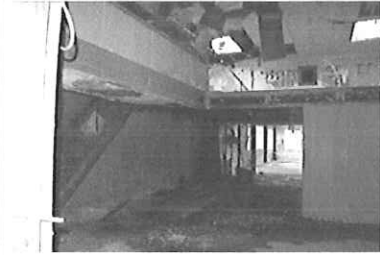
This is basically a garage workshop and is currently a storage area. Walls are masonry or block and the ceiling is the concrete structure of the first floor system. The floor is concrete. There are storage rooms at the front of the building and some storage and underground areas beneath the front of the building. These may extend beneath the sidewalk, as there are indications of some settlement in the sidewalk paving that appear to correspond to the structural system. This must be investigated.

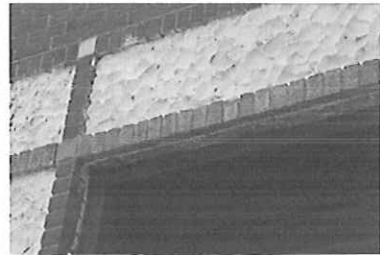
The stucco on the front is original. It is a very thick, molded stucco in a Tudor style over backer brick. The stucco will need repairs. Toward the top of the capital, on the left pilaster, there are bricks that need to be replaced. The mortar on the front is recessed. The original is a wire-cut brick on the front elevation, but the sides are smooth brick.

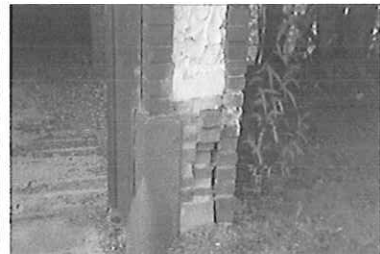
On the right side, the lower portion of the pilaster, there are about 5 courses of brick from the bottom that need to be replaced. There are also a couple of bricks around the entrance to the garage that need to be replaced. The steel lintels are rusting a little, but they are not sagging. They will need repaired, painted and caulked. The current garage door has an aluminum fascia surrounding the trim. This should be replaced when the garage door is replaced.

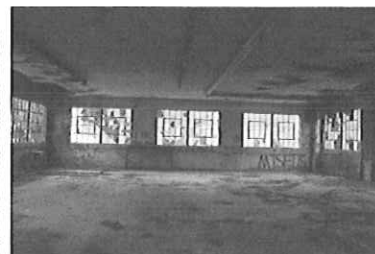
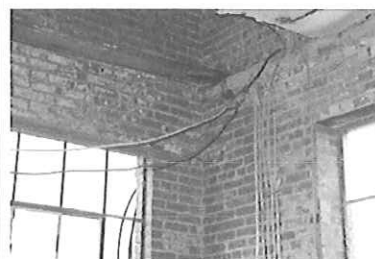
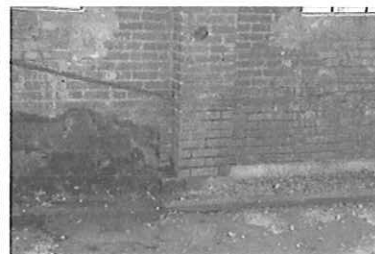
In the seventh bay, or the second window bay from the east, all of the bricks have fallen for five courses above the window lintel in the interior. There is only one wythe of brick left of the two wythe brick wall. The header bond course and the header bricks are still there, but everything else is gone. This needs to be addressed and stabilized as soon as possible. Other than that, the walls are what were expected. A significant amount of pointing (about 75%-100%) is needed on the south wall.

Both the north and south walls are deteriorated at the rear, where the roof drains to downspouts on the exterior and there has been significant deterioration to the masonry as a result of the damaged scuppers, downspouts etc. See also exterior masonry issues and the photos.

The east wall, which is the back wall of the building, is in much better condition. The paint still exists there. This wall needs window repair, and painting. There is some significant deterioration in the northeast corner, due to roof damage, and this area will need a significant amount of pointing. It also will likely require dismantling and reconstruction of the upper portion of the masonry.

In the north wall, in the first bay starting from the east, the window appears to be racked. It looks like the entire wall is racking to the east, starting at about the sill level of the window. The second bay appears to be doing the same thing. Above the lintel the northeast corner needs to be rebuilt, as it appears to be in some rather deteriorated condition. This entire wall needs 100% pointing, including the pilasters. The first pilaster from the east appears to be separating from the wall. This will need to be reconstructed and toothed into the wall, or other bonding or masonry stitching system employed.

The floor appears to be in relatively good condition. It is concrete, and has some cracks. Cracks usually run north and south, in line with the pilasters.

Point the masonry as indicated in the observations sections. Use mortar that matches the original in strength composition and appearance. Follow the Secretary of the Interiors Standards for Rehabilitation and Preservation Briefs.

Remove and replace damaged and spalled brick as mentioned above. Remove and reconstruct sections of the walls as indicated in the observations. These include:

- The northeast corner and sections of the north wall above the first floor windows and below the windows.
- The southeast corner at the top.
- The south elevation at window locations noted above.
- The lower section of the south elevation beneath the windows, in rising damp areas.
- Front pilaster as noted.
- Interior pilaster as noted.
- Interior south wall adjacent to the garage entrance.
