**SOLICITATION NUMBER: LSH14035****Addendum Number: 6**

### ASBESTOS REPORT

Project Number:  
13-458

Property Address:  
Lakin Hospital  
1 Bateman Circle  
Lakin, WV 25287

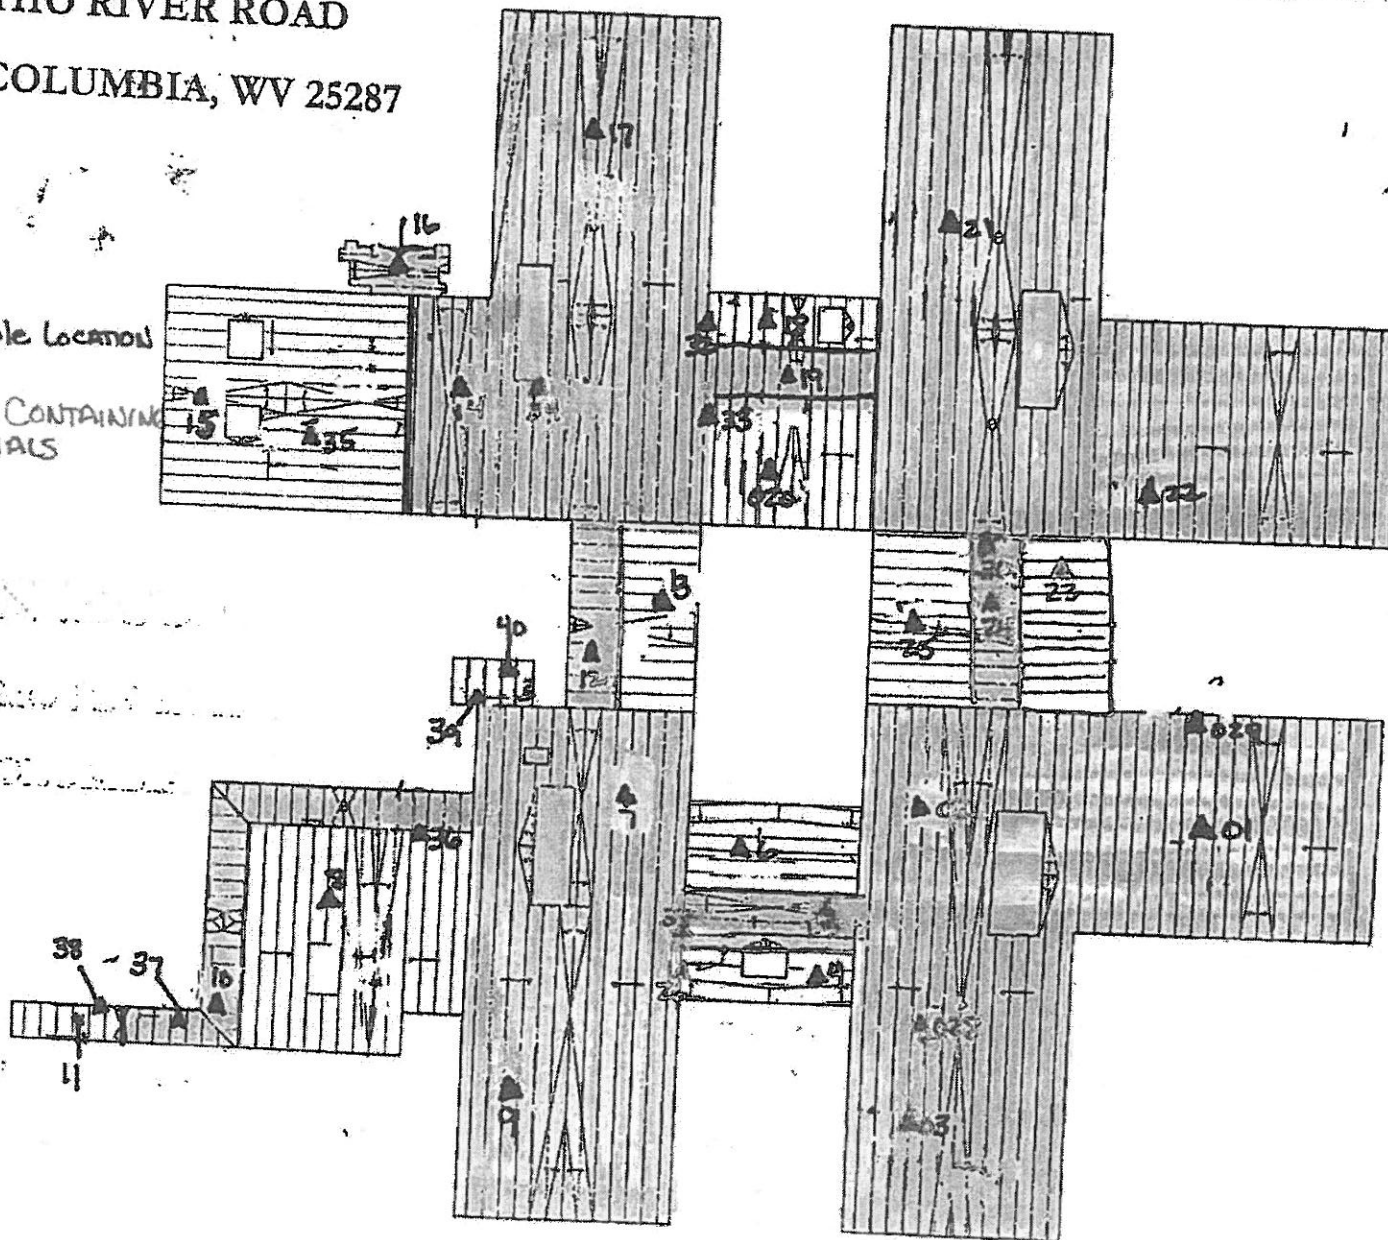
- ▲ - Approx. Sample Location
- - ASBESTOS CONTAINING MATERIALS
