**PROPOSAL FOR
WEST VIRGINIA CAPITOL DOME
MOISTURE INTRUSION**

**Solicitation No. CEOI 0211
GSD15000000001**

Re: West Virginia Capitol Dome, Moisture Intrusion
Solicitation No. CEOI 0211 GSD15000000001

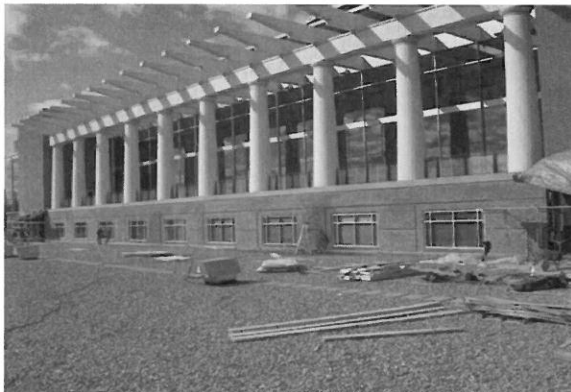
Deficiencies in through wall flashing within masonry wall adjacent to practice court roof led to profuse water infiltration (Left).

After a series of diagnostic testing, WDP discovered that the source of water infiltration in the center court was attributed to a lack of a continuous air and weather barrier behind the metal

panels and deficiencies in flashing. This primary cause was the sill pan flashing below the mechanical penthouse louvers which were located over 100 feet above center court. The flashing was missing effective end dams and not properly integrated with structural steel columns. Additionally, the flashing laps were completely ineffective and there were numerous unsealed penetrations in the flashing. In order to conduct these repairs, the mechanical louvers had to be removed, revealing inadequate structural attachments and a structurally unstable arched end wall

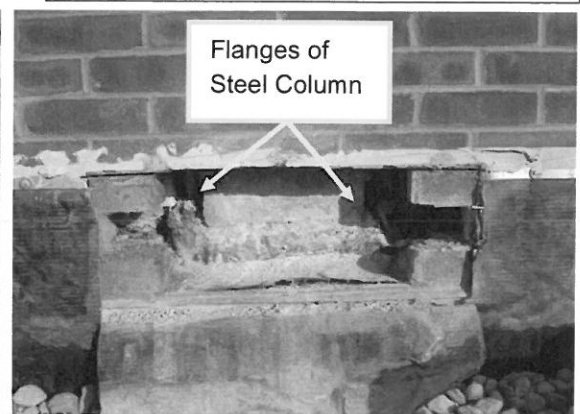
Flashing did not return to flanges of steel structural columns. This allowed drainage within the masonry cavity to completely bypass the flashing and continue directly to the interior spaces below the roof (Below Right)
