Ref: PTR 14046

National Bus Sales and Leasing, Inc. appreciates this opportunity to submit a bid for transit vehicles to the State of West Virginia. Our offerings, a Goshen Coach Pacer II mounted on a Ford E-450 with a 6.8L gas engine for Classes A-F, and a Goshen Coach Impulse mounted on a Ford E-450 with a 6.8L gas engine for Classes G-R meets the intent and letter of your specifications with the following documentation, clarifications and/or explanations per your Required Bid Documentation Checklist.

EXECUTIVE SUMMARY	3
ABBREVIATIONS	5
BUS CHECK-IN	6
1. MAINTAINABILITY	
1.1 ACCESSIBILITY OF COMPONENTS AND SUBSYSTEMS	17
1.2 SERVICING, PREVENTATIVE MAINTENANCE, AND REPAIR AND MAINTENANCE DURING TESTING	20

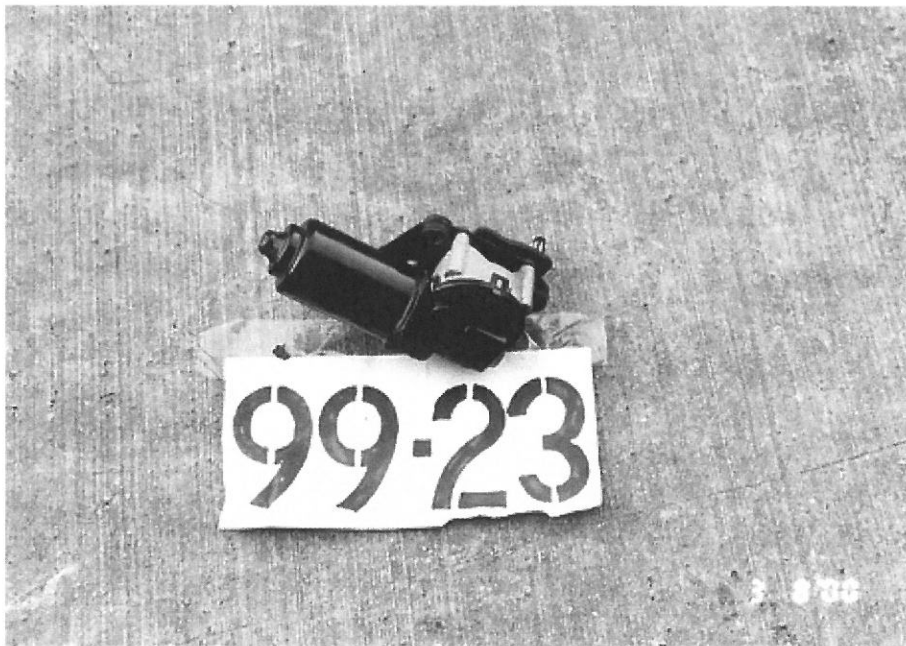
WIPER

MOTOR

REMOVAL AND REPLACEMENT

(1.5 MAN HOURS)

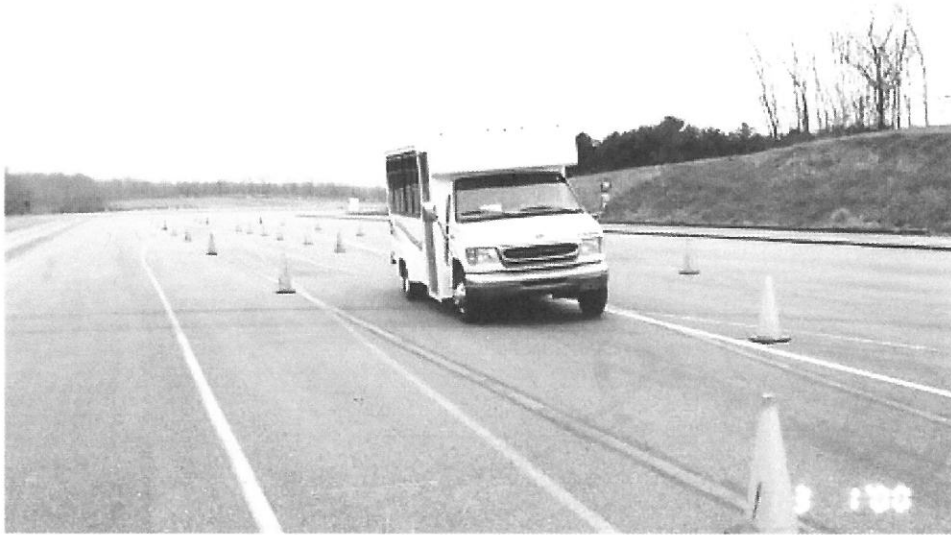
RIGHT - HAND APPROACH

SAFETY TEST: DOUBLE LANE CHANGE	
Maximum safe speed tested for double-lane change to left	45 mph
Maximum safe speed tested for double-lane change to right	45 mph
Comments of the position of the bus during the lane change:	
A safe profile was maintained through all portions of testing.	
Comments of the tire/ground contact patch:	
Tire/ground contact was maintained through all portions of testing.

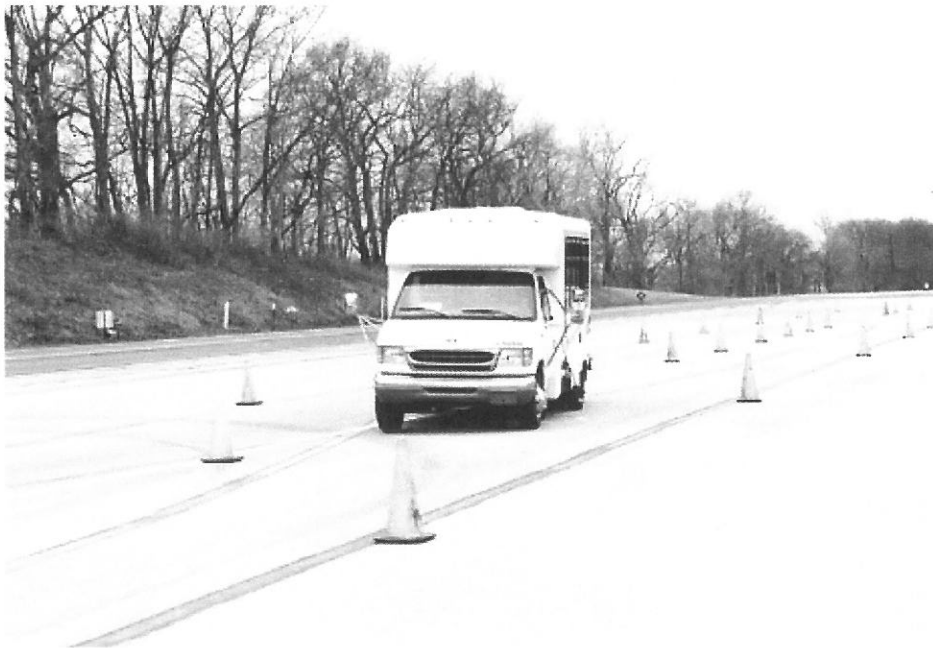
LEFT - HAND APPROACH

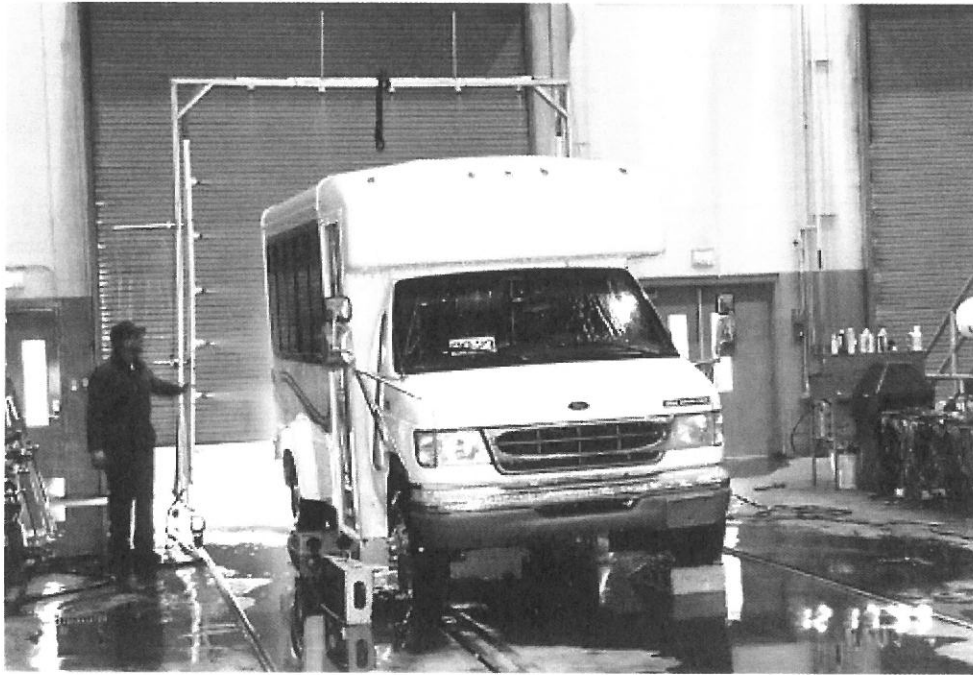
RIGHT FRONT 6" LOWER

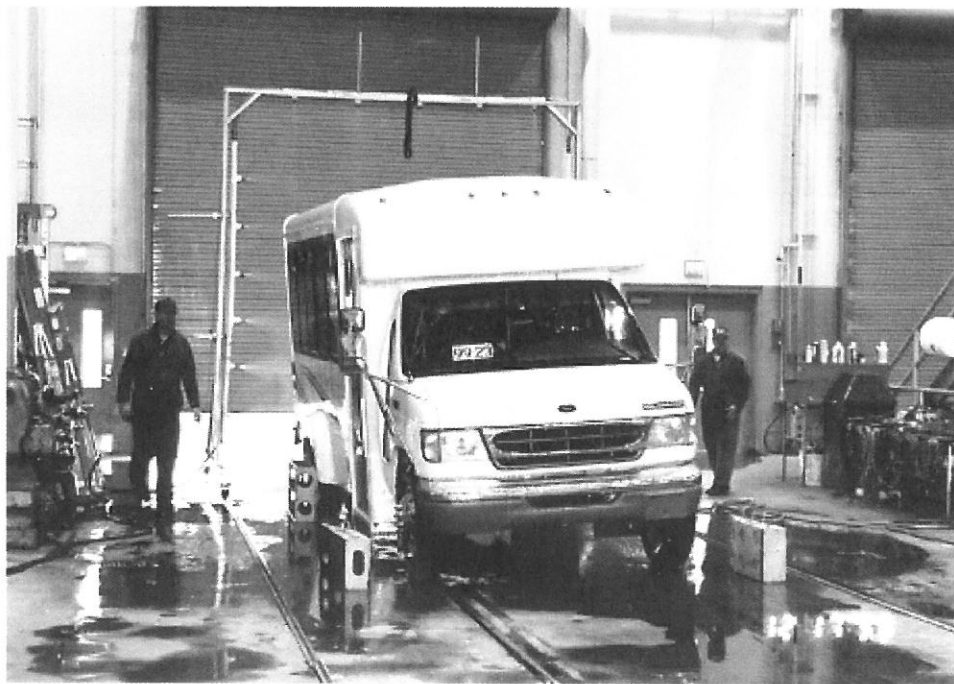
LEFT REAR 6" HIGHER

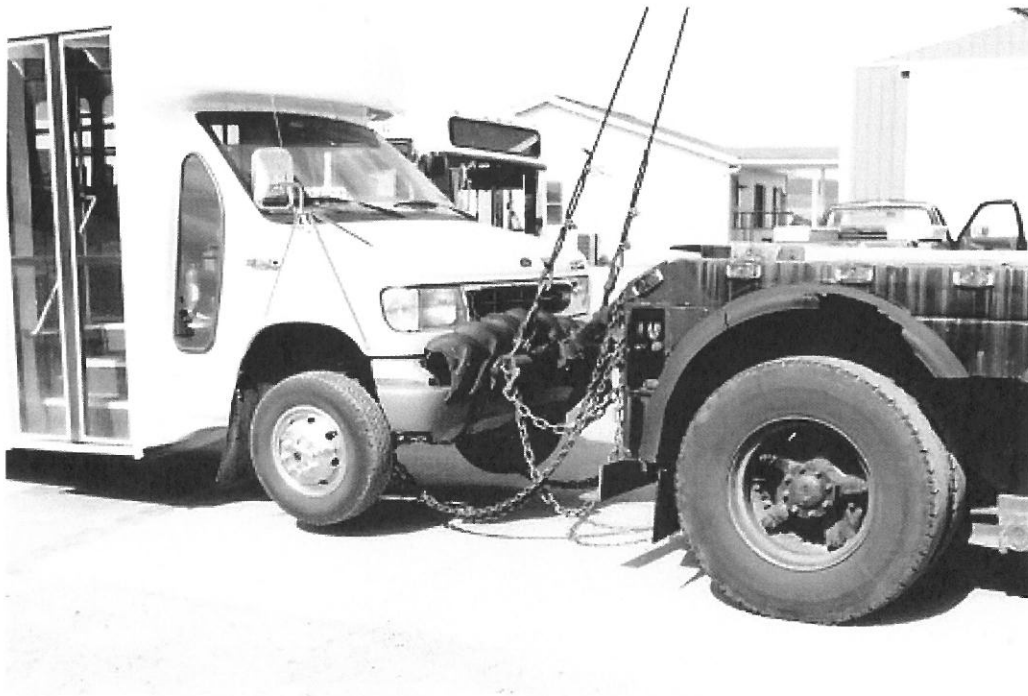
TOWING INTERFACE

Inspect tow equipment-bus interface.
Comments: A safe and adequate connection was made between the tow equipment and bus interface.
Inspect tow equipment-wrecker interface.
Comments: A safe and adequate connection was made between the tow equipment and wrecker.
Towing Comments: The test bus was chained by the front axle. A 6" x 6" wooden beam was incorporated to protect the radiator and a rubber pad to protect the bumper.
Description and location of any structural damage: None noted.
General Comments: A front lift tow was performed.

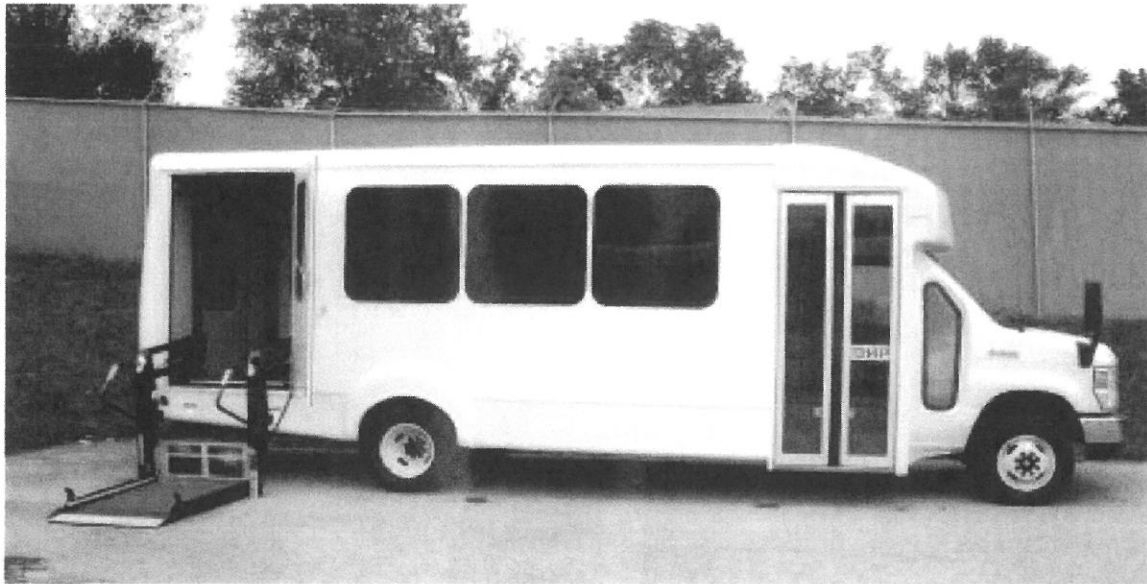
**GOSHEN COACH
MODEL 2013 IMPULSE EQUIPPED WITH A BRAUN MODEL
NCL919FIB-2 HANDICAP LIFT**
