Solicitation Description: WV State Capitol Monuments Maintenance

STATE OF WEST VIRGINIA CAPITOL MONUMENTS MAINTENANCE & CONSERVATION

2025 TREATMENT REPORT

SMITH ART CONSERVATION, LLC

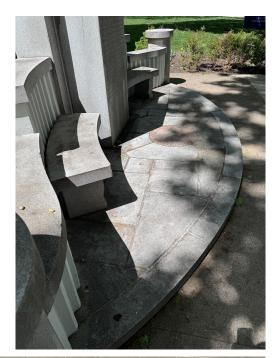
BOOKER T. WASHINGTON MONUMENT

The monument is structurally sound and stable with no visible areas of damage. Typical soiling, dirt, and debris (predominantly on the flooring). Wax coating remains stable with good patina condition. All stone in good shape with sealant refreshed in 2023 and 2024. The vertical ridged back wall was repainted in 2024 and has held up well and in great condition.

- All surfaces were pressure wash rinsed using 1900 psi and a wide fan tip to remove embedded biological staining, soiling, dirt and debris.
- Bronze surfaces washed with Orvus WA paste detergent using natural fiber brushes.
- All surfaces allowed to air dry.
- Bronze bust was applied with a light coat of Butchers clear paste wax and buffed to a sheen using linen cloth

Continue annual maintenance of hose pressure washing with detergent on all stone surfaces and application of wax coating on bronze followed by buffing. D/2 application as needed following detergent washing.

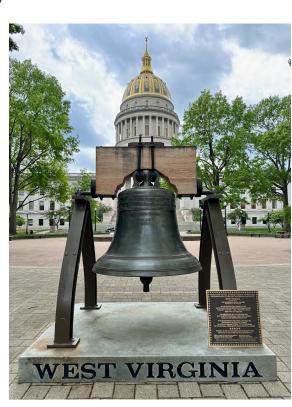
LIBERTY BELL

The Liberty Bell was given full restoration treatment in 2019 by Evergreene Architectural Arts to address issues in the yolk including a full repainting of steel frames. The yolk, showing signs of sagging, noted in 2022 report and again during the 2023-24 reports was removed and re-built. The new yoke system was re-installed in the summer of 2024. Prior to the 2025 maintenance, all aspects of the bell and yoke are in good condition.

- Bronze bell was washed with Orvus WA paste detergent using natural fiber brushes and rinsed
- All surfaces allowed to air dry.
- Bronze bell was applied with a light coat of Butchers clear paste wax and buffed to a sheen using linen cloth

Apply coat of linseed oil or teak oil on the yoke upon completion of each annual maintenance. Monitor wood for signs of separation.

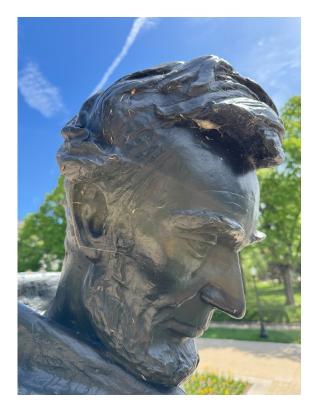
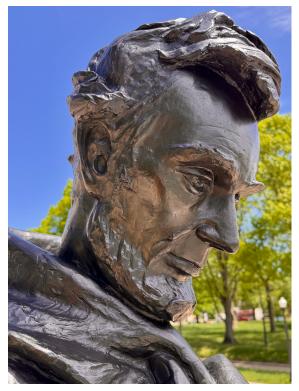
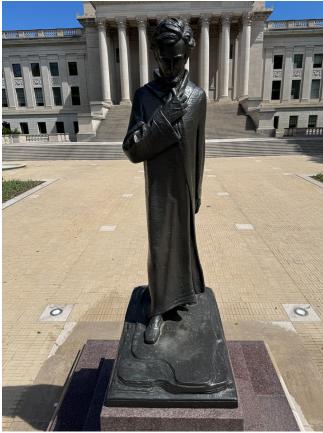
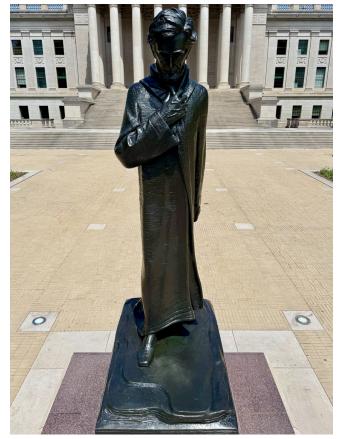
LINCOLN WALKS AT MIDNIGHT

Lincoln is securely mounted to the base. No areas of damage were detected within the granite seams. Wax coating is currently stable yet shows typical buildup of dirt and soiling. Wax coating is due for re-application. Heavy pollen layer was found all over the bronze and base including wasp nest and debris lodged in the crevices of the bronze.

- All surfaces were washed with Orvus WA paste detergent using natural fiber brushes. Hose pressure water used to rinse.
- All surfaces allowed to air dry.
- Bronze surfaces heated gently with a large propane torch to evacuate moisture and prepare for wax application
- Bronze bust was applied with a light coat of Butchers clear paste wax tinted with a UV stable charcoal pigment to re-saturate intended patina tone.
- All surfaces buffed with horsehair brushes and linen cloths

Continue annual washing and waxing plan. No further action required beyond scope work

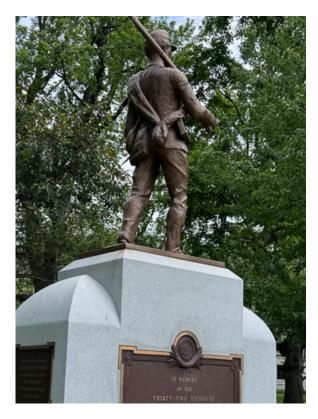
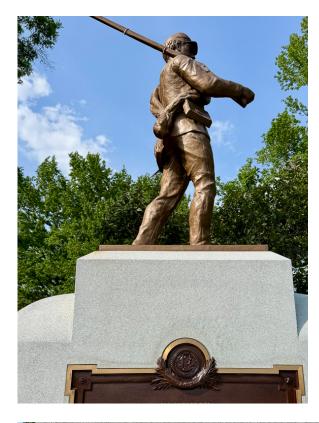
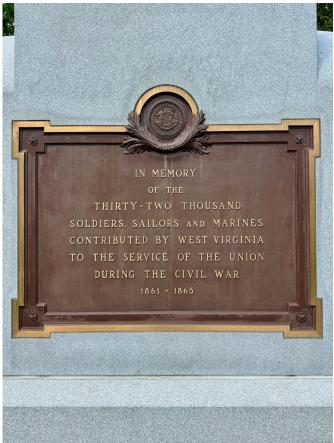
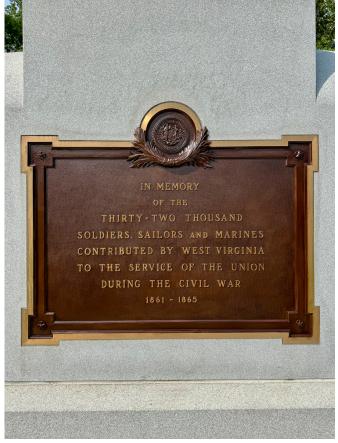
UNION SOLDIERS AND SAILORS MONUMENT

Treated by SAC during the annual maintenances, the monument is in good condition overall. Cornerstone was reset during the 2023 maintenance with all old/failed polyurethane joint sealant removed and replaced with new sealant. Plaque was applied with oil treatment in 2023 however due to significant UV exposure and heat on the plaque, the surfaces appear dry. Moderate biological staining and debris are found throughout the tiered base.

- All surfaces were pressure wash rinsed using 1900 psi and a wide fan tip to remove embedded biological staining, soiling, dirt and debris.
- Statue and plague surfaces washed with Orvus WA paste detergent using natural fiber brushes.
- All surfaces rinsed with water and allowed to air dry.
- Statue was applied with a light coat of Butchers clear paste wax and buffed to a sheen using linen cloths and horsehair brushes.
- Polyurethane sealant was refreshed in two localized ares of cracking.
- Plaques applied with Sculpt Nouveau clear metal oil

Continue annual maintenance plan of washing, waxing, and buffing statue and sealing of plaques using Sculpt Nouveau metal oil. Washing and cleaning of granite base and injection refreshment as needed using Vulkem 116 polyurethane sealant (limestone color)

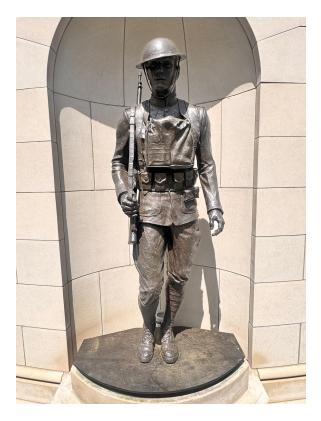
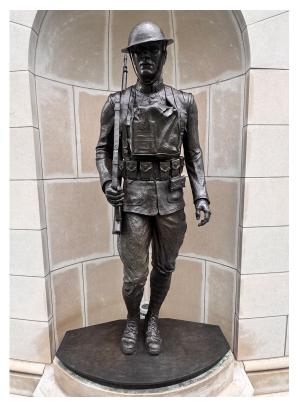
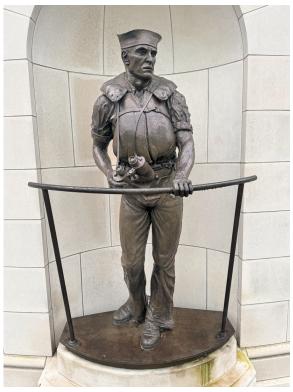
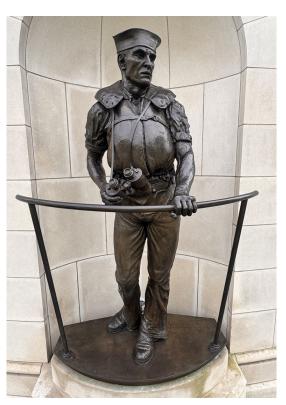
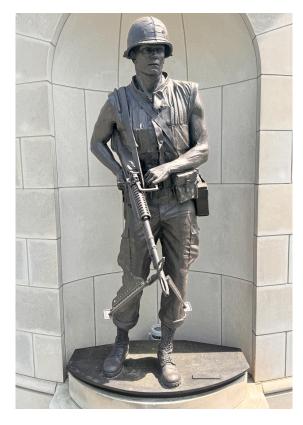
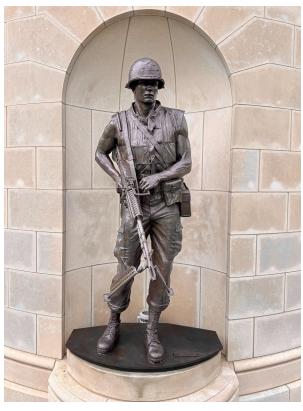
WEST VIRGINIA VETERANS MONUMENT

The monument remains in excellent overall condition with the exception of a few aspects. All bronzes are secure in their mountings with no major verdigris or corrosion developing, all lighting aspects are functioning as intended, railings firmly installed, and bronze vent surrounds over lights are stable and in good visual condition. All benches in good condition. Interior walls in excellent condition save for some typical atmospheric soiling. Bronze statues retain their intended patina however expected organic debris, webbing, bird droppings, and atmospheric soiling over the course of a year lead to a slight dull appearance. Biological growth staining is minimal. During the maintenance cycles of 2022-24, SAC has applied D/2 on stone work to mitigate dark staining particularly at the uppermost surfaces of the exterior block walls

- All surfaces were washed with Orvus WA paste detergent using natural fiber brushes. 900psi pressurized detergent bath used to clean statues in conjunction with brush cleaning. All surfaces clean-water rinsed
- All surfaces allowed to air dry.
- Bronze surfaces heated gently with a large propane torch to evacuate moisture and prepare for wax application
- Bronze statues applied with a light coat of Butchers clear paste wax tinted with a UV stable charcoal pigment to re-saturate intended patina tone.
- All surfaces buffed with horsehair brushes and linen cloths
- D/2 Biological solution was spray-applied on all stone surfaces showing slight darkening from bio-staining.
- Grates and railings cleaned and waxed.
- Interior plaques after cleaning were applied with a clear metal oil (Sculpt Nouveau)

Continue annual maintenance program of washing and waxing. D/2 application on stone as needed.

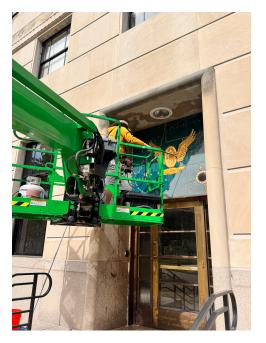
SPIRIT OF WEST VIRGINIA

The murals are in good condition overall, however because they are inset, no rainwater reaches the tile allowing a slow and steady buildup of dust, grime, and soiling which appears as a film over the surfaces. Tiles are all firmly adhered to the surface with no losses to the mortar detected. Condition prior to treatment is similar each year due to relatively stable environment wear and location.

- All surfaces were washed with Orvus WA paste detergent using natural fiber brushes. 900psi pressurized detergent bath used to clean tiles in conjunction with brush cleaning. All surfaces cleanwater rinsed
- All surfaces allowed to air dry.

Continue annual maintenance program of washing and monitoring any potential cracking or mortar losses. No further recommendations at this time.
