**EXPRESSION OF INTEREST**

**CEDAR LAKES DAM  
RESTORATION/  
WAREHOUSE  
STABILIZATION PROJECT**

**AGR 1800000001**

**FEBRUARY 1, 2018**

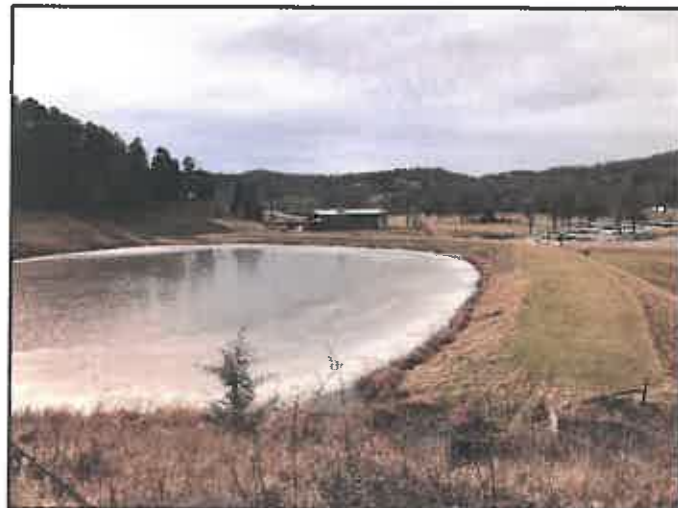
Cedar Lakes Dam No. 1

- Irregularities in the downstream embankment slope near the principal spillway (location of potential embankment instability).
- Vegetation within the lake upstream of the principal spillway which may restrict flow to the spillway.
- Vegetated auxiliary spillway (located along the left abutment) appears to convey flow along the downstream toe (if activated), which can cause excessive erosion and potential embankment failure.

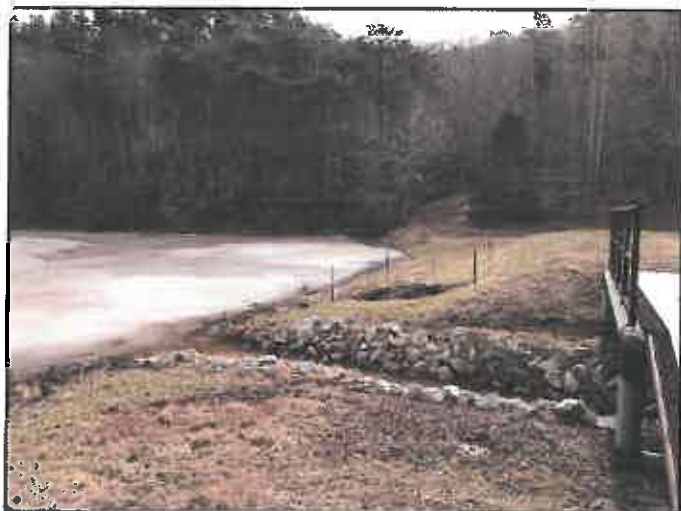
Cedar Lakes Dam No. 2

- The principal spillway riser and surrounding embankment had significant damage, which if activated, can cause potential dam failure.
- Corrugated metal outlet pipe showed severe deterioration along the invert of the pipe.
- The recently constructed riprap channel showed multiple locations of displaced riprap.

The cursory site inspection of the dams revealed an isolated location of potential embankment instability near the principal spillway at Dam No. 1 and damage to the embankment at Dam No. 2 caused by the failure of the principal spillway riser at Dam No. 2.

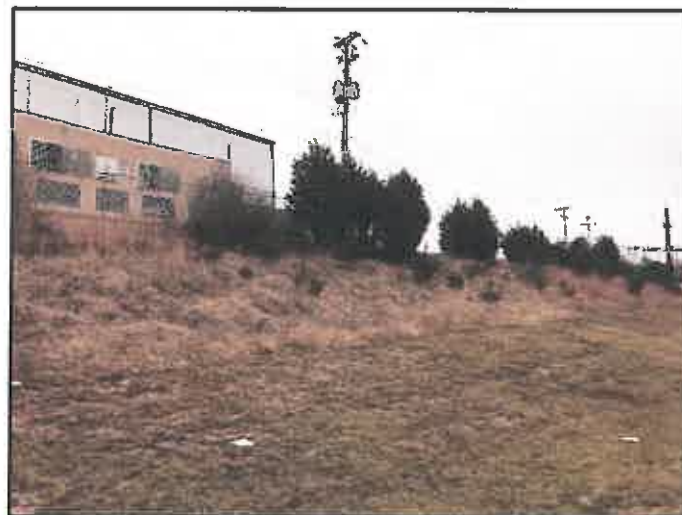
Slip Location at Food Distribution Warehouse

- Location of the slip identified on the slope, apparent scarp near the fence at the top of the slope.
- Slope failure may impact perimeter fence, existing utilities, and the building foundation.

For Project B, Michael Baker will perform site investigation at the location of the existing slip, conduct subsurface explorations, and perform geotechnical analyses to identify the cause of the slip and to develop a permanent solution to reduce potential hazards to the warehouse facility. For Projects A and B, design alternatives will be prepared to address the deficiencies identified during the inspection and analyses. Michael Baker will assist in obtaining the necessary state and federal permits based for the selected alternative. A final bidding package, which will consist of final construction drawings, specifications, and engineering cost estimates will be prepared for the selected alternatives. In addition, Michael Baker will provide construction contract administrative services to ensure that the project is constructed in accordance with the contract documents.

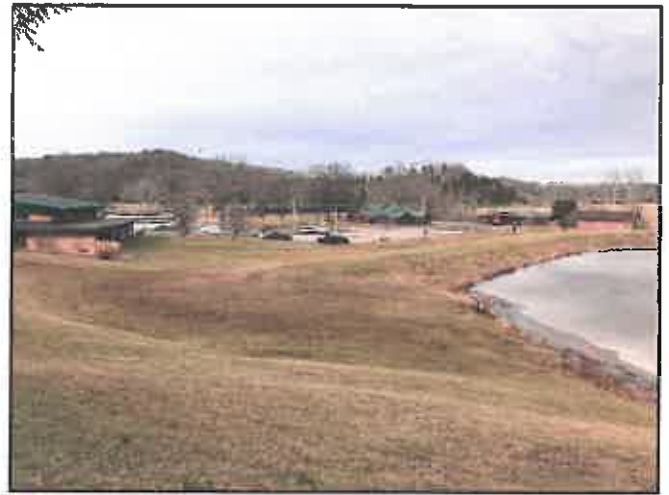
Auxiliary Spillway at Dam No. 1

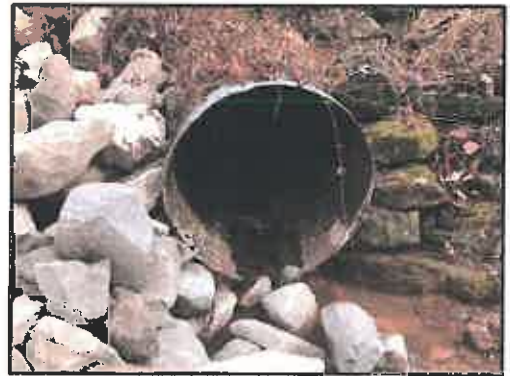
CMP outlet pipe with corrosion along invert at Dam No. 2

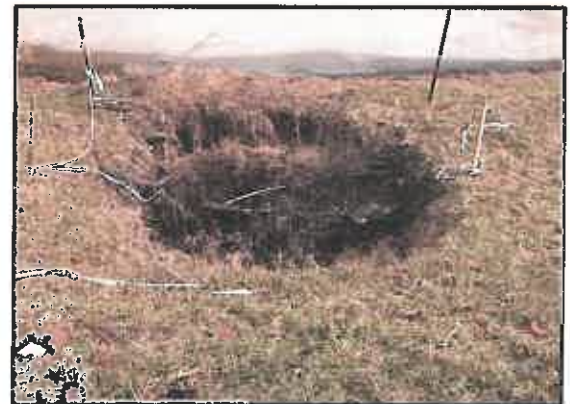
Damaged principal spillway riser and embankment at Dam No. 2

Depending on the existing information available, a hydrologic and hydraulic analysis will be performed for Dams No. 1 and No. 2 to determine the adequacy of the existing principal and auxiliary spillways. Based on WV Dam Safety Rule (47CSR34), dams that are equipped with an auxiliary spillway must have sufficient capacity to convey the design storm through both spillways without overtopping the embankment. In addition, the principal spillway at Dam No. 1 will be analyzed to ensure that it has adequate capacity to convey the 100-year design event without activating the vegetated auxiliary spillway for Dam No. 1 (assuming the auxiliary spillway does not have overtopping erosion protection below the vegetation).

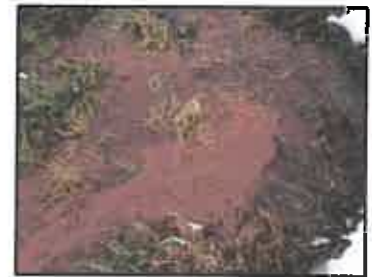
Seepage at a Toe of a Dam

**SEEPAGE** – Seepage occurs in all dams, and engineered dams are designed to minimize and control the harmful effects of seepage. Seepage can appear at or above the toe of the earth embankment and signifies high internal water pressure where there is less embankment weight to counteract the uplift. Michael Baker would recommend the required amount of lake drawdown to relieve seepage pressure and quickly provide the design for emergency relief structures like enlarged toe drains or gravel berms and design permanent drainage control in the form of enlarge reconstructed toe drains and relief wells. If the lake can be drained, an upstream clay blanket would be an option. Seepage and boils beyond the toe would be handled similarly with the added measure of sandbagging the boils. Installation of piezometers may be needed to quantify seepage pressure.

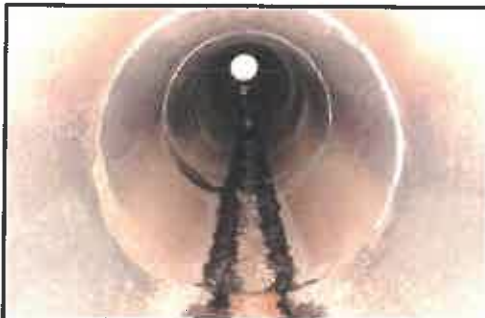
Leakage through Pipe Joints

Seepage through the dam's natural earth or rock abutments or along the embankment-abutment interface is a common problem. Michael Baker would recommend underdrains to control minor seepage and lined groin channels to control surface erosion. In extreme cases, grouting of the foundation soil or rock may be required. Another common issue is seepage paths along the outlet conduit. Michael Baker might recommend the placement of a sand diaphragm or grouting around the perimeter of the conduit to reduce soil or backfill permeability or, in the case of a smaller embankment like Lake Alma, conduit removal and replacement.

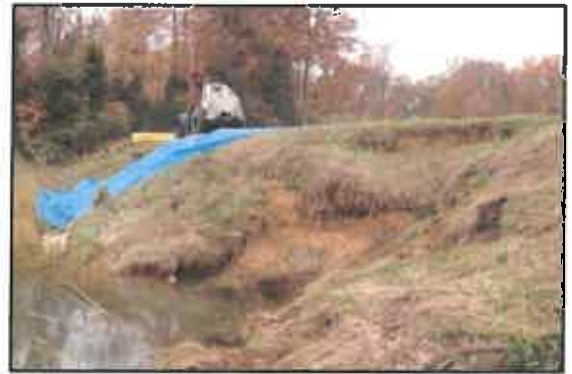
**SLOPE STABILITY** – Any slope movement on a dam embankment or abutment would be an immediate cause for concern. The severity of the slope failure depends on the size and depth of movement and whether or not it is accompanied with seepage. Michael Baker has designed repairs for slides on dams by removal and replacement with compacted fill or rock fill with inverted filters. We have also used berms if the slide occurred in the lower part of the embankment.

Embankment Slope Stability Issues

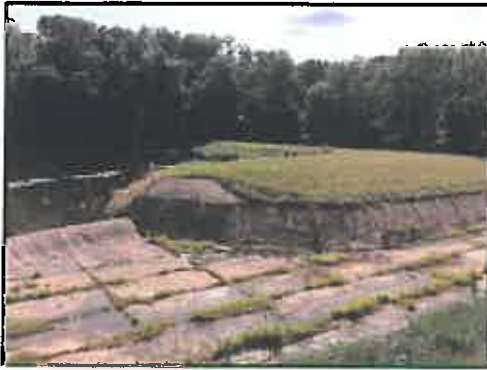
Deteriorated Spillway and Chute

**DETERIORATED STRUCTURES** – Old dams look like old bridges with respect to deterioration of concrete and steel. Salt-caused corrosion may not be involved but the constant exposure to water and ice takes its toll. Concrete poured for dams during the Depression can be amazingly functional for decades but at some point the deterioration threatens the safety of the dam. Michael Baker has extensive concrete inspection and assessment experience for dams and will rely on this experience to determine if repair or replacement is required. Michael Baker has prepared plans and specs for concrete repairs of spillway walls, slabs, weirs, pipe joints, and pipe end sections. Michael Baker has designed replacement structures for spillway and conduits that cannot be repaired.

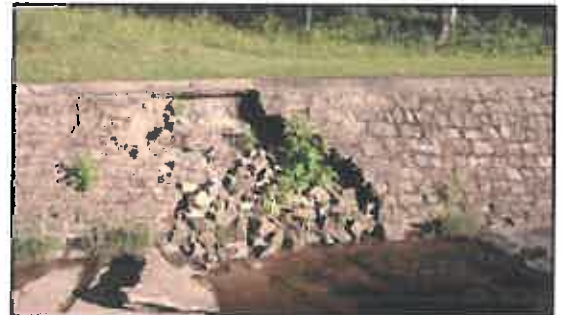
**UNDERMINING OF STRUCTURES** – The undermining of structures is a typical issue with dams. Sections of the spillway, energy dissipation basin, training walls, and cutoff walls can be undermined by the constant erosive forces water flowing through the spillway system. Inspections and monitoring would be required to establish and track the progression of any undermining. Potential solutions for undermined structures range from the placement of a new cutoff that would extend under the existing undermined endwall, pressurized grouting of undermined slabs, to replacement of the structure, depending on the severity and location of the undermining.

Failure of Stone Training Wall

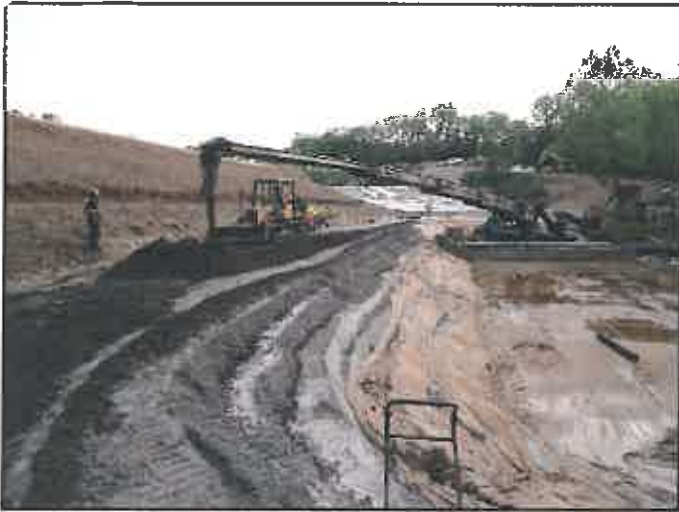
RCC Placement

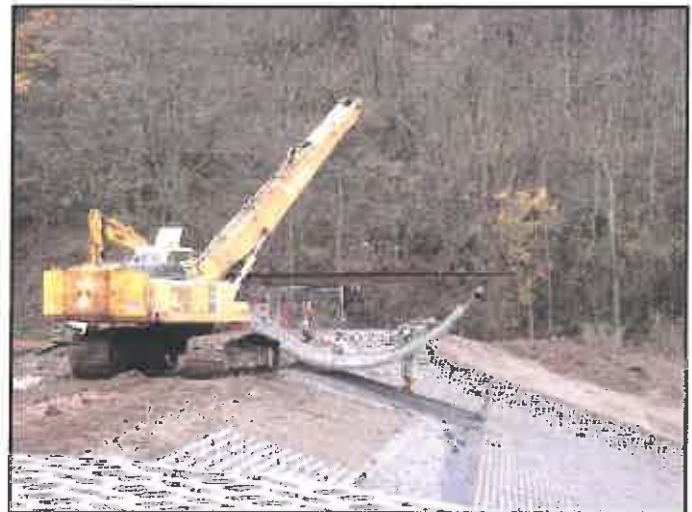
ACB Placement

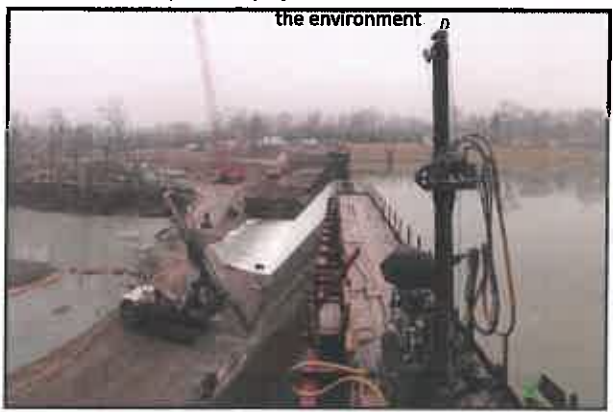
**STABILITY ENHANCEMENTS** – With rising construction costs, it is often preferable to stabilize an existing structure versus replace that structure with an inherently more stable structure. This is particularly true with concrete gravity dams, which typically involve the installation of high-capacity rock anchors. Michael Baker has completed a number of stabilization projects and has been nationally recognized for its innovation and foresight in incorporating contingency plans to address potential issues before they occur. A great example of that is the Canonsburg Dam, which was designed by Michael Baker and, through the firm's construction oversight, was completed one month ahead of schedule and the base project completed under the original bid. This success was due to a number of innovative features that allowed the anchoring to be completed under normal pool conditions. These features included:

Movable Drilling Platform, Causeway, and Installation of Rock Anchors and Passive Dowels

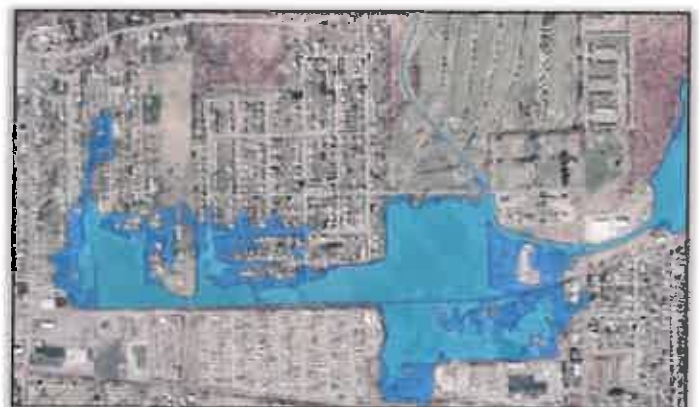
High resolution models allow for intricate mapping in residential areas

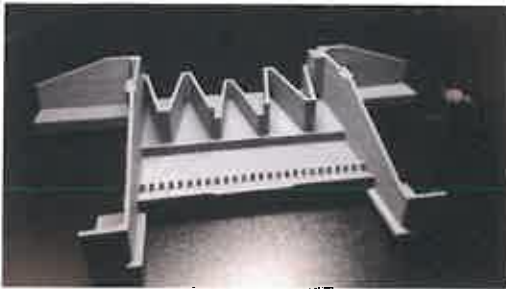
3D Printed Labyrinth Spillway Model

3D modeling also provides benefits for dam construction through enhanced visualization of the project during design; refinement of complex details within the Contract Drawings; modeling the anticipated construction sequence; and project visualization for the owner, public, and other stakeholders.

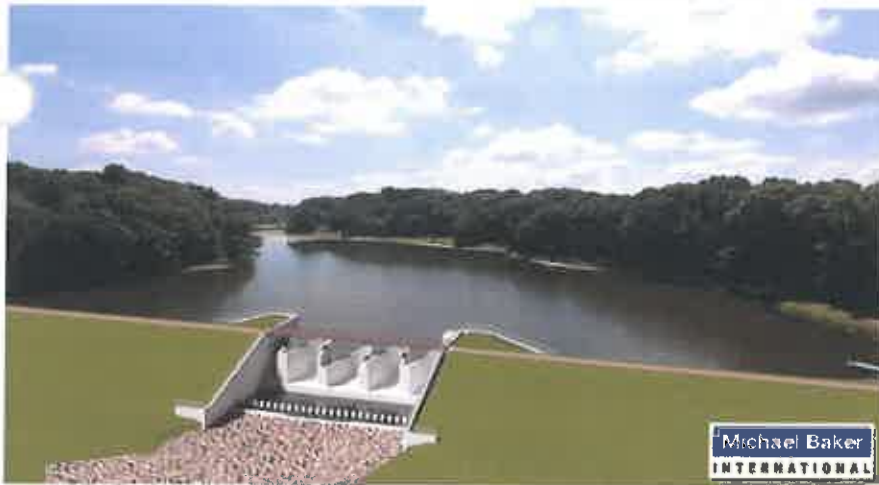
3D Rendering Used For Public Outreach

Michael Baker has used 3D modeling to realize project benefits through 3D representation of complex details like the detailing of waterstops in complex structures such as labyrinth spillways. Waterstops required between labyrinth cycles, training walls, base slabs, and cutoff walls can be visualized using a 3D model and aid in the development of isometric views and refined details of the intricate connections to be added to the Contract Drawings. This provides additional details of critical waterstop connections before construction and allows the engineer's design intent to be more clearly conveyed to the contractor.
