# Proposal

Facilities Assessment & Master Planning

## Building Condition Assessment

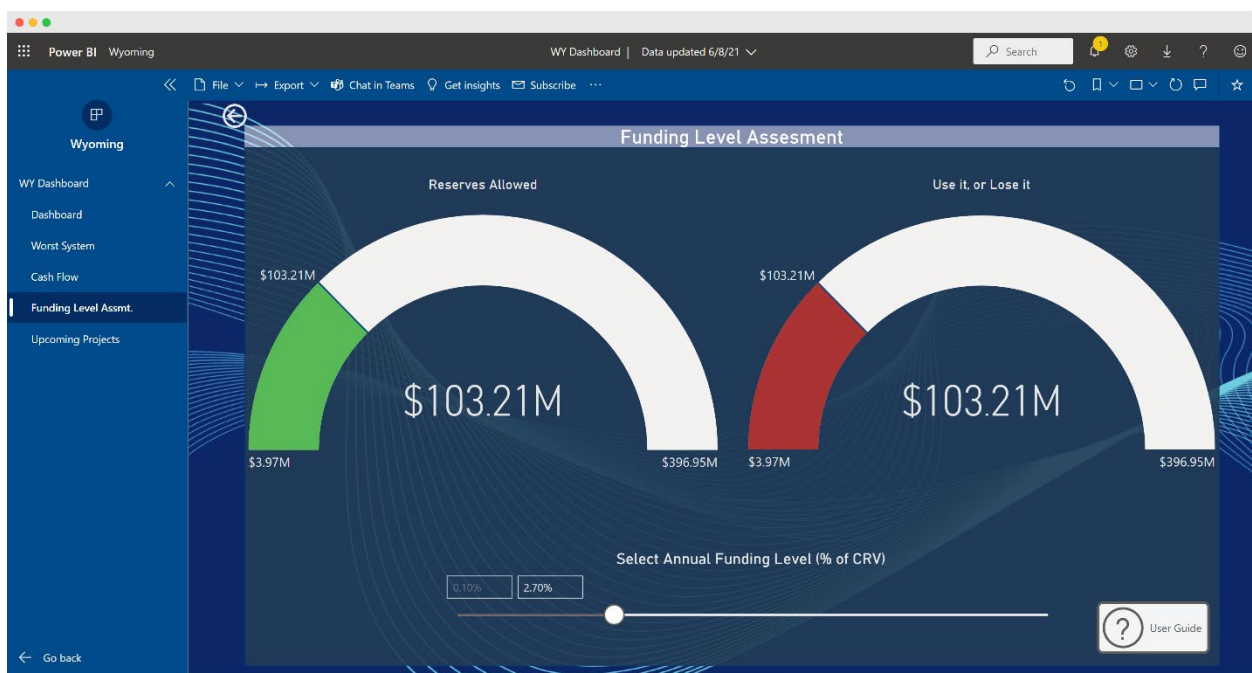
### Funding Needs Analysis Tool

The following is an example of a visualization and funding analysis that would enable the Agency to visualize and communicate the impacts of funding decisions both now and in the future. This simple-to-use and powerful tool can be customized to allow for adjustments in factors such as inflation and funding levels resulting in a visual representation of the long-term impact of funding at specified levels.

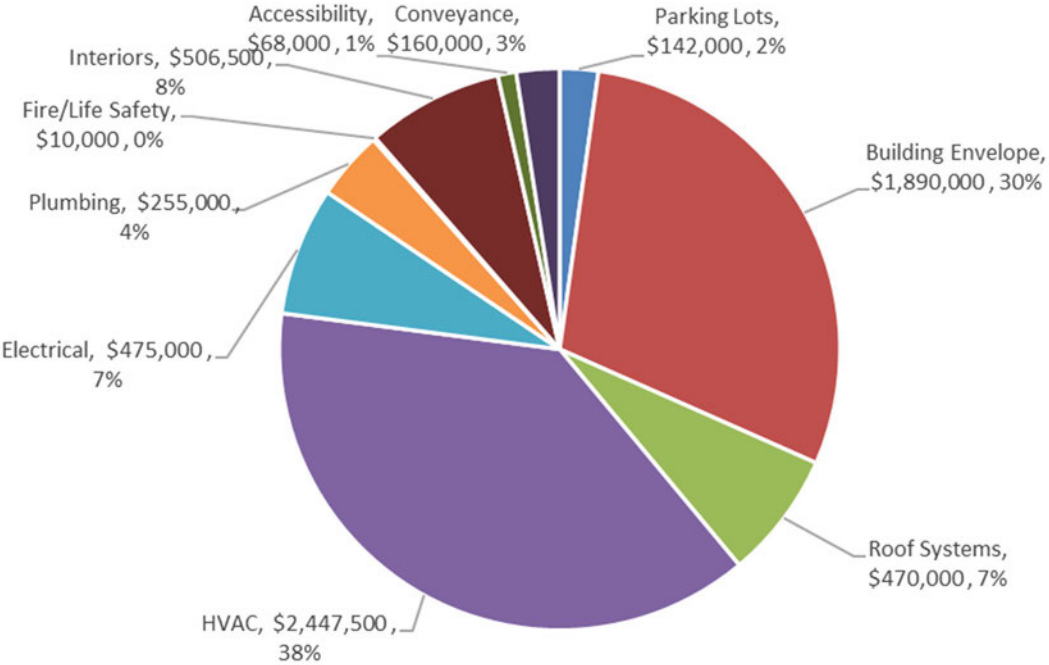
Figure 1. Capital Expenditure Breakdown

Overall, FEA identified approximately **\$6,424,000 in current deficiencies and capital renewal** to be addressed within the next 15 years. Our opinion of cost to address the deficiencies identified for each system is described in detail in the respective report sections and summarized in the Fifteen Year Capital Expenditure Forecast provided in Appendix A.

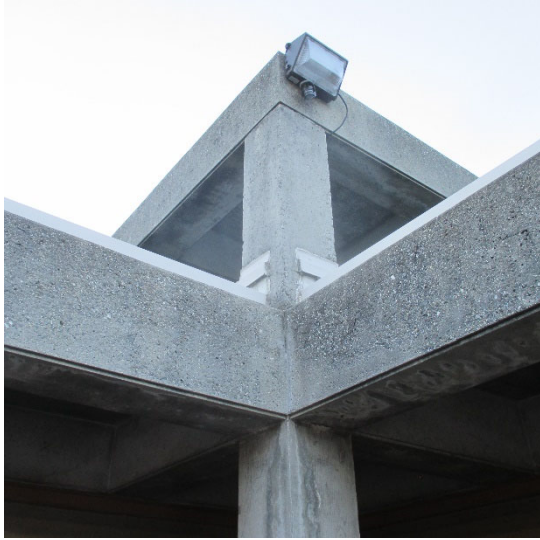
**Photograph No. 1**

Overview of concrete frame of the [REDACTED] buildings.

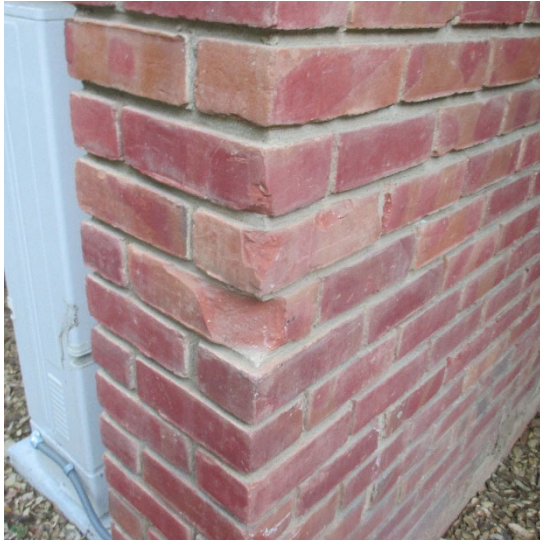
**Photograph No. 2**

Impact damage evident on some building corners.

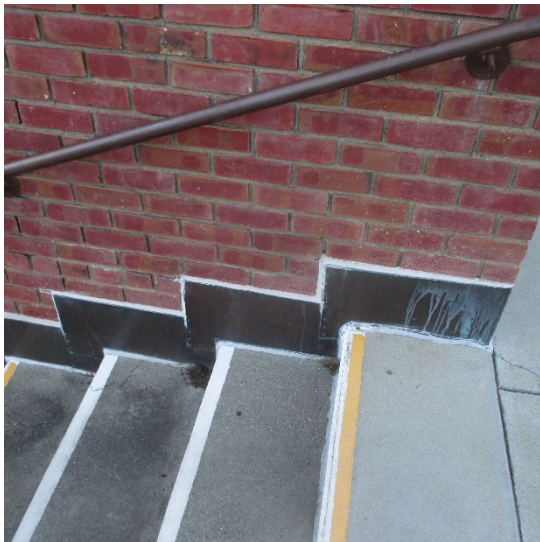
**Photograph No. 3**

Deteriorating sealant between plaza deck and walls.

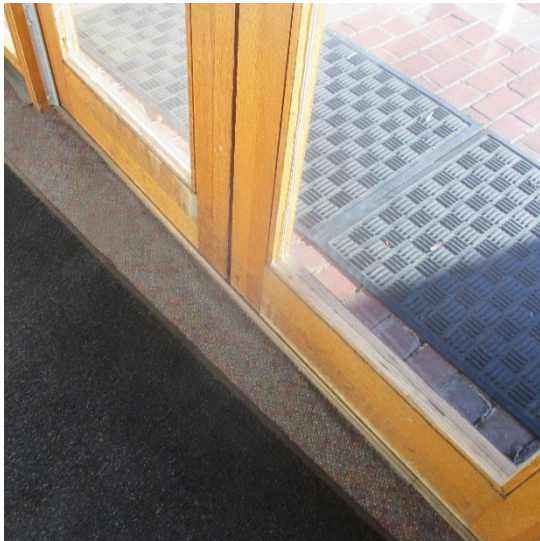
**Photograph No. 5**

Older single glazed wood doors at the police building entrance.

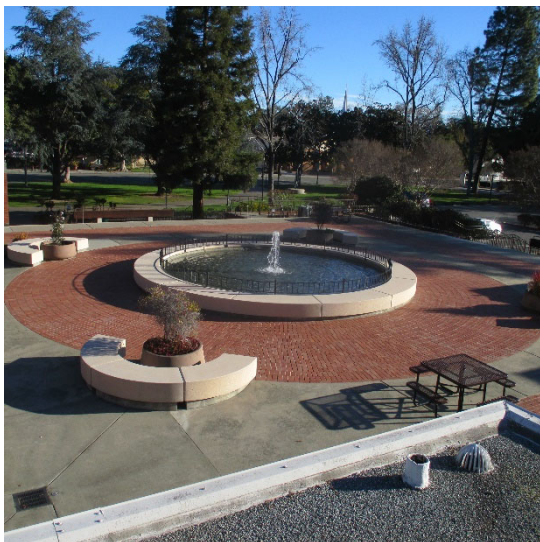
**Photograph No. 6**

Overview of plaza deck, fountain and area drain. Taken from police building roof.

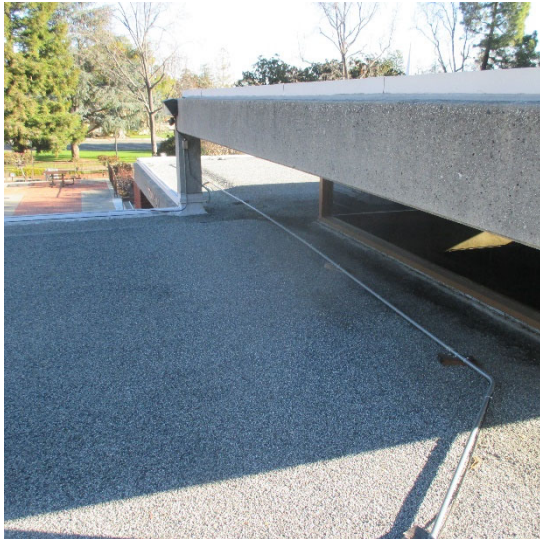
**Photograph No. 7**

Overview of [REDACTED] offices roof, showing upper roof and clerestory windows.

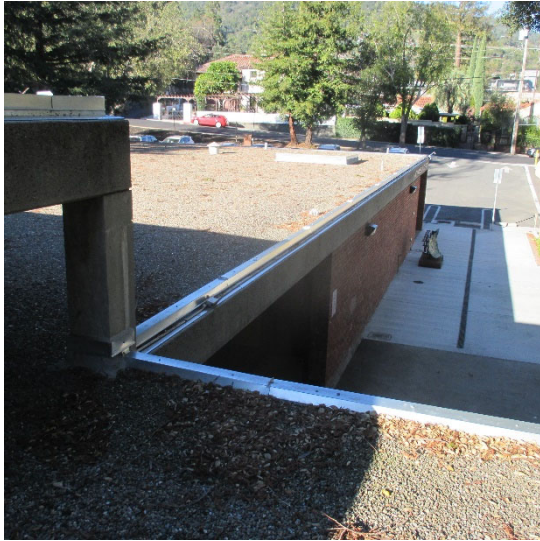
**Photograph No. 8**

Overview of the new museum roof.

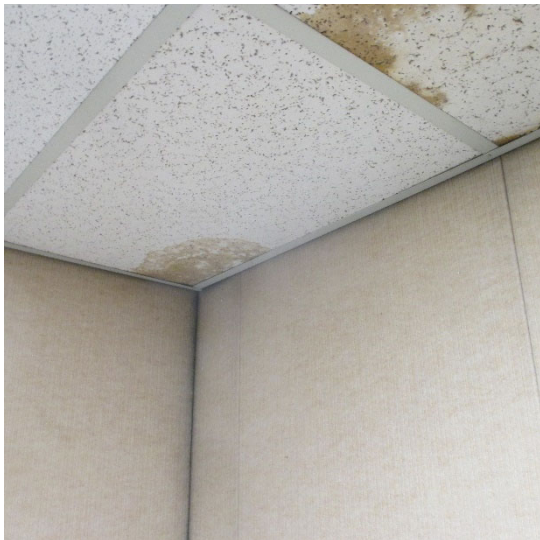
**Photograph No. 9**

Water damaged tiles in the civic center offices.

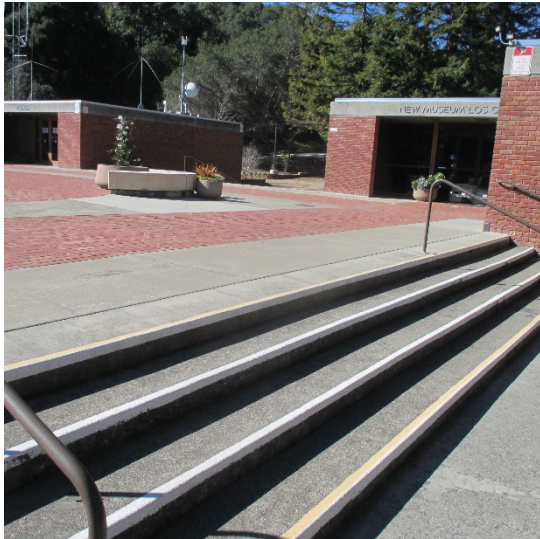
**Photograph No. 10**

The west side plaza steps, lacking an accessible ramp.

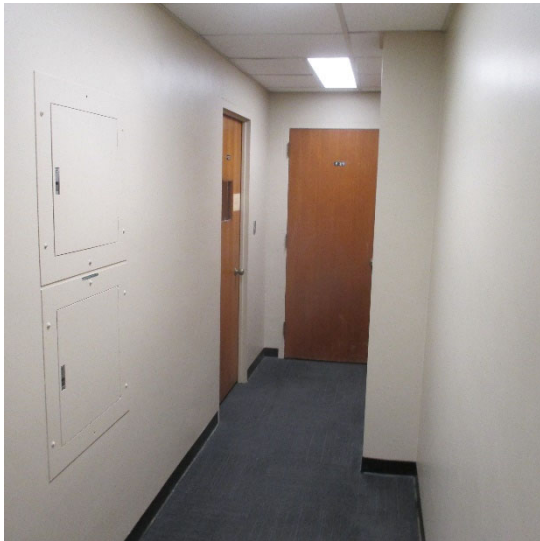
**Photograph No. 11**

Typical police building finishes.

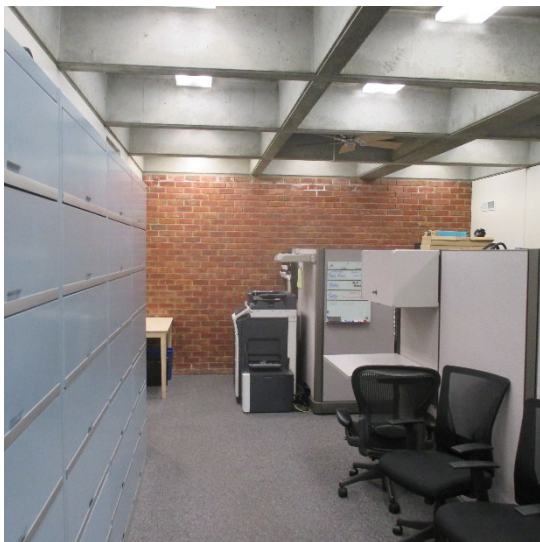
**Photograph No. 12**

Typical [REDACTED] offices finishes.

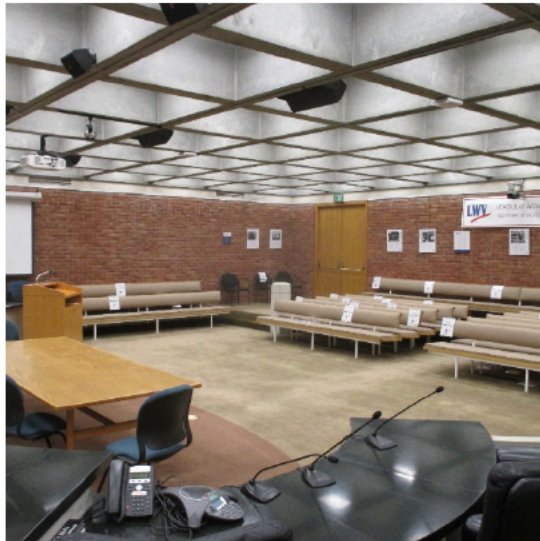
**Photograph No. 13**

Overview of council chambers.

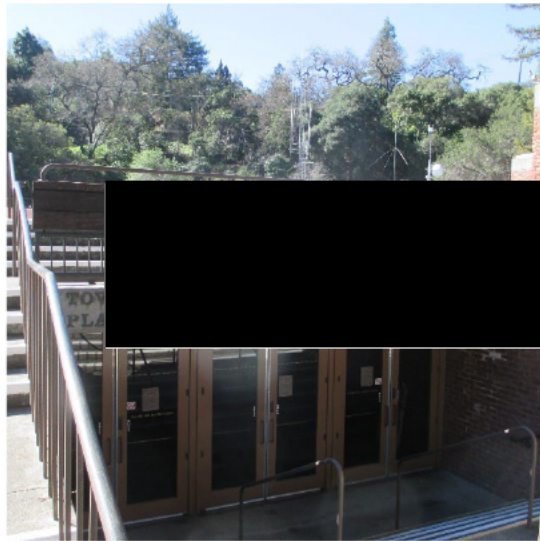
**Photograph No. 14**

Overview of [REDACTED] main entrance doors

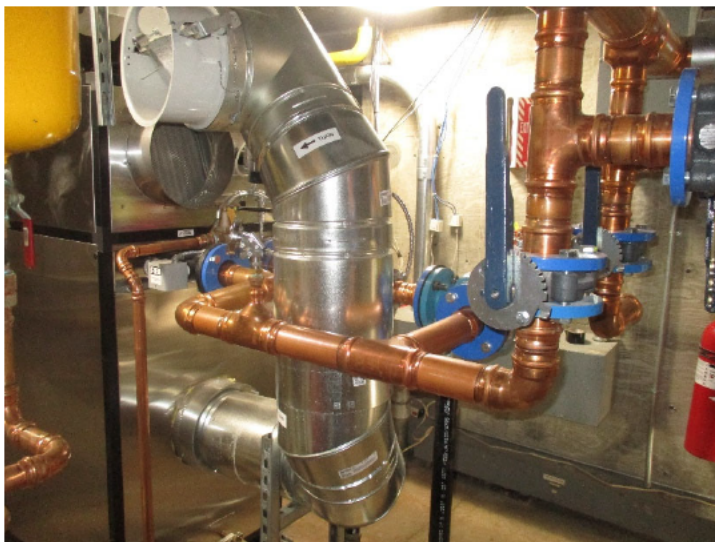
**Photograph No. 15**

The boiler was newly replaced, but piping insulation was not installed by the installing contractor. Installation of insulation is recommended to increase energy efficiency.

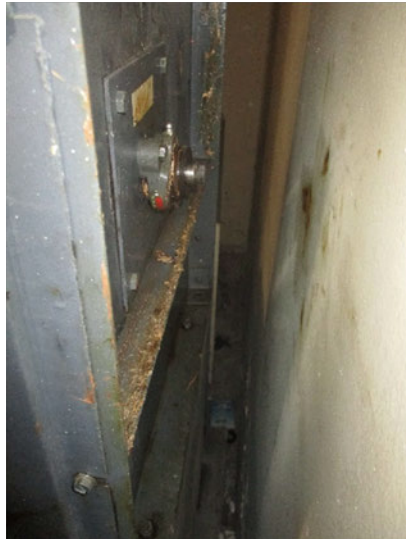
**Photograph No. 16**

The original air handler for the police dispatch was still in operations and in poor condition. Replacement is recommended.

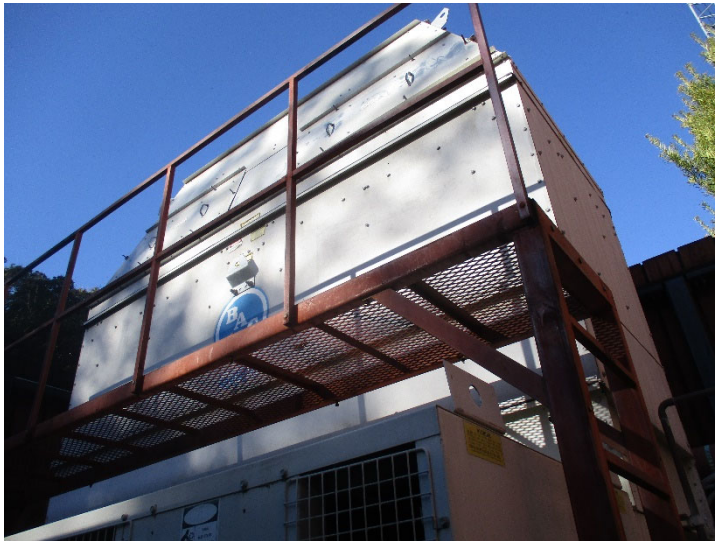
**Photograph No. 17**

Baltimore Air Coil cooling tower was in fair condition and recommended for replacement around 2030.

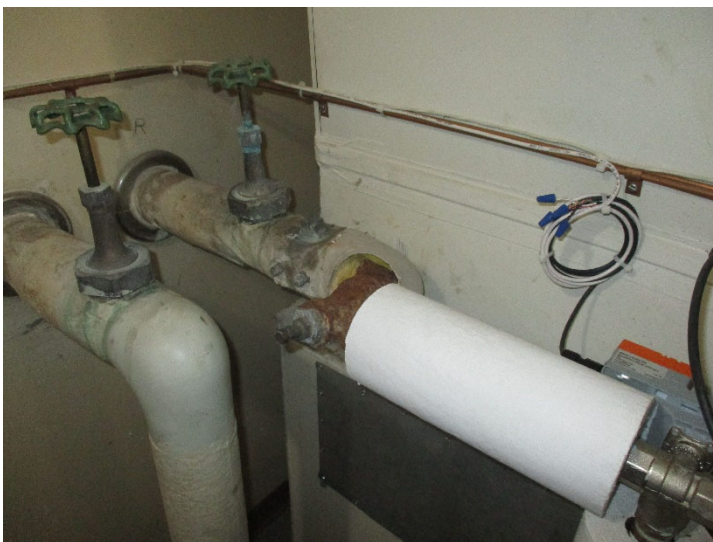
**Photograph No. 18**

Original globe valves were still in use in the HVAC system and largely inoperable, meaning portions of systems cannot be isolated to perform maintenance and repairs.

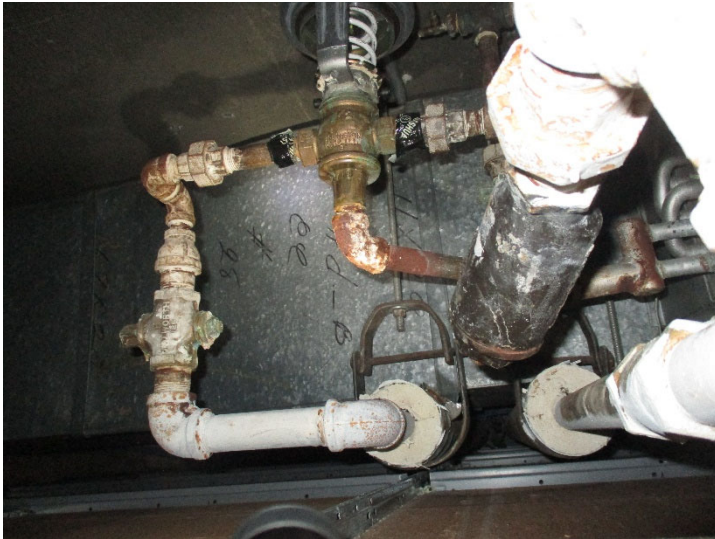
**Photograph No. 19**

Original terminal unit above ceiling in administration area. Three-way valve had been replaced due to leak, but piping and coil is original and beyond estimated useful life. Piping insulation is reportedly asbestos.

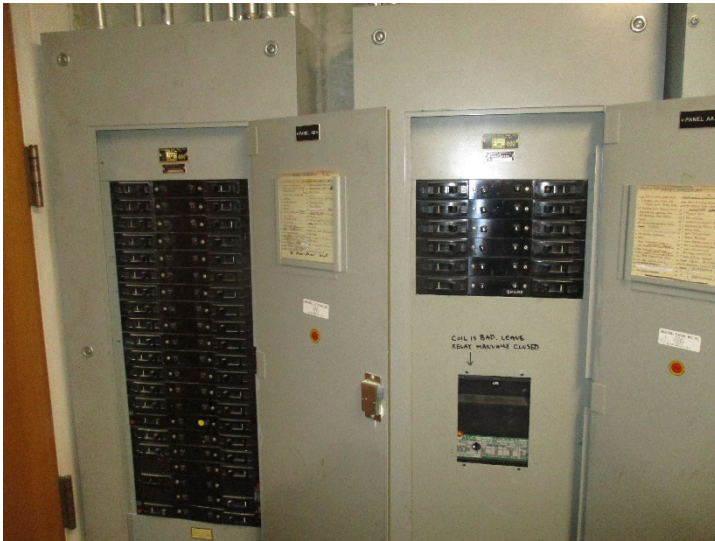
**Photograph No. 20**

Original electrical service infrastructure from 1967 is still in use and recommended for replacement.

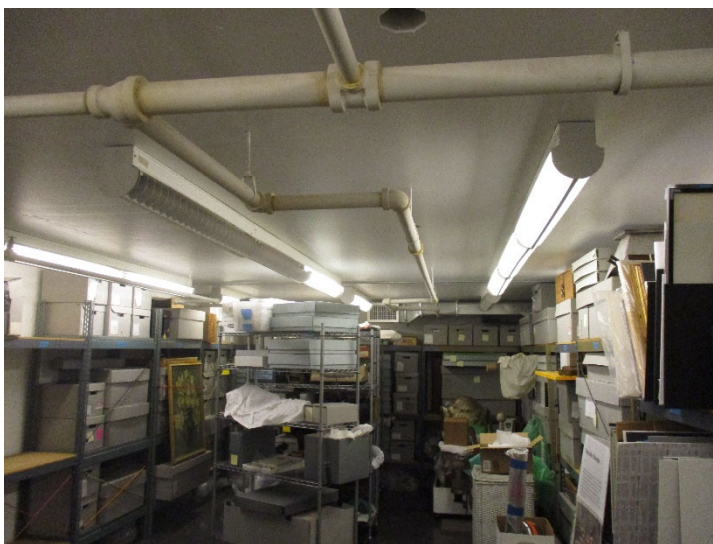
**Photograph No. 21**

Fire sprinkler piping in 1974 addition was in fair condition. Replacement of heads when they reach 50 years of age is required by NFPA.

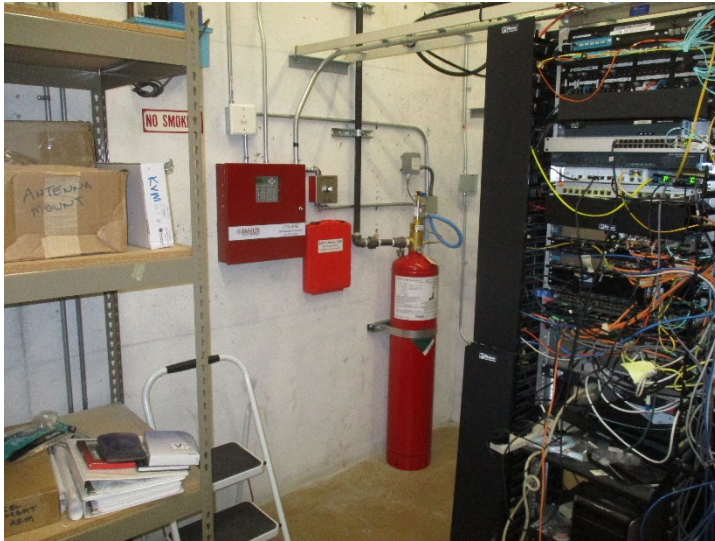
**Photograph No. 22**

New FM-200 fire suppression system installed for IT rooms were in excellent condition and expected to last beyond the study period.

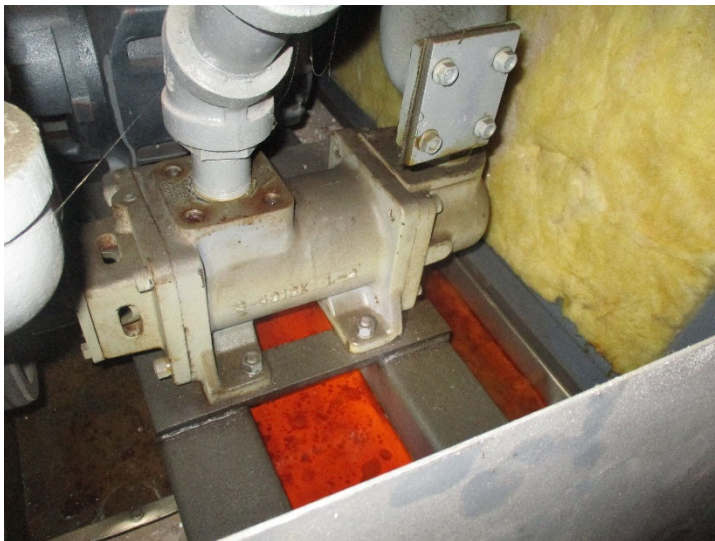
**Photograph No. 23**

Hydraulic elevator drive unit for the “staff” elevator was leaking and in need of repair. The entire “staff” elevator was beyond its estimated useful life and in poor condition.
