# Request for Quotation

RFQ NUMBER
DNR209014

LINE	QUANTITY	UOP	CAT. NO.	ITEM NUMBER	UNIT PRICE	AMOUNT
***** ADDENDUM NO. 2 *****						
THIS ADDENDUM IS ISSUED PROVE THE VENDOR TECHNICAL QUESTIONS AND AGENCY RESPONSES PER THE ATTACHED.						
BID OPENING HAS CHANGED TO: NOVEMBER 5, 2008 AT 1:30 PM						
0001	1	LS		968-42		
GENERAL CONSTRUCTION						
***** THIS IS THE END OF RFQ DNR209014 ***** TOTAL: _____

**CASS SCENIC RAILROAD STATE PARK**

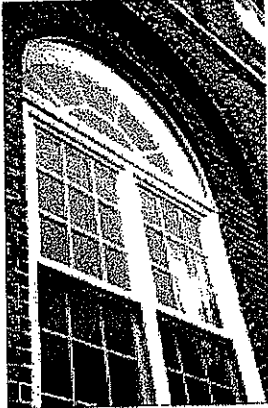
When the paint on the wood windows became too thick, it was removed and the window repainted.  
Photo: NPS files.

When paint builds up to a thickness of approximately 1/16" (approximately 16 to 30 layers), one or more extra coats of paint may be enough to trigger cracking and peeling in limited or even widespread areas of the building's surface. This results because excessively thick paint is less able to withstand the shrinkage or pull of an additional coat as it dries and is also less able to tolerate thermal stresses. Thick paint invariably fails at the weakest point of adhesion--the oldest layers next to the wood. Cracking and peeling follow. Therefore, if there are no signs of paint failure, it may be somewhat risky to add still another layer of unneeded paint simply for color's sake (extreme changes in color may also require more than one coat to provide proper hiding power and full color). When paint appears to be nearing the critical thickness, a change of accent colors (that is, just to limited portions of the trim) might be an acceptable compromise without chancing cracking and peeling of paint on wooden siding.

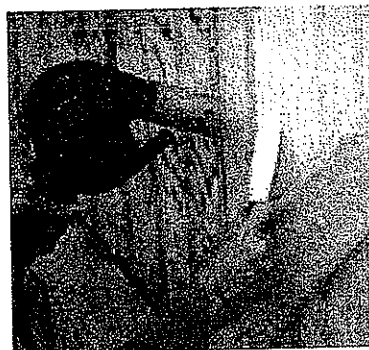
The nozzle on the electric heat gun permits hot air to be aimed into cavities on solid decorative surfaces, such as this carriage house door. After the paint has been sufficiently softened, it can be carefully removed with a scraper. Photo: NPS files.

Although the heat gun is heavier and more tiring to use than the heat plate, it is particularly effective for removing paint from detail work because the nozzle can be directed at curved and intricate surfaces. Its use is thus more limited than the heat plate, and most successfully used in conjunction with the heat plate. For example, it takes about two to three hours to strip a paneled door with a heat gun, but if used in combination with a heat plate for the large, flat area, the time can usually be cut in half. Although a heat gun seldom scorches wood, it can cause fires (like the blow torch) if aimed at the dusty cavity between the exterior sheathing and siding and interior lath and plaster. A fire may smolder for hours before flames break through to the surface. Therefore, this thermal device is best suited for use on solid decorative elements, such as molding, balusters, fretwork, or "gingerbread."

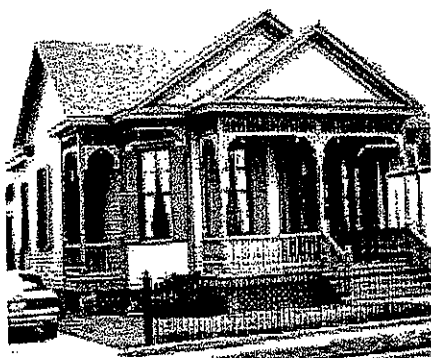
Decorative features were painted with a traditional oil-based paint as a part of the rehabilitation. Photo: NPS files.
