RFQ NUMBER
DNR212130

Cabwaylingo State Forest
Proposed New Dining Hall Construction

ADDENDUM #1

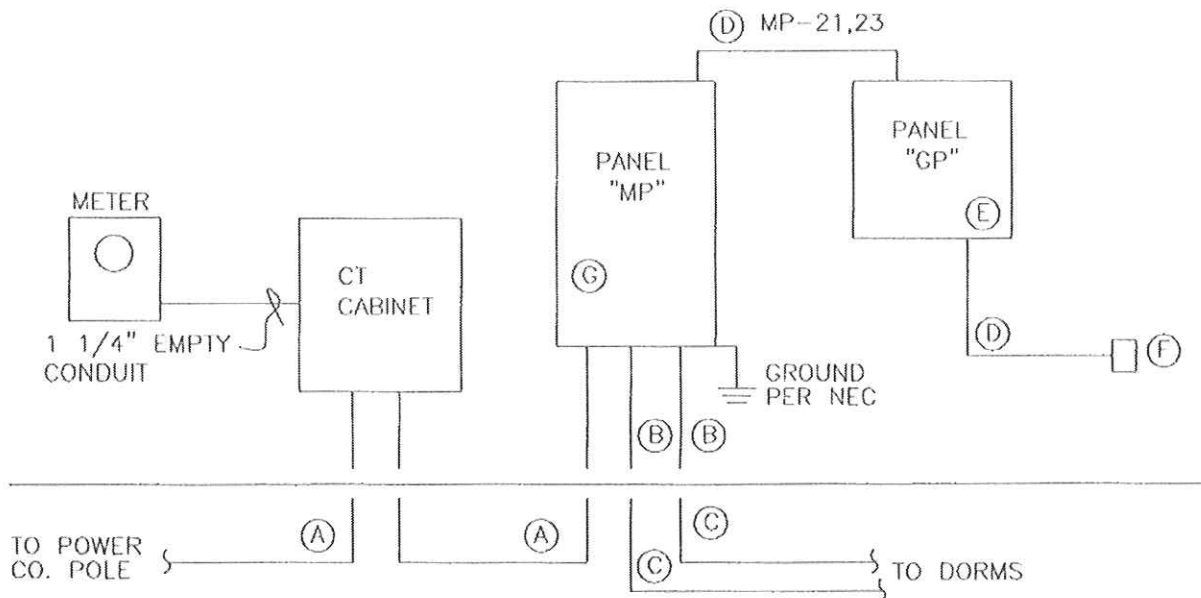
ELECTRICAL RISER

RISER NOTES:

- (A) 1 - 4" CONDUIT WITH 3 - 500MCM.
- (B) 1- 1-1/2" CONDUIT WITH 3 - #2 + #8 GRD.
- (C) INTERCEPT EXISTING UNDERGROUND CONDUITS TO DORMS. PULL NEW FEEDERS TO DORMS.
- (D) 1 - 1" CONDUIT WITH 3 - #6 + #10 GRD.
- (E) PROVIDE 60-AMP, 240-VOLT GENERATOR PANEL WITH GROUND BAR (SQUARE D #QO48M60DSGP OR EQUAL).
- (F) PROVIDE A 60-AMP, 240-VOLT PORTABLE GENERATOR PLUG ON EXTERIOR OF BUILDING.
- (G) PROVIDE 2P/60-AMPS, 240-VOLT BREAKER TO FEED GENERATOR PANEL "GP". USE CIRCUIT # MP-21,23.

- a. Refer to Electrical Riser: Omit and replace with SK-E1.
