SOLICITATION NUMBER: HOP14082

HOP14082-ADDENDUM#1
Resurfacing of Dietary Department Flooring

ASBESTOS REPORT

Property Address:
Hopemont Hospital
150 Hopemont Drive
Terra Alta, WV 26764
Kitchen and Cafeteria floors

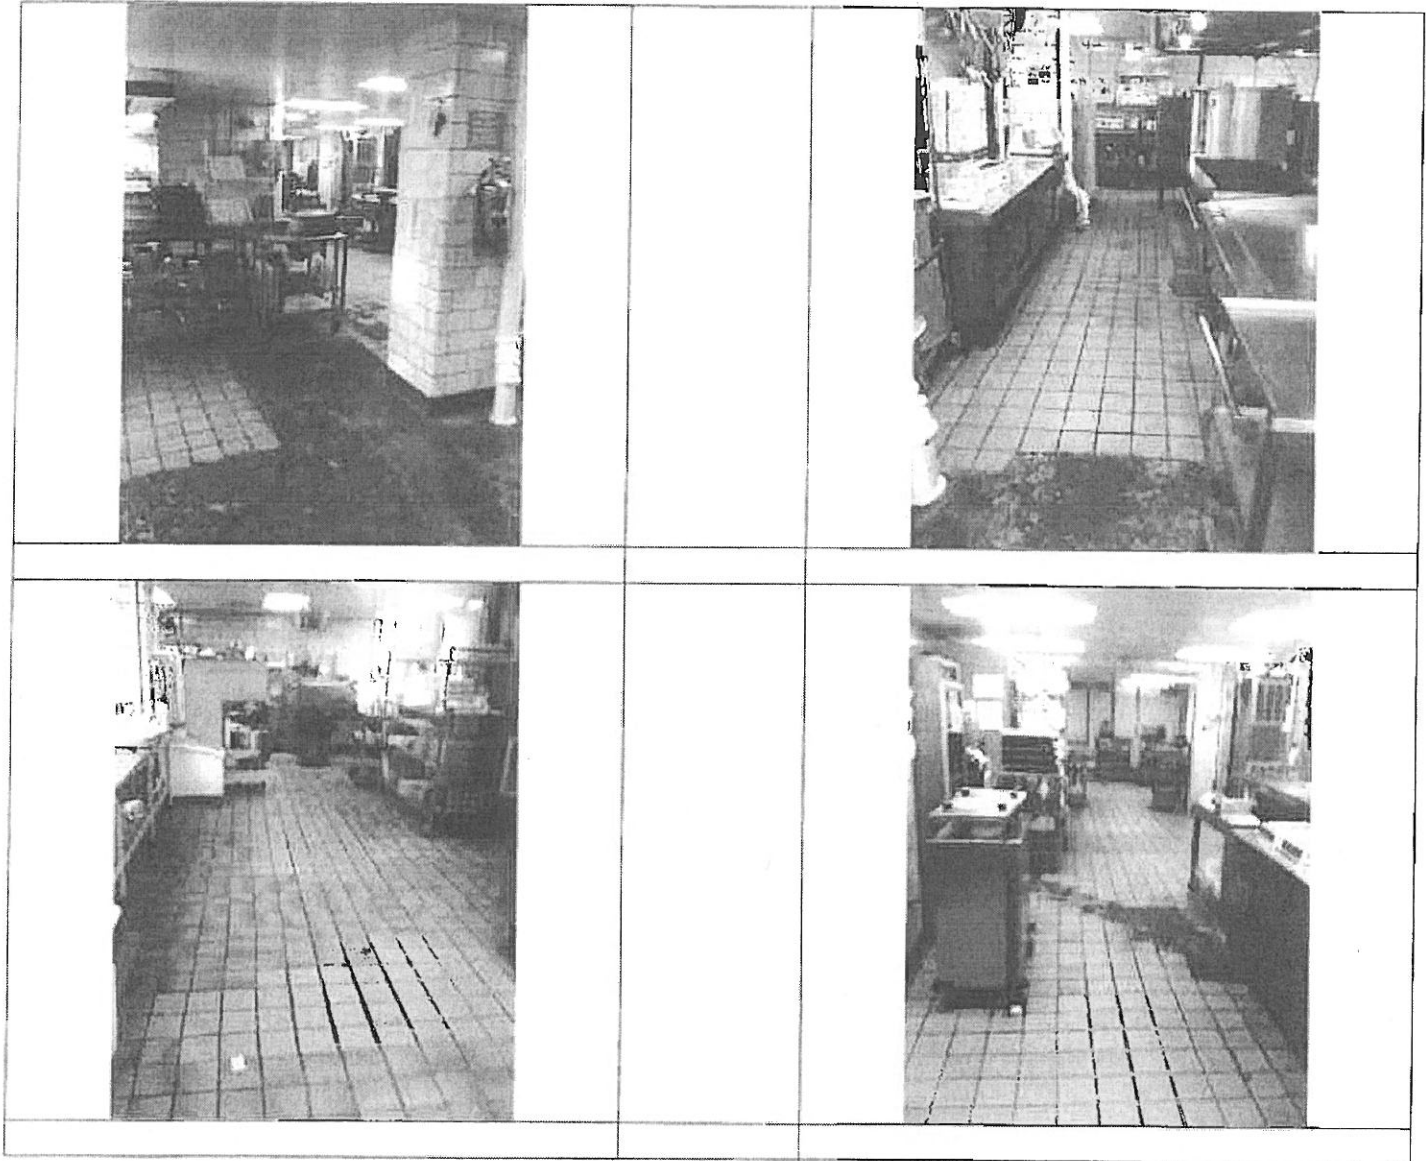
Section 5 - Photograph/Drawings

Ms. Shelby Hauser requested a limited scope asbestos inspection on kitchen and cafeteria floors only at Hopemont Hospital 150 Hopemont Drive Terra Alta, WV. There were no asbestos containing materials detected in areas tested.
