RFQ NUMBER
 DNRB11006

EXPRESSION OF INTEREST
Canaan Valley Resort State Park
Sleeping Unit Replacements and Other Improvements
DNRB 211006

Canaan Valley Resort State Park and Conference Center is located in Davis, WV and currently hosts many activities within the park property, including overnight accommodations at the lodge. The purpose of this report is to summarize structural deficiencies and provide recommendations for structural repairs and general maintenance items for the 5 overnight sleeping facilities surrounding the main lodge. The 5 facilities are Raven Lodge, Wild Goose Lodge, Deer Lodge, Woodcock Lodge, and Beaver Lodge, and will be referred to as such throughout the entirety of this report. As part of this report, an Order of Magnitude Cost Estimate for Structural Repairs has been prepared as well as an Order of Magnitude Cost Estimate for General Maintenance Items.

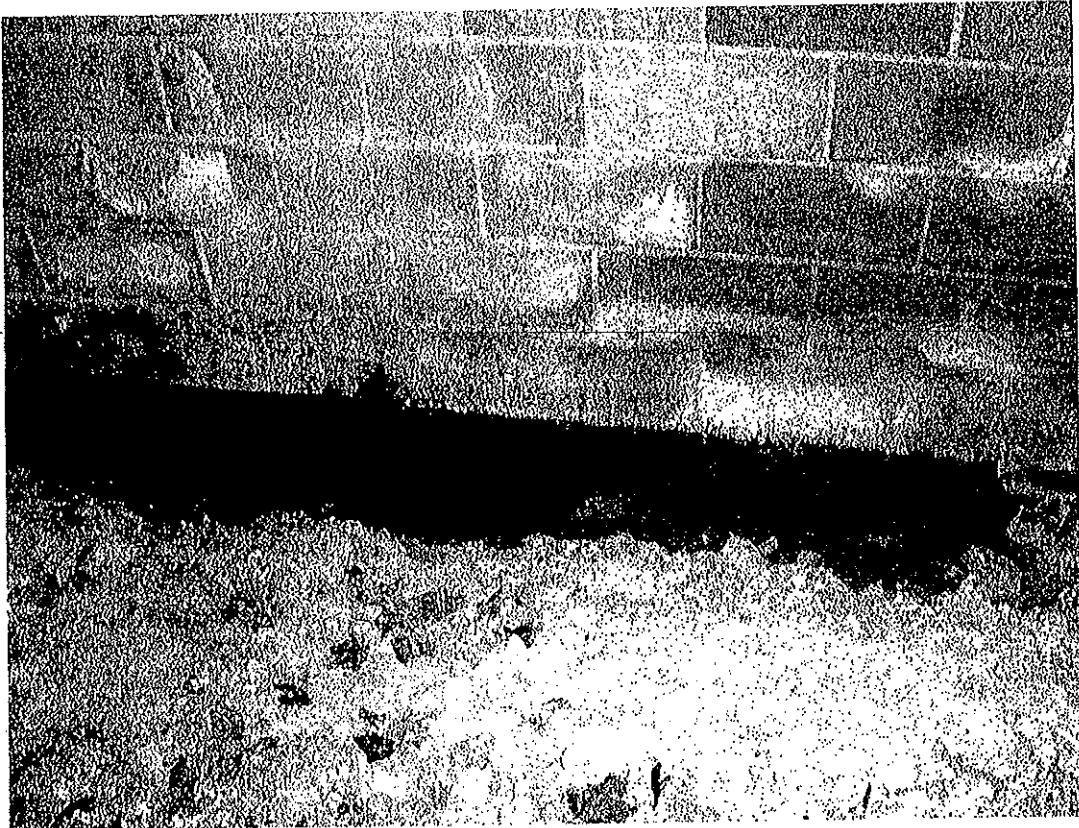
- **Areas of standing water were noticed on top of the perimeter strip wall footing** (See Photos 2, 5, 6, and 7-Appendix A)
- **Mold/algae growth in the crawlspace is prevalent** (See Photo 8-Appendix A)

Photo 5. Standing Water Around Interior of Foundation Wall of Raven Lodge

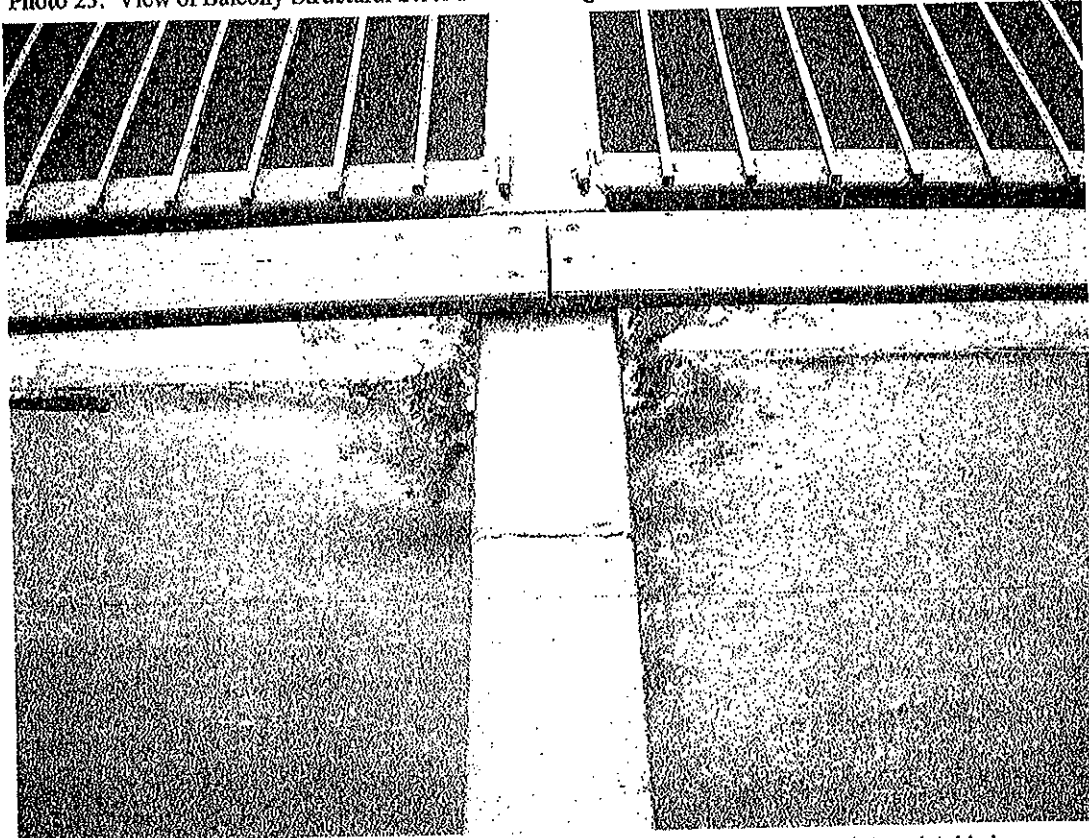
- Prior repairs to the beams supporting the concrete deck are evident (See Photo 26-Appendix A)
- Structural steel angle below the railing has been removed and a wood board was added in place (See Photo 24-Appendix A)

Photo 24. Edge Angle Along Face of Concrete Slab has been Removed and Wood Board Added

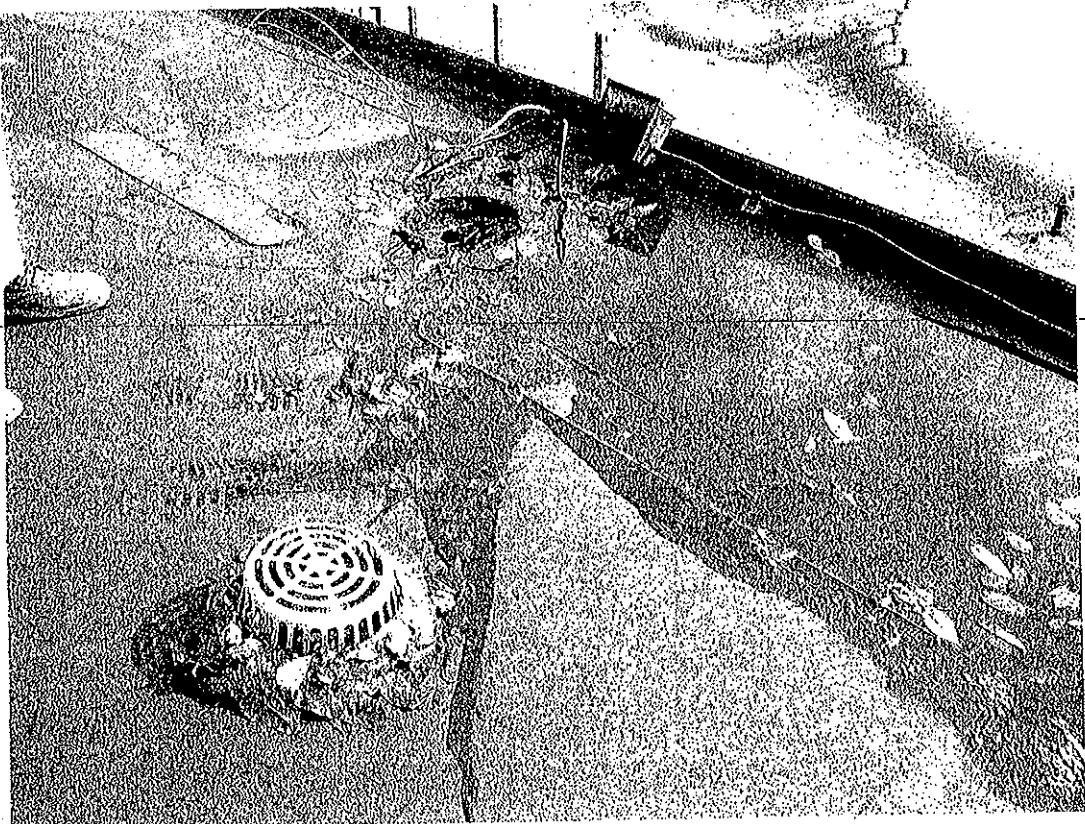
- Water is ponding at various locations on the roof (See Photos 35 and 36-Appendix A)
- **Leaves and other deleterious materials are blocking the roof drains** (See Photo 37-Appendix A)

Photo 37. Leaves Blocking Roof Drain

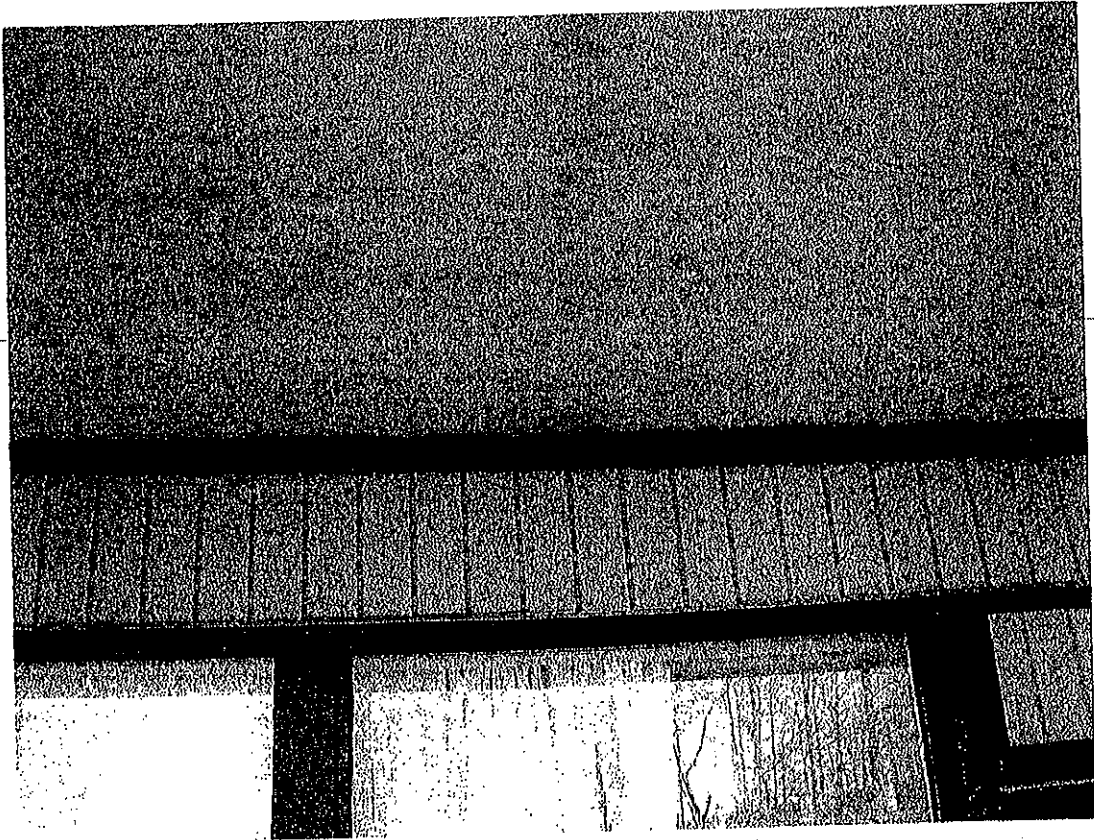
Photo 69. Deflection and Out of Plane Movement of Siding Above Window

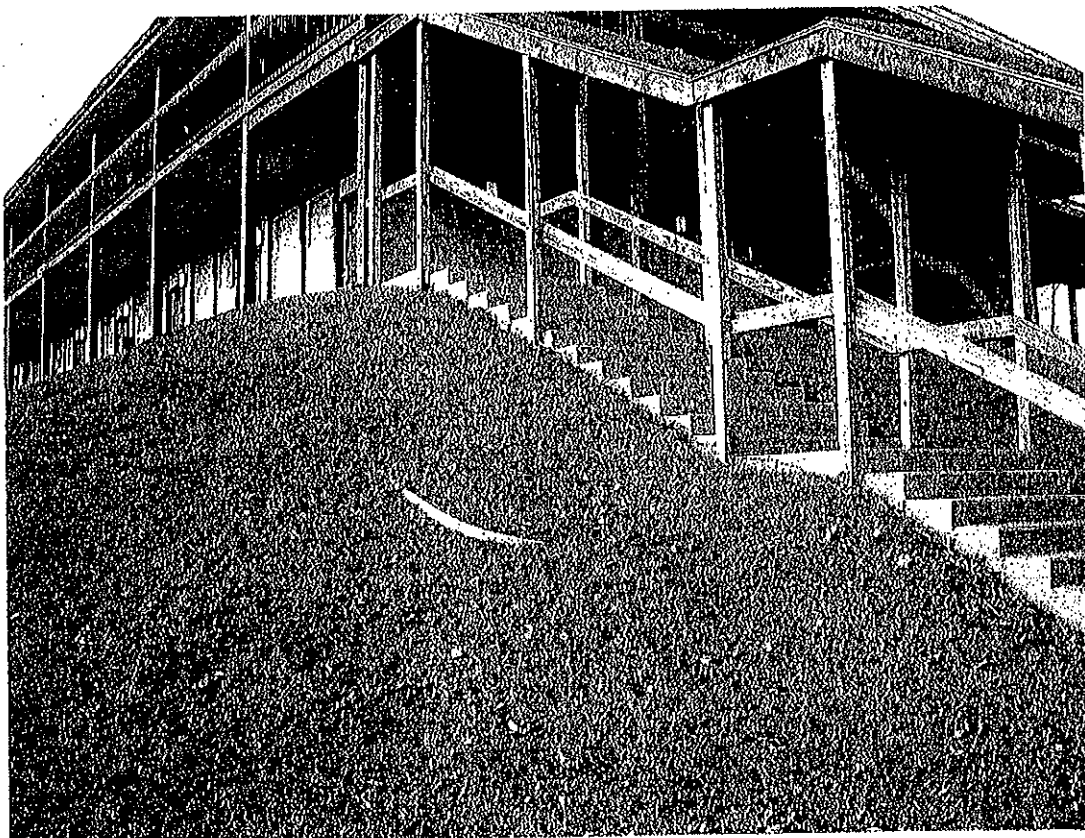
- **There is an exposed PVC conduit at the rear of the Raven Lodge that presents a safety hazard** (See Photo 112-Appendix A)
- The swale in front of Wild Goose Lodge is not properly sloped for positive drainage (See Photo 113-Appendix A)
- There is a water valve extension behind the Raven Lodge that should be repaired (See Photo 111-Appendix A)

Photo 112. Exposed Gray PVC Conduit
