Solicitation Description: Campus Chill Water Loop / Plant Evaluation and Enhancements

Expression of Interest
West Virginia –General Services Division
Campus Chilled Water Loop / Plant Evaluation
CEOI GSD2300000007

Chilled Water Loop/ Plant Evaluation and Enhancements Project Goals

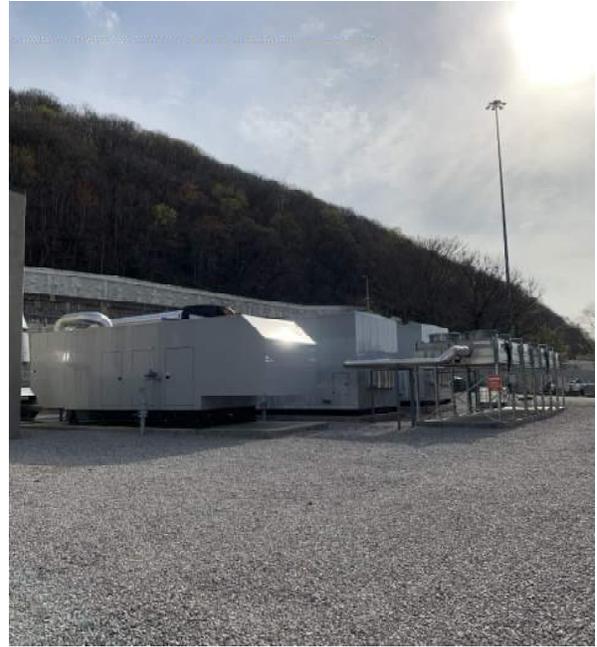
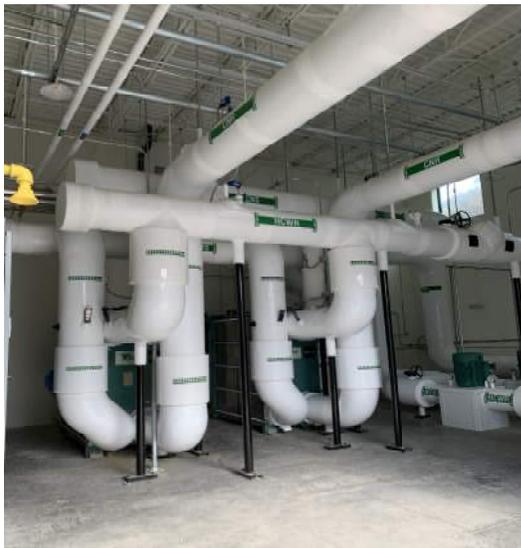
The existing chiller plant serving the WV State Capital Complex is 20 years old. The Owner wishes to reduce energy costs associated with the peak electrical demand metering applied to the plant's electrical service. MEI was retained to evaluate multiple options to reduce electrical demand, and thereby the operating costs. The determined optimal solution is to use large, medium voltage, natural gas generators which could operate select chillers during peak demand to reduce electrical peak demand. A 5kV switchgear will allow the select chillers and their respective pumps to operate under generator load when they are required to come online. A new 2,300 ft² building will be constructed to house the new switchgear, pumps, and heat exchangers to allow the chillers to still operate as a plant. The project was completed in May of 2022.

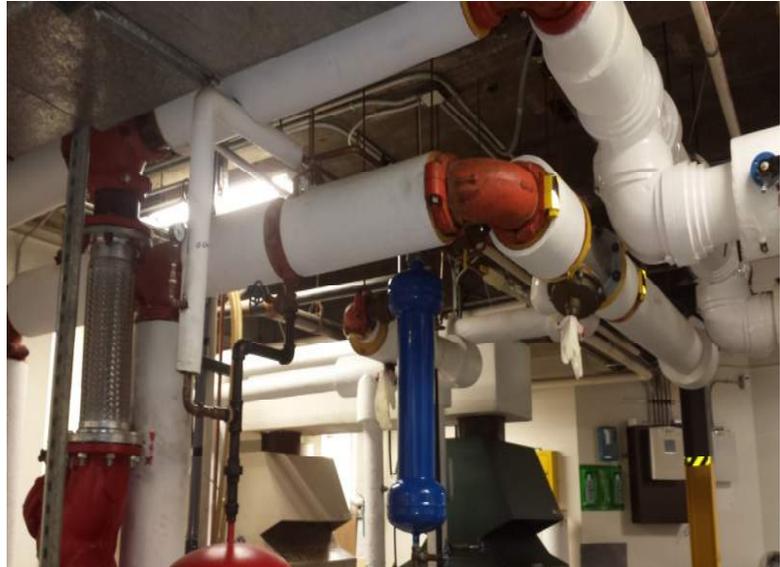
The PVC piping system at Building 25 had a history of leaking, along with smaller piping sagging over time and breaking, prompting the owner to replace the entire system. The building was a logistic challenge to design due to offset multi-level mezzanines, resulting in low deck-to-deck heights in the lower levels. A new, rolled-groove piping system was installed, including a new cooling tower and supporting structure, and connected to the original boilers. To eliminate the problems associated with manganese, which forms solids and clogs piping, the system was converted from water to propylene glycol with the flow rates adjusted to accommodate the change. The water source heat pumps which serve the building were flushed and cleaned to prevent contamination of the new water. MEI designed a phased approach to accomplish the piping, which was adjusted in consultation with the owner and contractor during construction to minimize the impact on the building occupants, who remained in the building during the entire construction period. MEI worked on an almost daily basis with the contractor to accomplish the re-piping of the building, providing support and real-time answers to questions and to work around challenges.

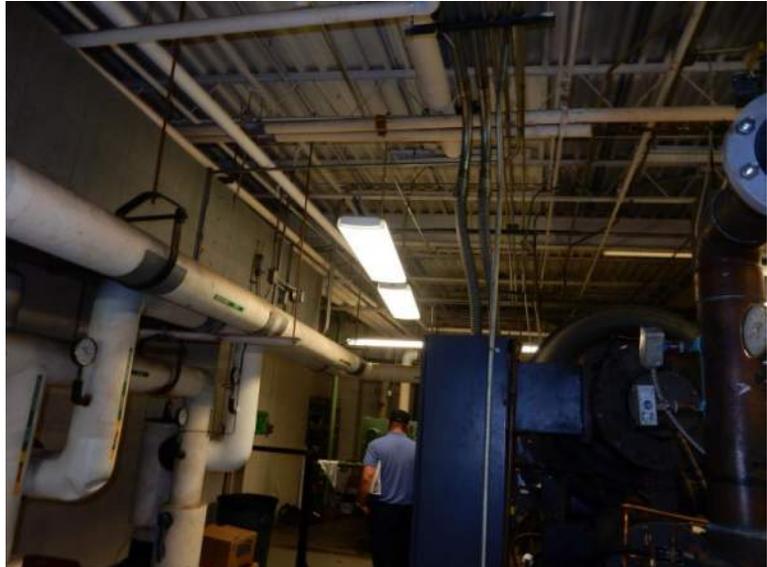
The 30-plus year old chiller serving Building 36 failed in the spring of 2016. MEI was retained to design the installation of a temporary rental chiller, which remains in service at this time. MEI was then retained to design a full HVAC retrofit to the building due to the condition of the air handlers, ductwork, VAV boxes, and associated systems. The building presented unique challenges as it was originally two buildings in which the common space was later in filled to create one building. The deck to deck heights in some areas are very limited, resulting in the need for accurate evaluation, design, and detailing in the construction documents. MEI designed a phased approach to accomplish the project. The phasing was developed directly with the owner to minimize the impact on the building occupants; who had to relocate to swing space phase by phase. Instead of just replacing the existing system in-kind, MEI designed a system utilizing three rooftop units ducted vertically through the building, which eliminates the sole source failures that have plagued the system for several years. The project is ready for bid at this time.

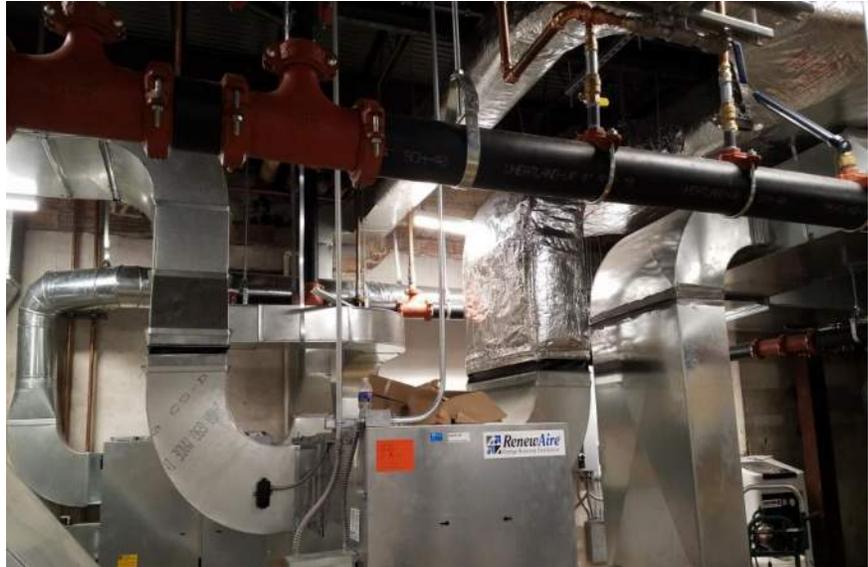
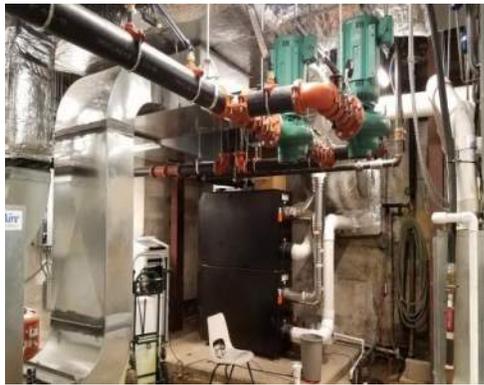
As part of renovations to Withers Brandon Hall at Alderson Broaddus University, MEI was brought in to evaluate and design upgrades to the HVAC system. The existing chiller and piping insulation had failed. The existing system was a two-pipe system with chiller and boilers serving fan coil units. MEI proposed to re-use the piping and replace the fan coil units with water source heat pumps (WSHP). This allows the existing piping to be re-used and piping insulation would not have to be replaced. The chiller will be replaced with a fluid cooler located outside the building. The three non-condensing boilers will be replaced with a much more efficient modulating condensing "double stack" boiler. The ventilation units are located in the unconditioned attic space and are difficult to perform maintenance on. New ducted heat pumps tied to energy recovery ventilators will tie into the existing fresh air duct to provide ventilation and relief air. The design limits the amount of modifications outside of the mechanical rooms which will aid with the compressed construction schedule. The project was completed in October 2019.

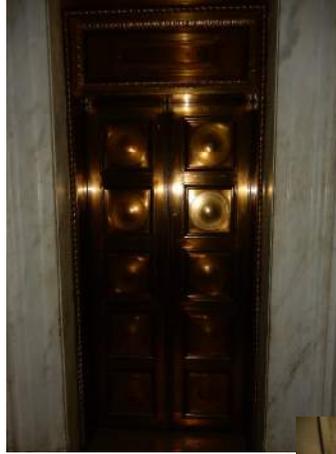
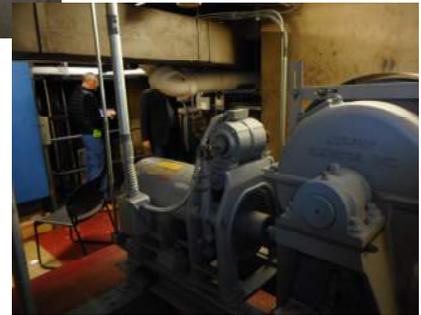
MEI and Richard Kennedy and Associates were retained to evaluate 31 existing elevator systems and design modernizations of each in a three phase project approach. The scope of service includes modernizing the machine rooms and bringing the systems into compliance with no or a few variances as possible. The team prepared a detailed report with discussions, estimates, recommendations, executive summary, and an elevator system “primer” to assist readers in more thoroughly comprehending the report. Phase I Involved 7 elevators at the WV Capitol Building, 2 elevators at WV Building 7, and 2 elevators at WV Building 25. The work related to the passenger elevator cars, doors, and landings will be in accordance to guidance from the WV State Historical Preservation Office. Phases I & II are currently in construction.

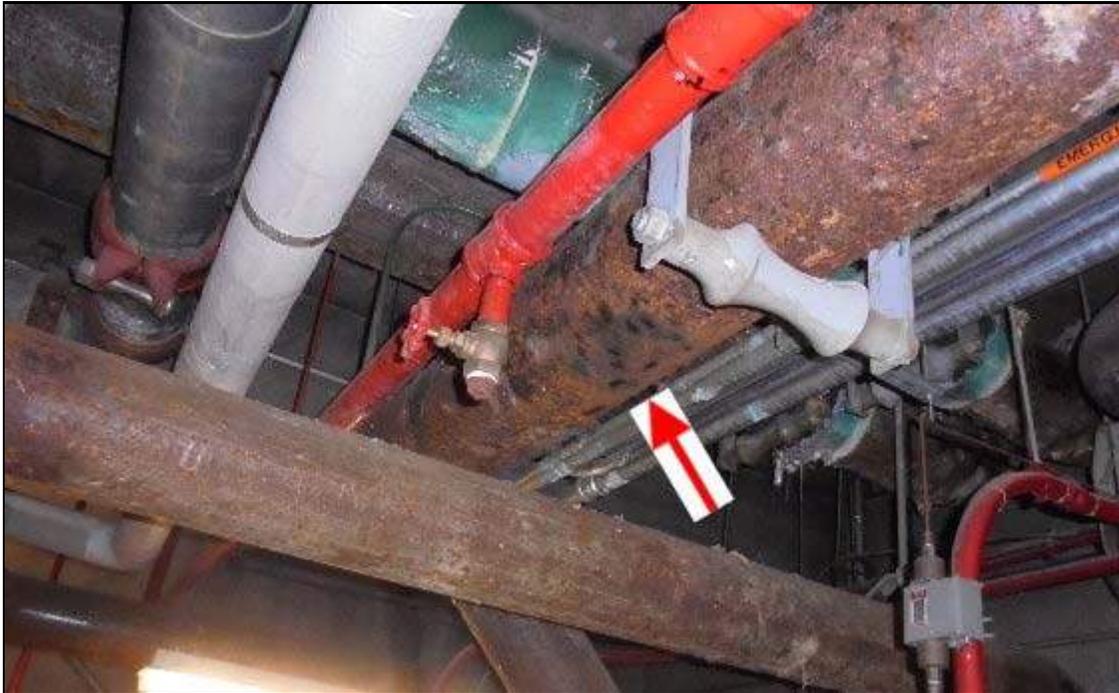
Pipe Identification and Operating Conditions

Service: Chill Water
Nominal Pipe Size: 10 in.
Actual Pipe Size: 10.75 in.
Schedule/Type: Schedule 40
Material: Carbon Steel
Construction: Welded
Flow: Return To HX
Pipe Pressure: 50 PSIG
Temperature: 65 Deg. F.
Pipe Orientation: Horizontal
Test Site I.D.: T-CHW-10-101
Site Drawing Number: n/a
Depth Allowance: 0.000 in.
Test Pattern: Bottom & Lower Sides

Location - Terminal B Tunnel: Chill water main return header to pumps. Test points located between pipe support and inlet to pump # 1.
Placed In Service: June 1, 1985
Date of Test: December 30, 2016
Time In Service: 31.6 Years
Original Wall Thickness: 0.365 in.
Minimum Allowable Thickness: 0.125 in. (0.033)
Minimum Thickness Based Upon: Default Minimum Value
Standard Deviation: 0.014 in. / **High to Low Range:** 0.049 in.
Minimum Theoretical Wall Thickness: 0.316 in.
Pitting Index: 10.6% - Significant Pitting Activity
Notes: None

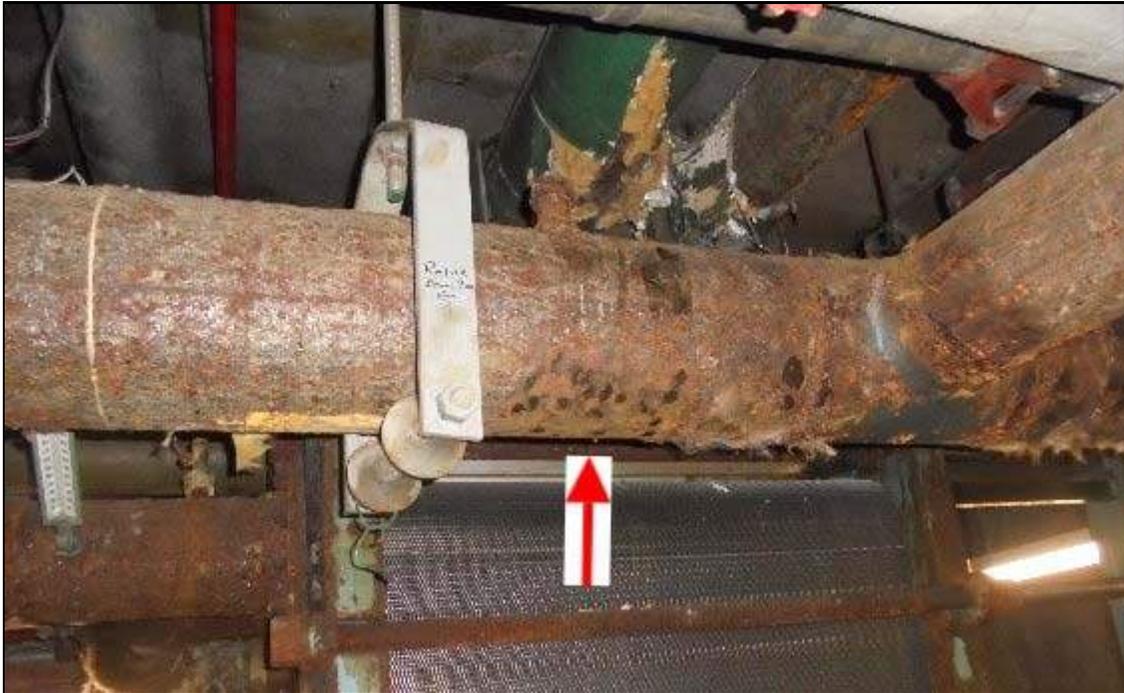
Photo File #: phl-1-02.jpg
 Detail: Pipe Location / Condition
 Orientation: Below Side View

Pipe Identification and Operating Conditions

Service: Chill Water
 Nominal Pipe Size: 10 in.
 Actual Pipe Size: 10.75 in.
 Schedule/Type: Schedule 40
 Material: Carbon Steel
 Construction: Welded
 Flow: Return To HX
 Pipe Pressure: 60 PSIG
 Temperature: 65 Deg. F.
 Pipe Orientation: Horizontal
 Test Site I.D.: T-CHW-10-102
 Site Drawing Number: n/a
 Depth Allowance: 0.000 in.
 Test Pattern: Bottom & Lower Sides

Placed In Service: June 1, 1985
 Date of Test: December 30, 2016
 Time In Service: 31.6 Years
Original Wall Thickness: 0.365 in.
Minimum Allowable Thickness: 0.125 in. (0.037)
 Minimum Thickness Based Upon: Default Minimum Value
 Standard Deviation: 0.014 in. / High to Low Range: 0.053 in.
 Minimum Theoretical Wall Thickness: 0.307 in.
 Pitting Index: 11.3% - Significant Pitting Activity
 Notes: None

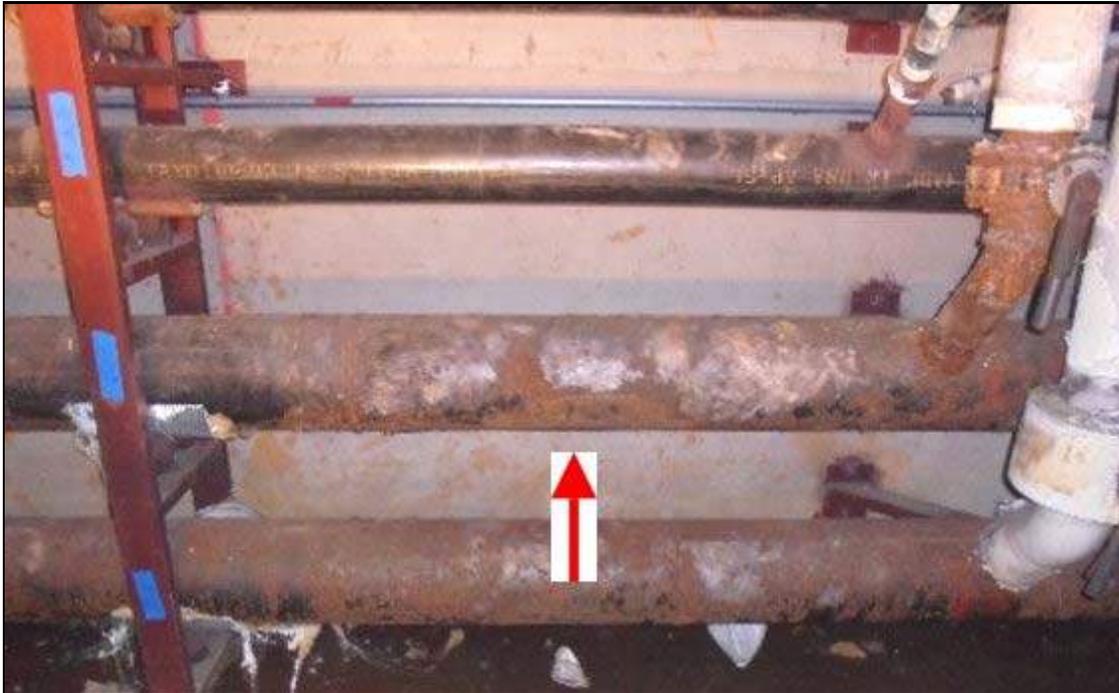
Photo File #: phl-1-06.jpg
 Detail: Pipe Location / Condition
 Orientation: Side View

Pipe Identification and Operating Conditions

Service: Chill Water
Nominal Pipe Size: 10 in.
Actual Pipe Size: 10.75 in.
Schedule/Type: Schedule 40
Material: Carbon Steel
Construction: Welded
Flow: Supply To Building
Pipe Pressure: 60 PSIG
Temperature: 55 Deg. F.
Pipe Orientation: Horizontal
Test Site I.D.: T-CHW-10-103
Site Drawing Number: n/a
Depth Allowance: 0.000 in.
Test Pattern: Bottom & Lower Sides

Placed In Service: June 1, 1985
Date of Test: December 30, 2016
Time In Service: 31.6 Years
Original Wall Thickness: 0.365 in.
Minimum Allowable Thickness: 0.125 in. (0.037)
Minimum Thickness Based Upon: Default Minimum Value
Standard Deviation: 0.008 in. / **High to Low Range:** 0.024 in.
Minimum Theoretical Wall Thickness: 0.325 in.
Pitting Index: 4.3 % - Acceptable Pitting Activity
Notes: None

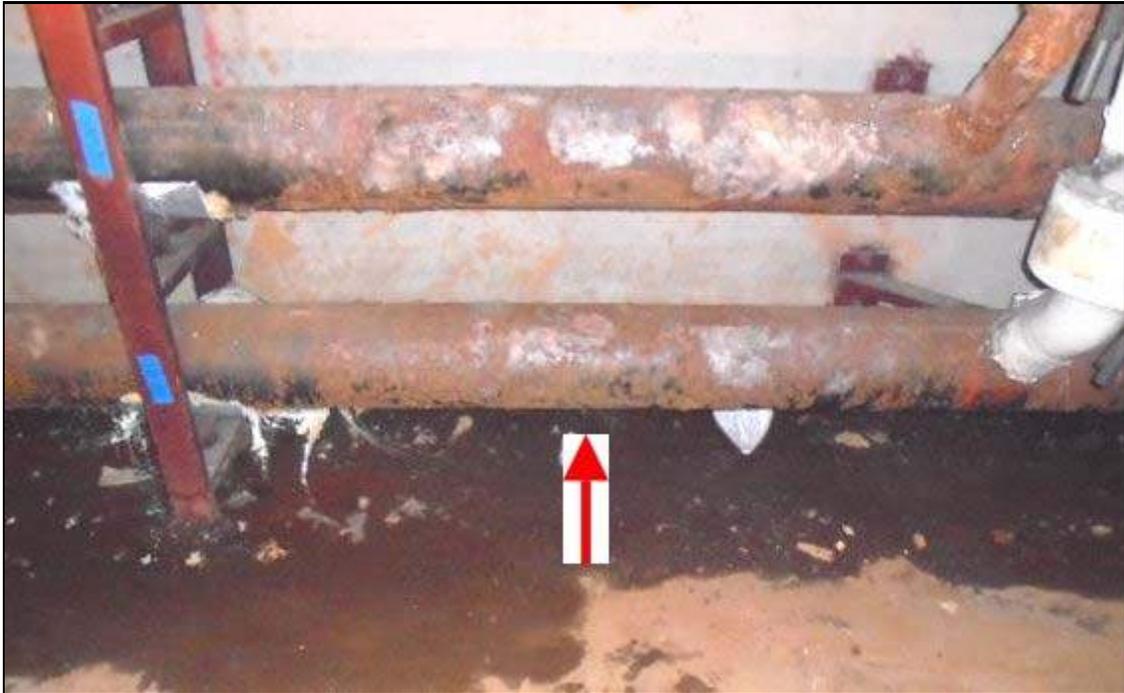
Photo File #: phl-1-07.jpg
 Detail: Pipe Location / Condition
 Orientation: Above Side View

Pipe Identification and Operating Conditions

Service: Chill Water
Nominal Pipe Size: 10 in.
Actual Pipe Size: 10.75 in.
Schedule/Type: Schedule 40
Material: Carbon Steel
Construction: Welded
Flow: Return To HX
Pipe Pressure: 50 PSIG
Temperature: 65 Deg. F.
Pipe Orientation: Horizontal
Test Site I.D.: T-CHW-10-104
Site Drawing Number: n/a
Depth Allowance: 0.000 in.
Test Pattern: Bottom & Lower Sides

Placed In Service: June 1, 1985
Date of Test: December 30, 2016
Time In Service: 31.6 Years
Original Wall Thickness: 0.365 in.
Minimum Allowable Thickness: 0.125 in. (0.033)
Minimum Thickness Based Upon: Default Minimum Value
Standard Deviation: 0.005 in. / **High to Low Range:** 0.019 in.
Minimum Theoretical Wall Thickness: 0.337 in.
Pitting Index: 3.7 % - Acceptable Pitting Activity
Notes: None

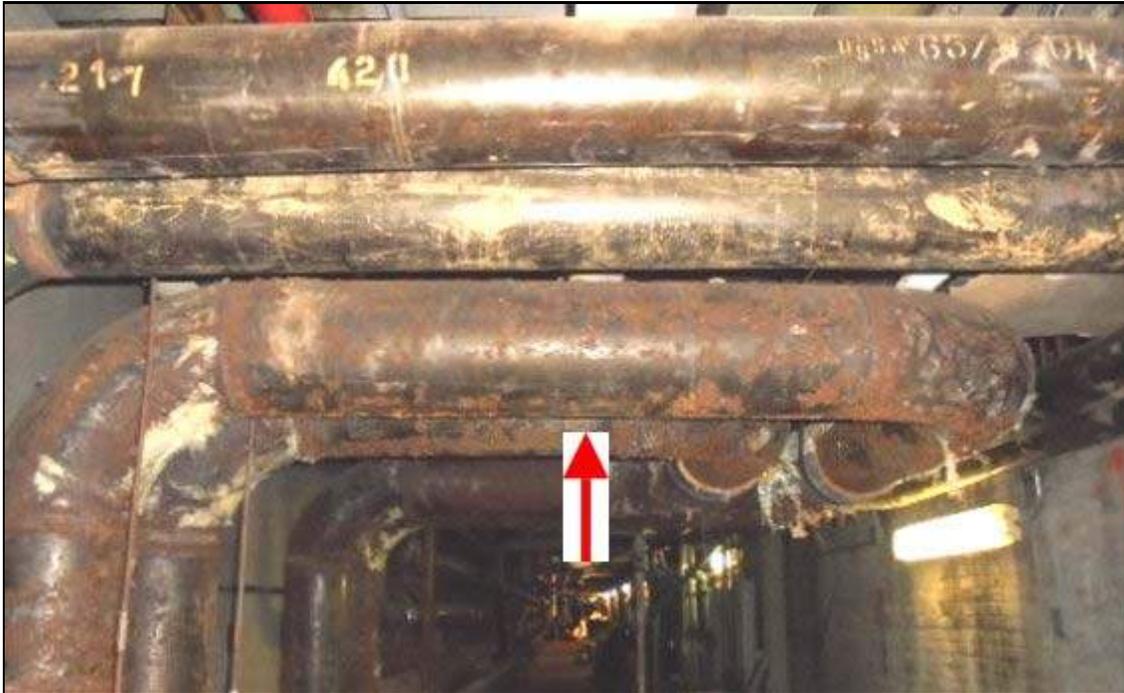
Photo File #: phl-1-18.jpg
 Detail: Pipe Location / Condition
 Orientation: Below Side View

Pipe Identification and Operating Conditions

Service: Chill Water
Nominal Pipe Size: 10 in.
Actual Pipe Size: 10.75 in.
Schedule/Type: Schedule 40
Material: Carbon Steel
Construction: Welded
Flow: Supply To Building
Pipe Pressure: 60 PSIG
Temperature: 55 Deg. F.
Pipe Orientation: Horizontal
Test Site I.D.: T-CHW-10-106
Site Drawing Number: n/a
Depth Allowance: 0.000 in.
Test Pattern: Bottom & Lower Sides

Location - Terminal B Tunnel: Chill water main supply line, at expansion loop after 3rd pipe support. Test points located midpoint between 2nd and 3rd elbow.
Placed In Service: June 1, 1985
Date of Test: December 30, 2016
Time In Service: 31.6 Years
Original Wall Thickness: 0.365 in.
Minimum Allowable Thickness: 0.125 in. (0.037)
Minimum Thickness Based Upon: Default Minimum Value
Standard Deviation: 0.012 in. / **High to Low Range:** 0.042 in.
Minimum Theoretical Wall Thickness: 0.321 in.
Pitting Index: 8.9 % - Moderate Pitting Activity
Notes: None

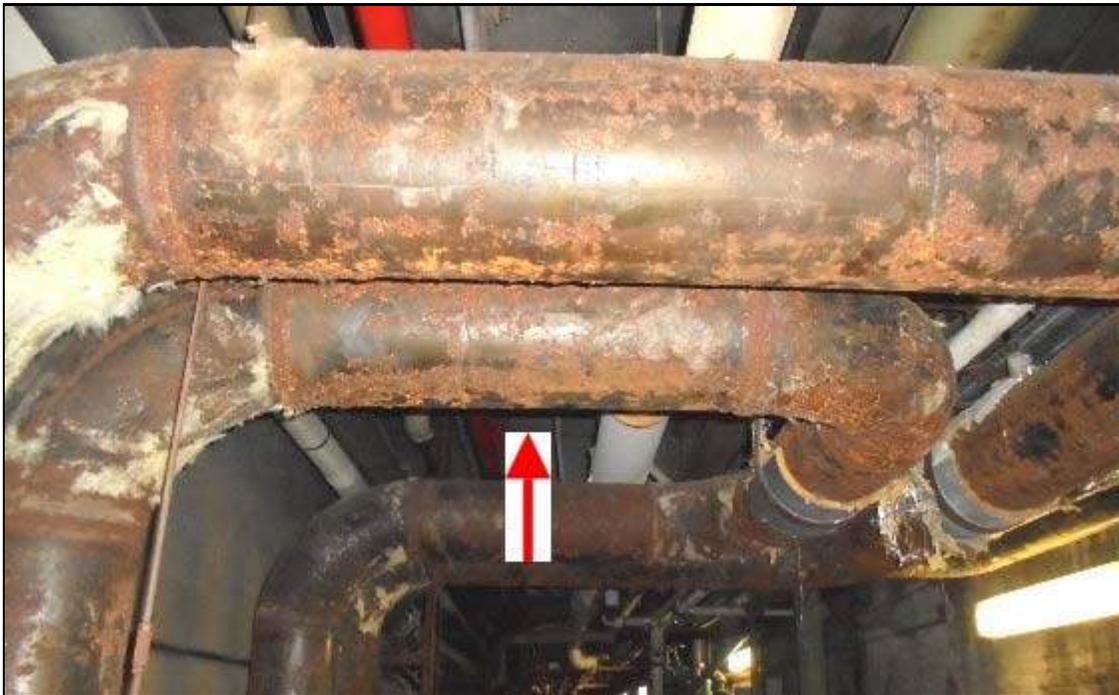
Pipe Identification and Operating Conditions

Service: Chill Water
Nominal Pipe Size: 10 in.
Actual Pipe Size: 10.75 in.
Schedule/Type: Schedule 40
Material: Carbon Steel
Construction: Welded
Flow: Return To HX
Pipe Pressure: 50 PSIG
Temperature: 65 Deg. F.
Pipe Orientation: Horizontal
Test Site I.D.: T-CHW-10-107
Site Drawing Number: n/a
Depth Allowance: 0.000 in.
Test Pattern: Bottom & Lower Sides

Placed In Service: June 1, 1985
Date of Test: December 30, 2016
Time In Service: 31.6 Years
Original Wall Thickness: 0.365 in.
Minimum Allowable Thickness: 0.125 in. (0.033)
Minimum Thickness Based Upon: Default Minimum Value
Standard Deviation: 0.012 in. / **High to Low Range:** 0.038 in.
Minimum Theoretical Wall Thickness: 0.321 in.
Pitting Index: 7.5 % - Moderate Pitting Activity
Notes: None

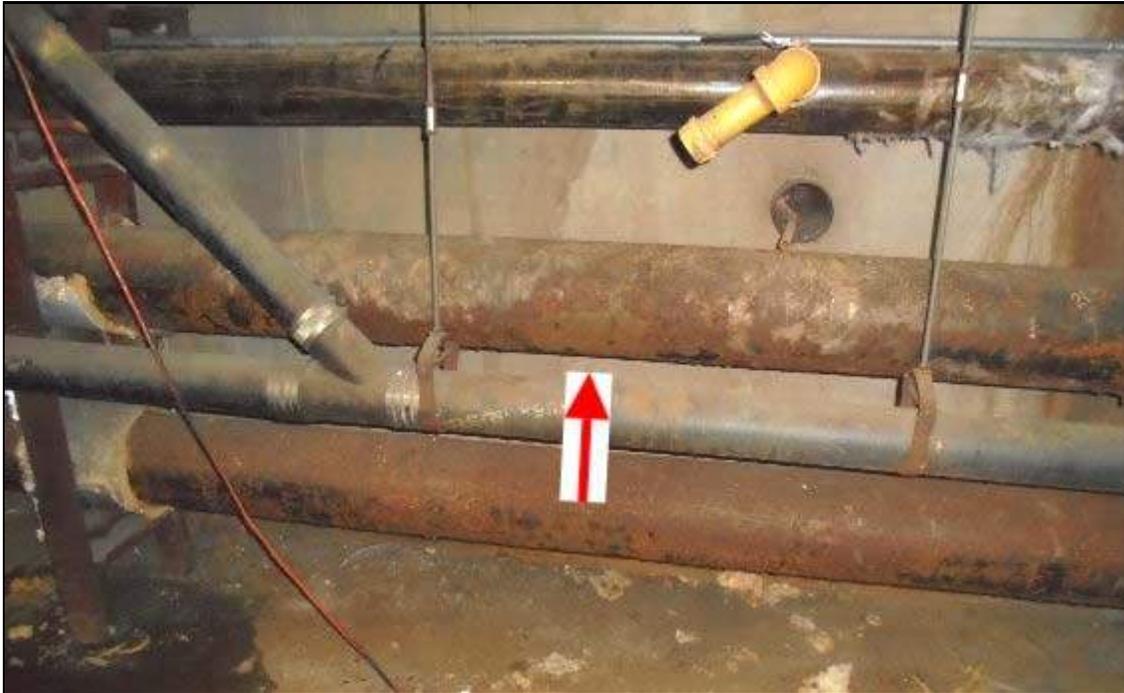
Photo File #: phl-1-24.jpg
 Detail: Pipe Location / Condition
 Orientation: Side View

Service: Chill Water
Nominal Pipe Size: 10 in.
Actual Pipe Size: 10.75 in.
Schedule/Type: Schedule 40
Material: Carbon Steel
Construction: Welded
Flow: Supply To Building
Pipe Pressure: 60 PSIG
Temperature: 55 Deg. F.
Pipe Orientation: Horizontal
Test Site I.D.: T-CHW-10-108
Site Drawing Number: n/a
Depth Allowance: 0.000 in.
Test Pattern: Bottom & Lower Sides

Placed In Service: June 1, 1985
Date of Test: December 30, 2016
Time In Service: 31.6 Years
Original Wall Thickness: 0.365 in.
Minimum Allowable Thickness: 0.125 in. (0.037)
Minimum Thickness Based Upon: Default Minimum Value
Standard Deviation: 0.014 in. / **High to Low Range:** 0.053 in.
Minimum Theoretical Wall Thickness: 0.315 in.
Pitting Index: 9.9 % - Moderate Pitting Activity
Notes: None

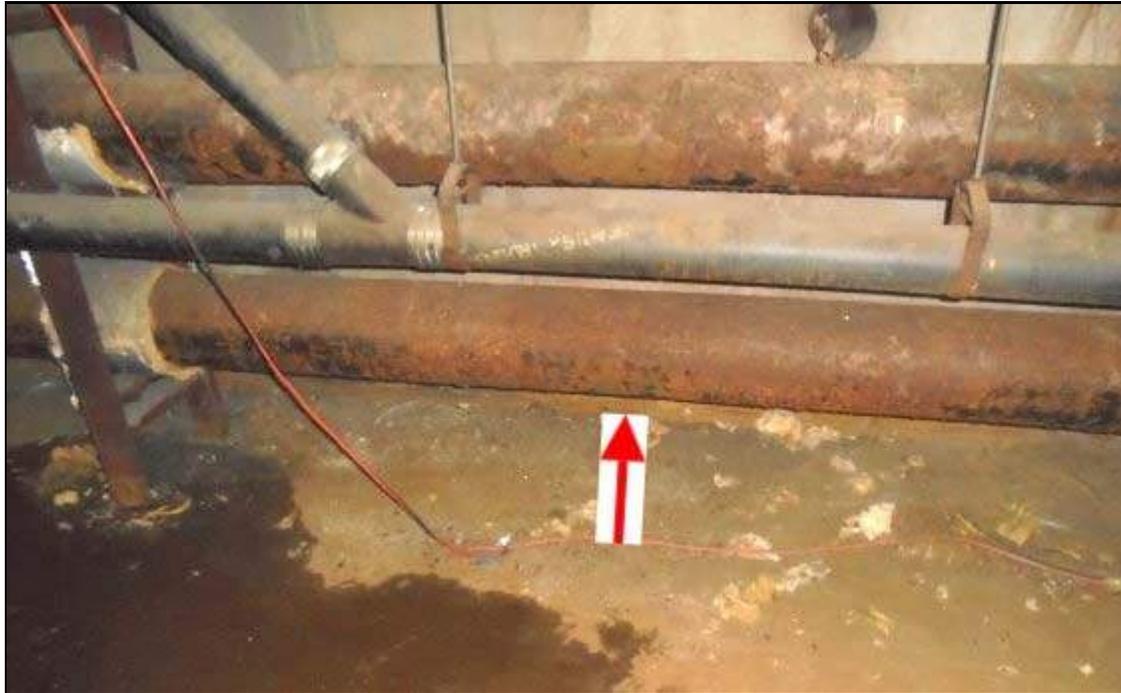
Service: Chill Water
 Nominal Pipe Size: 10 in.
 Actual Pipe Size: 10.75 in.
 Schedule/Type: Schedule 40
 Material: Carbon Steel
 Construction: Welded
 Flow: Return To HX
 Pipe Pressure: 50 PSIG
 Temperature: 65 Deg. F.
 Pipe Orientation: Horizontal
 Test Site I.D.: T-CHW-10-109
 Site Drawing Number: n/a
 Depth Allowance: 0.000 in.
 Test Pattern: Bottom & Lower Sides

Placed In Service: June 1, 1985
 Date of Test: December 30, 2016
 Time In Service: 31.6 Years
Original Wall Thickness: 0.365 in.
Minimum Allowable Thickness: 0.125 in. (0.033)
 Minimum Thickness Based Upon: Default Minimum Value
 Standard Deviation: 0.010 in. / High to Low Range: 0.037 in.
 Minimum Theoretical Wall Thickness: 0.328 in.
 Pitting Index: 8.4 % - Moderate Pitting Activity
 Notes: None

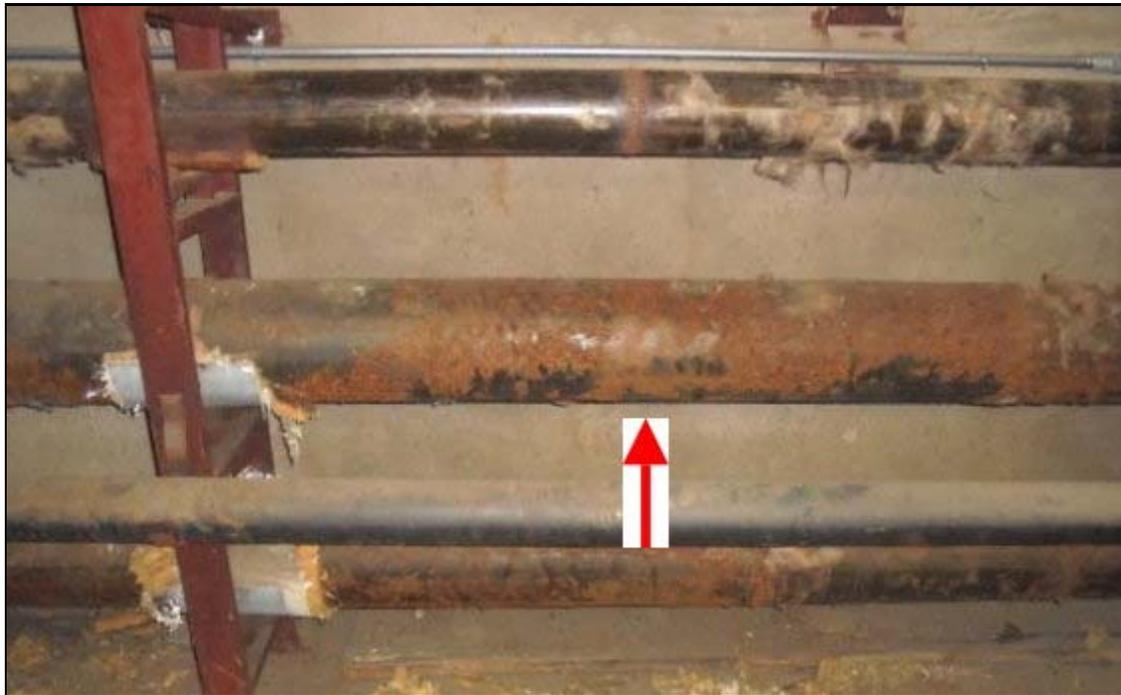
Photo File #: phl-1-31.jpg
Detail: Pipe Location / Condition
Orientation: Side View

Service: Chill Water
Nominal Pipe Size: 10 in.
Actual Pipe Size: 10.75 in.
Schedule/Type: Schedule 40
Material: Carbon Steel
Construction: Welded
Flow: Supply To Building
Pipe Pressure: 60 PSIG
Temperature: 55 Deg. F.
Pipe Orientation: Horizontal
Test Site I.D.: T-CHW-10-110
Site Drawing Number: n/a
Depth Allowance: 0.000 in.
Test Pattern: Bottom & Lower Sides

Placed In Service: June 1, 1985
Date of Test: December 30, 2016
Time In Service: 31.6 Years
Original Wall Thickness: 0.365 in.
Minimum Allowable Thickness: 0.125 in. (0.037)
Minimum Thickness Based Upon: Default Minimum Value
Standard Deviation: 0.014 in. / **High to Low Range:** 0.051 in.
Minimum Theoretical Wall Thickness: 0.308 in.
Pitting Index: 11.0% - Significant Pitting Activity
Notes: None

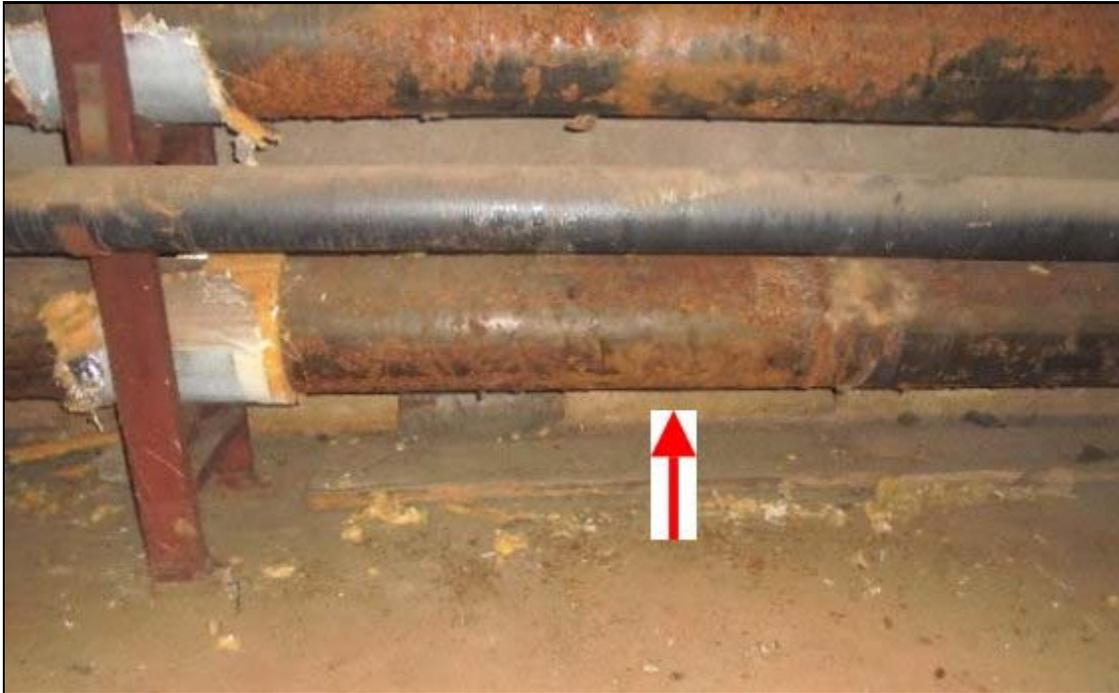
Photo File #: phl-1-32.jpg
 Detail: Pipe Location / Condition
 Orientation: Side View

Service: Chill Water
Nominal Pipe Size: 10 in.
Actual Pipe Size: 10.75 in.
Schedule/Type: Schedule 40
Material: Carbon Steel
Construction: Welded
Flow: Return To HX
Pipe Pressure: 50 PSIG
Temperature: 65 Deg. F.
Pipe Orientation: Horizontal
Test Site I.D.: T-CHW-10-111
Site Drawing Number: n/a
Depth Allowance: 0.000 in.
Test Pattern: Bottom & Lower Sides

Placed In Service: June 1, 1985
Date of Test: December 30, 2016
Time In Service: 31.6 Years
Original Wall Thickness: 0.365 in.
Minimum Allowable Thickness: 0.125 in. (0.033)
Minimum Thickness Based Upon: Default Minimum Value
Standard Deviation: 0.010 in. / **High to Low Range:** 0.037 in.
Minimum Theoretical Wall Thickness: 0.325 in.
Pitting Index: 7.7 % - Moderate Pitting Activity
Notes: None

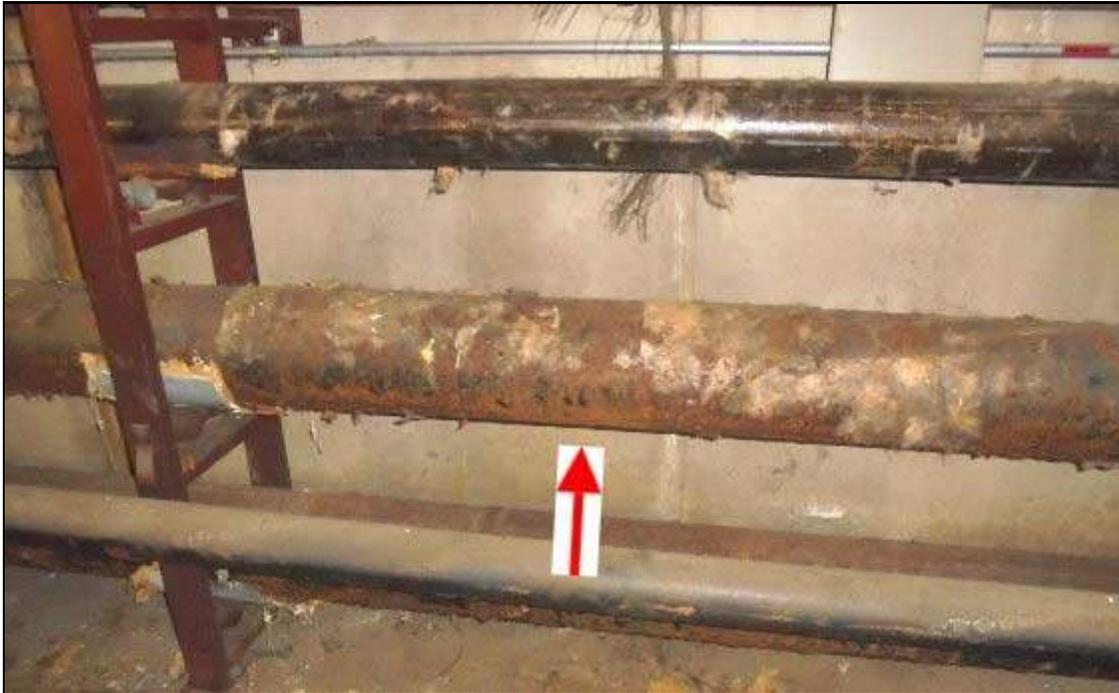
Service: Chill Water
Nominal Pipe Size: 10 in.
Actual Pipe Size: 10.75 in.
Schedule/Type: Schedule 40
Material: Carbon Steel
Construction: Welded
Flow: Supply To Building
Pipe Pressure: 60 PSIG
Temperature: 55 Deg. F.
Pipe Orientation: Horizontal
Test Site I.D.: T-CHW-10-112
Site Drawing Number: n/a
Depth Allowance: 0.000 in.
Test Pattern: Bottom & Lower Sides

Placed In Service: June 1, 1985
Date of Test: December 30, 2016
Time In Service: 31.6 Years
Original Wall Thickness: 0.365 in.
Minimum Allowable Thickness: 0.125 in. (0.037)
Minimum Thickness Based Upon: Default Minimum Value
Standard Deviation: 0.015 in. / **High to Low Range:** 0.051 in.
Minimum Theoretical Wall Thickness: 0.308 in.
Pitting Index: 10.6% - Significant Pitting Activity
Notes: None

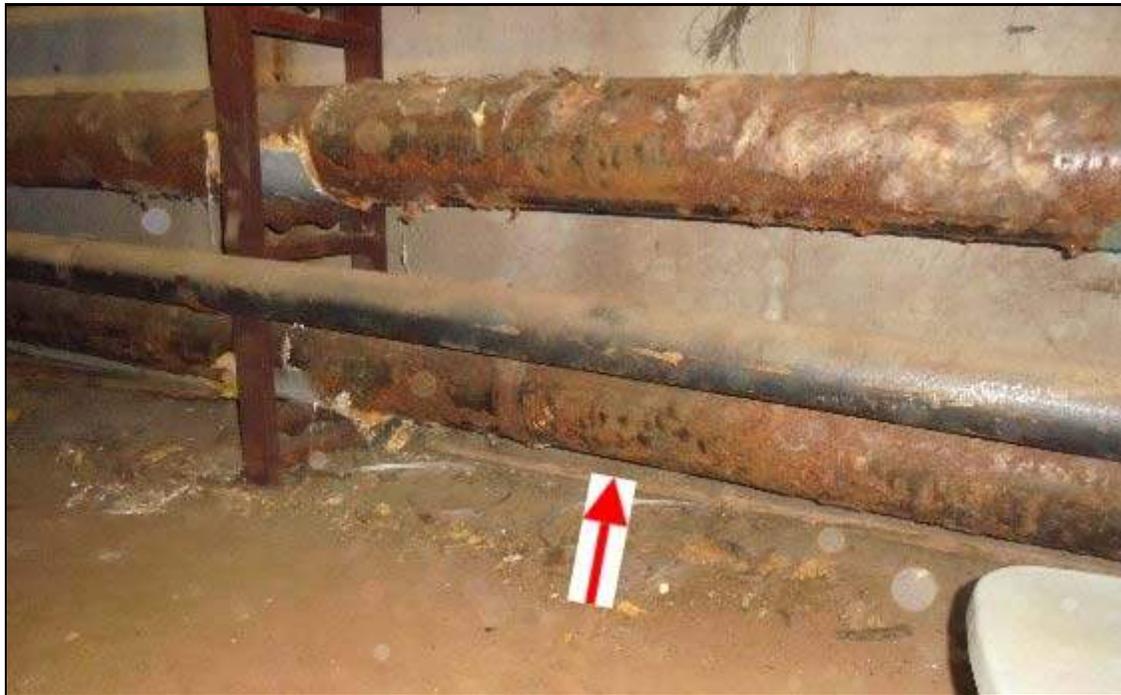
Service: Chill Water
 Nominal Pipe Size: 10 in.
 Actual Pipe Size: 10.75 in.
 Schedule/Type: Schedule 40
 Material: Carbon Steel
 Construction: Welded
 Flow: Return To HX
 Pipe Pressure: 50 PSIG
 Temperature: 65 Deg. F.
 Pipe Orientation: Horizontal
 Test Site I.D.: T-CHW-10-113
 Site Drawing Number: n/a
 Depth Allowance: 0.000 in.
 Test Pattern: Bottom & Lower Sides

Placed In Service: June 1, 1985
 Date of Test: December 30, 2016
 Time In Service: 31.6 Years
Original Wall Thickness: 0.365 in.
Minimum Allowable Thickness: 0.125 in. (0.033)
 Minimum Thickness Based Upon: Default Minimum Value
 Standard Deviation: 0.009 in. / High to Low Range: 0.035 in.
 Minimum Theoretical Wall Thickness: 0.329 in.
 Pitting Index: 7.5 % - Moderate Pitting Activity
 Notes: None

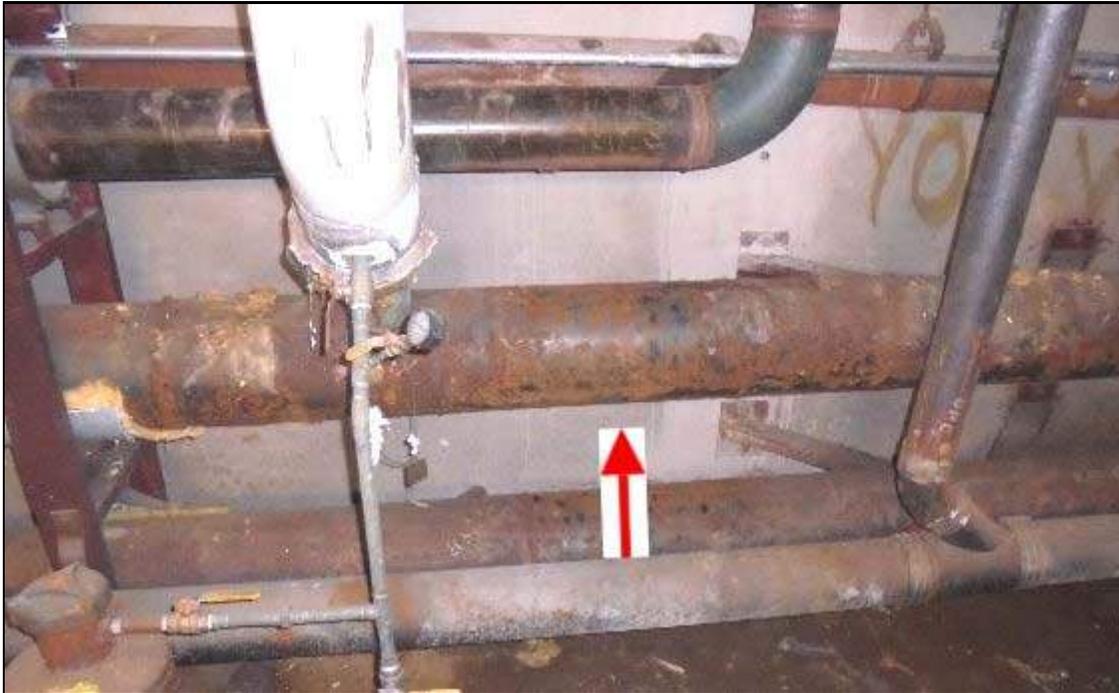
Service: Chill Water
Nominal Pipe Size: 10 in.
Actual Pipe Size: 10.75 in.
Schedule/Type: Schedule 40
Material: Carbon Steel
Construction: Welded
Flow: Supply To Building
Pipe Pressure: 60 PSIG
Temperature: 55 Deg. F.
Pipe Orientation: Horizontal
Test Site I.D.: T-CHW-10-114
Site Drawing Number: n/a
Depth Allowance: 0.000 in.
Test Pattern: Bottom & Lower Sides

Placed In Service: June 1, 1985
Date of Test: December 30, 2016
Time In Service: 31.6 Years
Original Wall Thickness: 0.365 in.
Minimum Allowable Thickness: 0.125 in. (0.037)
Minimum Thickness Based Upon: Default Minimum Value
Standard Deviation: 0.013 in. / **High to Low Range:** 0.042 in.
Minimum Theoretical Wall Thickness: 0.311 in.
Pitting Index: 9.0 % - Moderate Pitting Activity
Notes: None

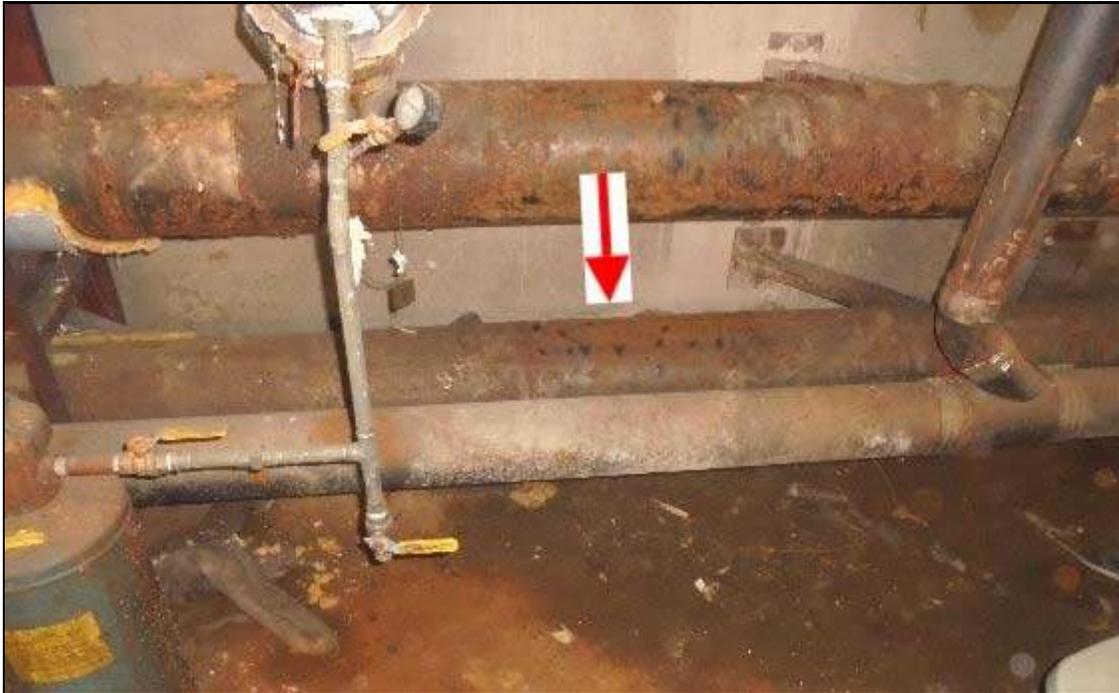
Service: Chill Water
Nominal Pipe Size: 10 in.
Actual Pipe Size: 10.75 in.
Schedule/Type: Schedule 40
Material: Carbon Steel
Construction: Welded
Flow: Return To HX
Pipe Pressure: 50 PSIG
Temperature: 65 Deg. F.
Pipe Orientation: Horizontal
Test Site I.D.: T-CHW-10-115
Site Drawing Number: n/a
Depth Allowance: 0.000 in.
Test Pattern: Random Points

Placed In Service: June 1, 1985
Date of Test: December 30, 2016
Time In Service: 31.6 Years
Original Wall Thickness: 0.365 in.
Minimum Allowable Thickness: 0.125 in. (0.033)
Minimum Thickness Based Upon: Default Minimum Value
Standard Deviation: 0.015 in. / **High to Low Range:** 0.049 in.
Minimum Theoretical Wall Thickness: 0.305 in.
Pitting Index: 11.2% - Significant Pitting Activity
Notes: None

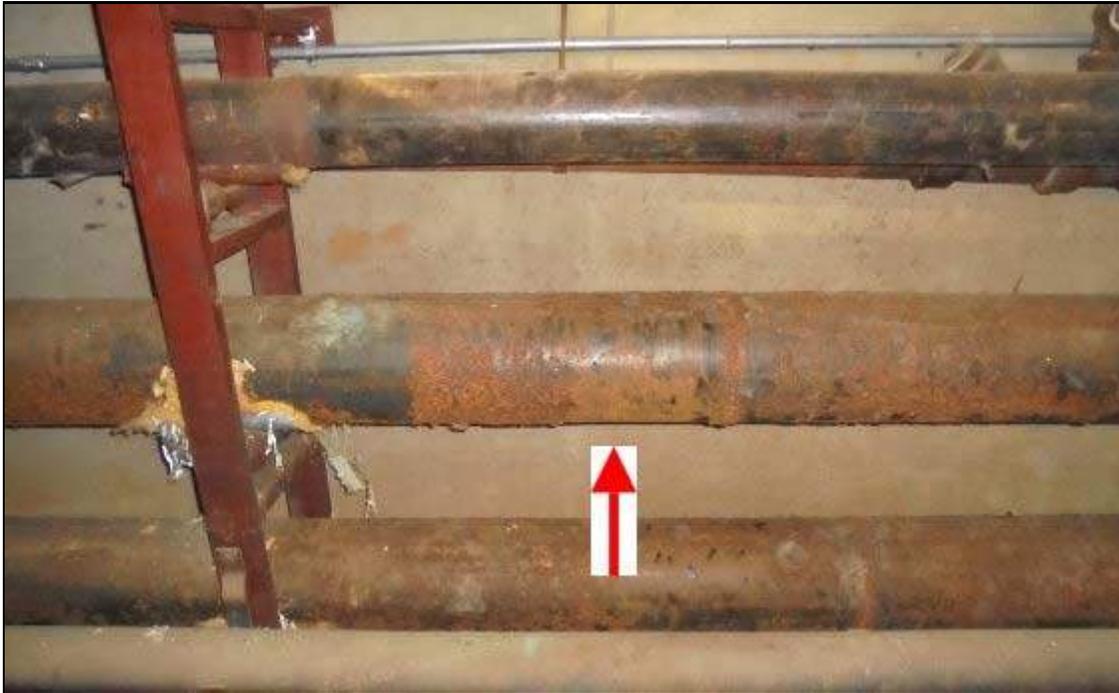
Service: Chill Water
Nominal Pipe Size: 10 in.
Actual Pipe Size: 10.75 in.
Schedule/Type: Schedule 40
Material: Carbon Steel
Construction: Welded
Flow: Supply To Building
Pipe Pressure: 60 PSIG
Temperature: 55 Deg. F.
Pipe Orientation: Horizontal
Test Site I.D.: T-CHW-10-116
Site Drawing Number: n/a
Depth Allowance: 0.000 in.
Test Pattern: Bottom & Lower Sides

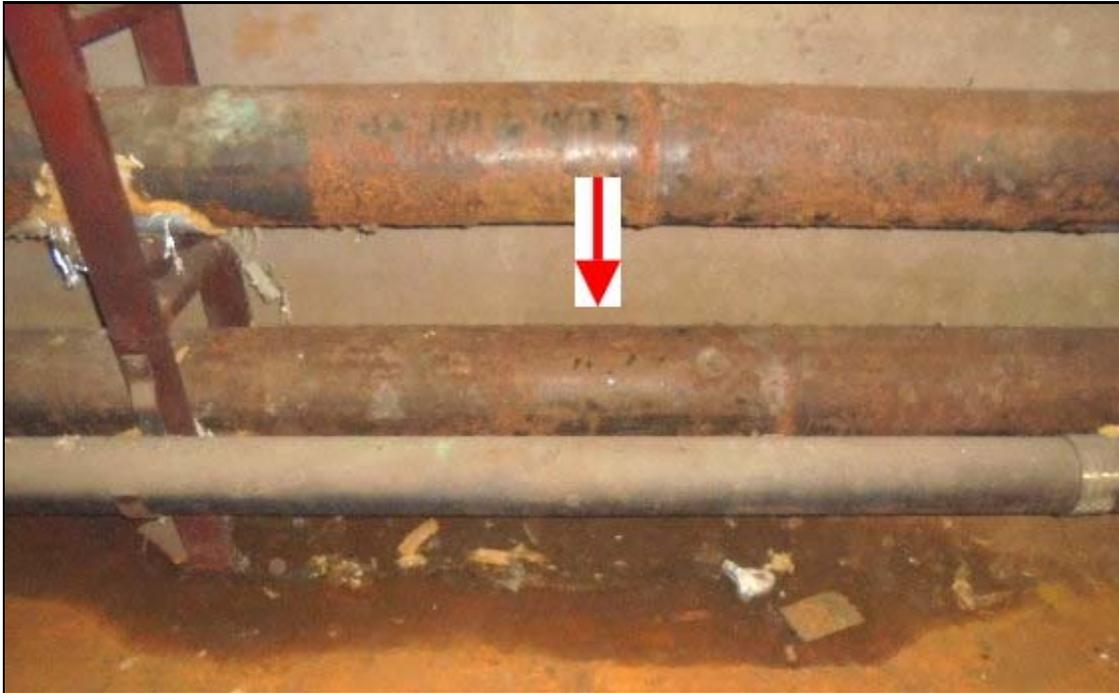
Service: Chill Water
 Nominal Pipe Size: 10 in.
 Actual Pipe Size: 10.75 in.
 Schedule/Type: Schedule 40
 Material: Carbon Steel
 Construction: Welded
 Flow: Return To HX
 Pipe Pressure: 50 PSIG
 Temperature: 65 Deg. F.
 Pipe Orientation: Horizontal
 Test Site I.D.: T-CHW-10-117
 Site Drawing Number: n/a
 Depth Allowance: 0.000 in.
 Test Pattern: Random Points

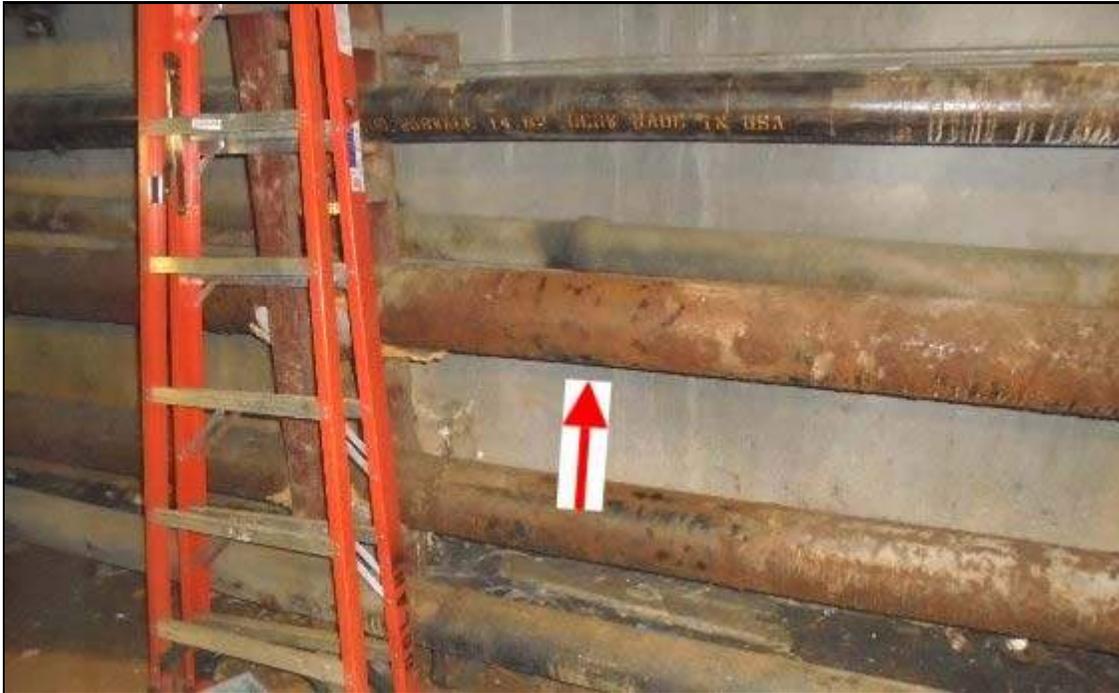
Location No: 17

Photo File #: phl-1-78.jpg
 Detail: Pipe Location / Condition
 Orientation: Side View

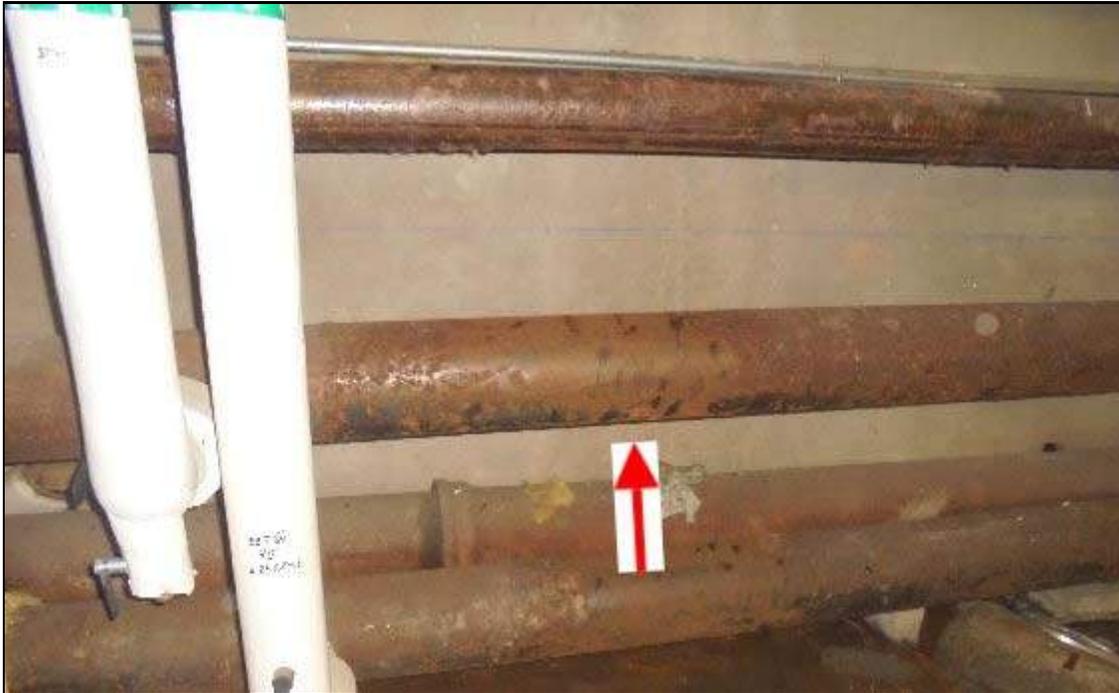
Location No: 21

Photo File #: phl-1-123.jpg
 Detail: Pipe Location / Condition
 Orientation: Side View

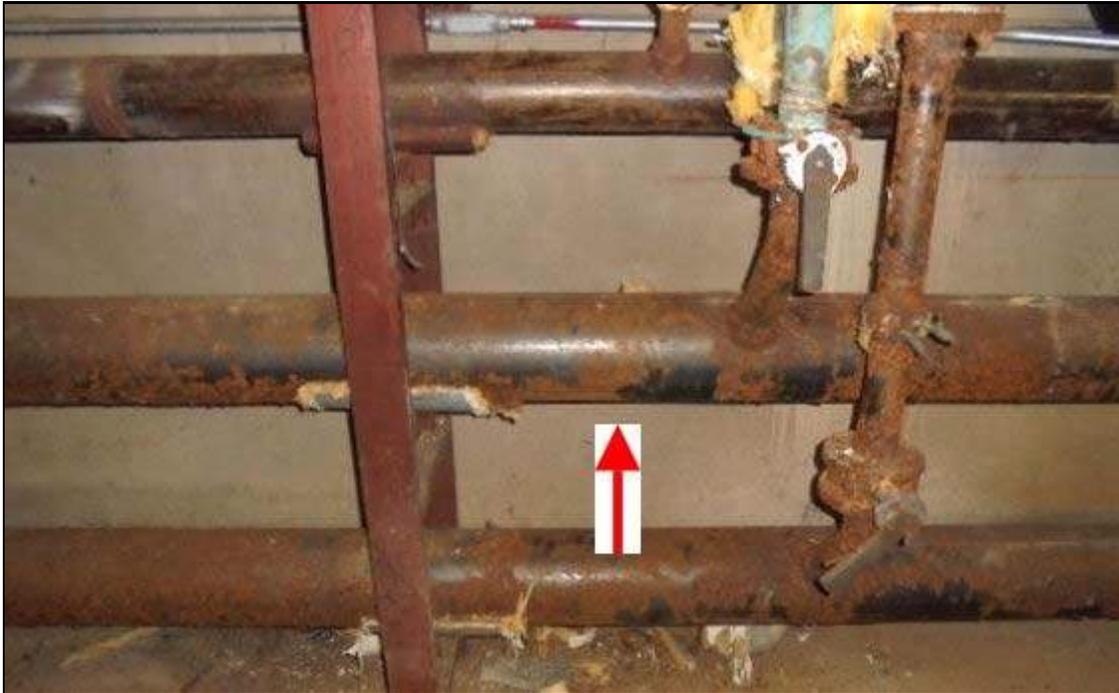
Location No: 23

Photo File #: phl-1-131.jpg
 Detail: Pipe Location / Condition
 Orientation: Side View
