Solicitation Description: Campus Chill Water Loop / Plant Evaluation and Enhancements

Expression of Interest
West Virginia –General Services Division
Campus Chilled Water Loop / Plant Evaluation
CEOI GSD2300000007

Chilled Water Loop/ Plant Evaluation and Enhancements Project Goals

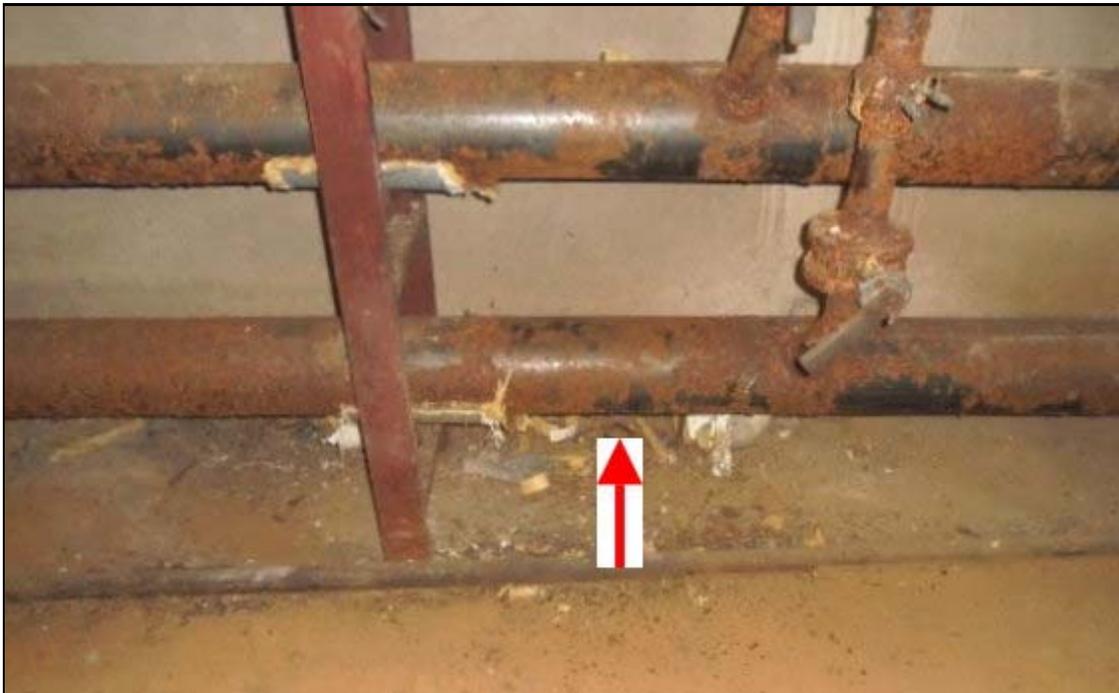
Location No: 24

Photo File #: phl-1-132.jpg
 Detail: Pipe Location / Condition
 Orientation: Above Side View

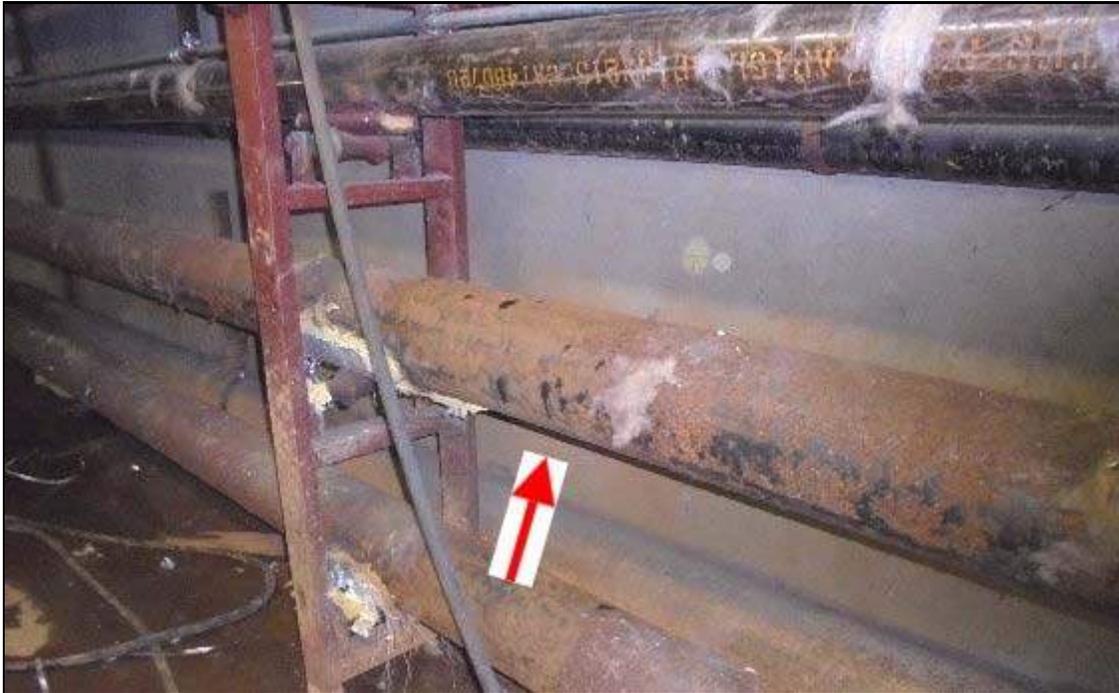
Service: Chill Water
Nominal Pipe Size: 8 in.
Actual Pipe Size: 8.63 in.
Schedule/Type: Schedule 40
Material: Carbon Steel
Construction: Welded
Flow: Supply To Building
Pipe Pressure: 60 PSIG
Temperature: 65 Deg. F.
Pipe Orientation: Horizontal
Test Site I.D.: T-CHW-8-130
Site Drawing Number: n/a
Depth Allowance: 0.000 in.
Test Pattern: Random Points

Placed In Service: June 1, 1985
Date of Test: December 30, 2016
Time In Service: 31.6 Years
Original Wall Thickness: 0.322 in.
Minimum Allowable Thickness: 0.125 in. (0.032)
Minimum Thickness Based Upon: Default Minimum Value
Standard Deviation: 0.010 in. / **High to Low Range:** 0.035 in.
Minimum Theoretical Wall Thickness: 0.278 in.
Pitting Index: 7.8 % - Moderate Pitting Activity
Notes: None

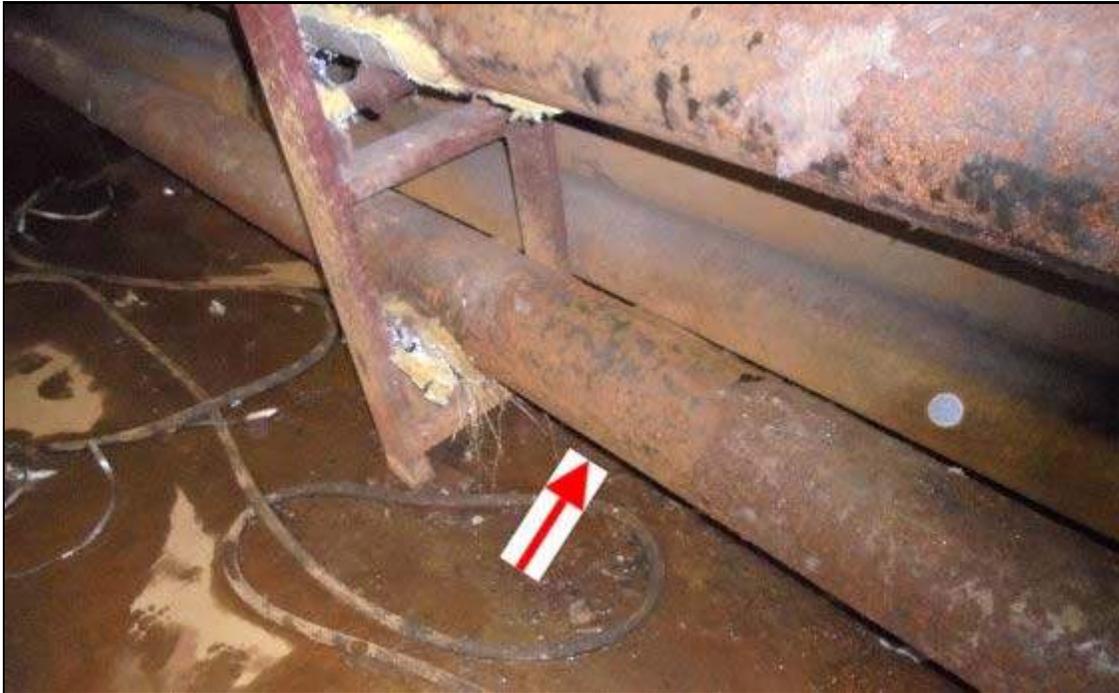
Service: Chill Water
 Nominal Pipe Size: 8 in.
 Actual Pipe Size: 8.63 in.
 Schedule/Type: Schedule 40
 Material: Carbon Steel
 Construction: Welded
 Flow: Return To HX
 Pipe Pressure: 50 PSIG
 Temperature: 55 Deg. F.
 Pipe Orientation: Horizontal
 Test Site I.D.: T-CHW-8-131
 Site Drawing Number: n/a
 Depth Allowance: 0.000 in.
 Test Pattern: Random Points

Placed In Service: June 1, 1985
 Date of Test: December 30, 2016
 Time In Service: 31.6 Years
Original Wall Thickness: 0.322 in.
Minimum Allowable Thickness: 0.125 in. (0.029)
 Minimum Thickness Based Upon: Default Minimum Value
 Standard Deviation: 0.004 in. / High to Low Range: 0.014 in.
 Minimum Theoretical Wall Thickness: 0.297 in.
 Pitting Index: 1.8 % - Insignificant Pitting Activity
 Notes: None

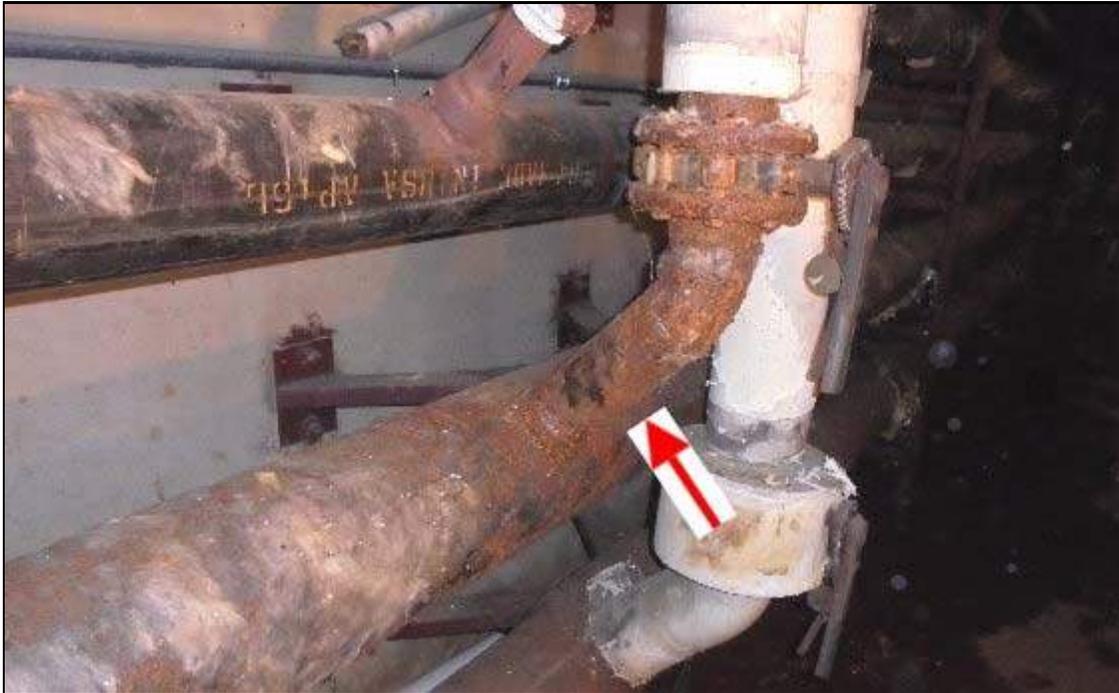
Service: Chill Water
 Nominal Pipe Size: 4 in.
 Actual Pipe Size: 4.50 in.
 Schedule/Type: Schedule 40
 Material: Carbon Steel
 Construction: Welded
 Flow: Supply To Building
 Pipe Pressure: 60 PSIG
 Temperature: 55 Deg. F.
 Pipe Orientation: Diagonal
 Test Site I.D.: T-CHW-4-105
 Site Drawing Number: n/a
 Depth Allowance: 0.000 in.
 Test Pattern: Random Points

Placed In Service: June 1, 1985
 Date of Test: December 30, 2016
 Time In Service: 31.6 Years
Original Wall Thickness: 0.237 in.
Minimum Allowable Thickness: 0.100 in. (0.024)
 Minimum Thickness Based Upon: Default Minimum Value
 Standard Deviation: 0.011 in. / High to Low Range: 0.038 in.
 Minimum Theoretical Wall Thickness: 0.178 in.
 Pitting Index: 12.2% - Significant Pitting Activity
 Notes: None

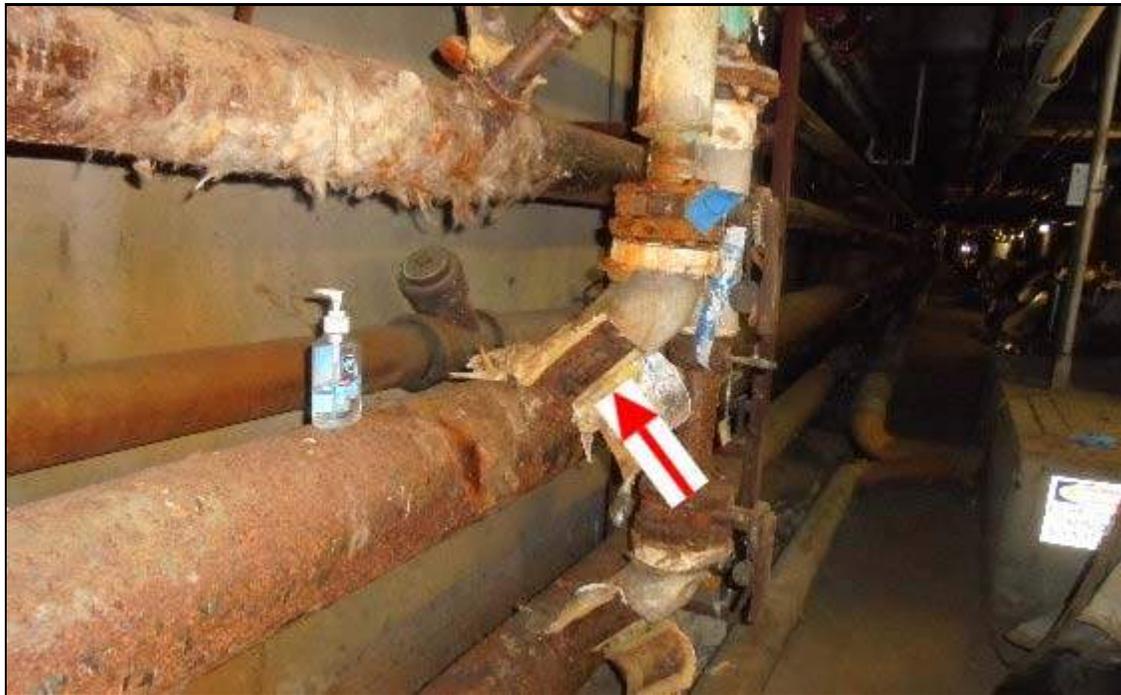
Service: Chill Water
Nominal Pipe Size: 3 in.
Actual Pipe Size: 3.50 in.
Schedule/Type: Schedule 40
Material: Carbon Steel
Construction: Welded
Flow: Supply To Building
Pipe Pressure: 60 PSIG
Temperature: 55 Deg. F.
Pipe Orientation: Diagonal
Test Site I.D.: T-CHW-3-120
Site Drawing Number: n/a
Depth Allowance: 0.000 in.
Test Pattern: Random Points

Location - Terminal B Tunnel: 5th chill water take-off from main supply line. Test points located between weldolet at main and elbow.
Placed In Service: June 1, 1985
Date of Test: December 30, 2016
Time In Service: 31.6 Years
Original Wall Thickness: 0.216 in.
Minimum Allowable Thickness: 0.100 in. (0.022)
Minimum Thickness Based Upon: Default Minimum Value
Standard Deviation: 0.008 in. / **High to Low Range:** 0.028 in.
Minimum Theoretical Wall Thickness: 0.172 in.
Pitting Index: 8.6 % - Moderate Pitting Activity
Notes: None

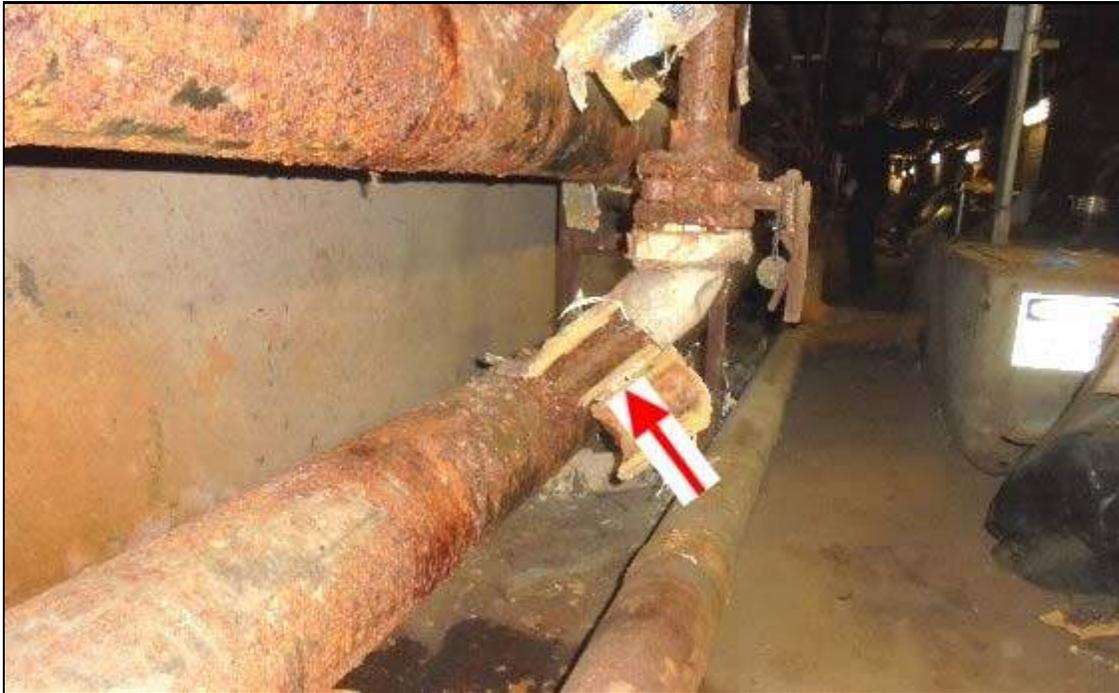
Service: Chill Water
 Nominal Pipe Size: 3 in.
 Actual Pipe Size: 3.50 in.
 Schedule/Type: Schedule 40
 Material: Carbon Steel
 Construction: Welded
 Flow: Return To HX
 Pipe Pressure: 50 PSIG
 Temperature: 65 Deg. F.
 Pipe Orientation: Diagonal
 Test Site I.D.: T-CHW-3-121
 Site Drawing Number: n/a
 Depth Allowance: 0.000 in.
 Test Pattern: Random Points

Placed In Service: June 1, 1985
 Date of Test: December 30, 2016
 Time In Service: 31.6 Years
Original Wall Thickness: 0.216 in.
Minimum Allowable Thickness: 0.100 in. (0.021)
 Minimum Thickness Based Upon: Default Minimum Value
 Standard Deviation: 0.021 in. / High to Low Range: 0.071 in.
 Minimum Theoretical Wall Thickness: 0.123 in.
 Pitting Index: 28.1% - High Pitting Activity
 Notes: None

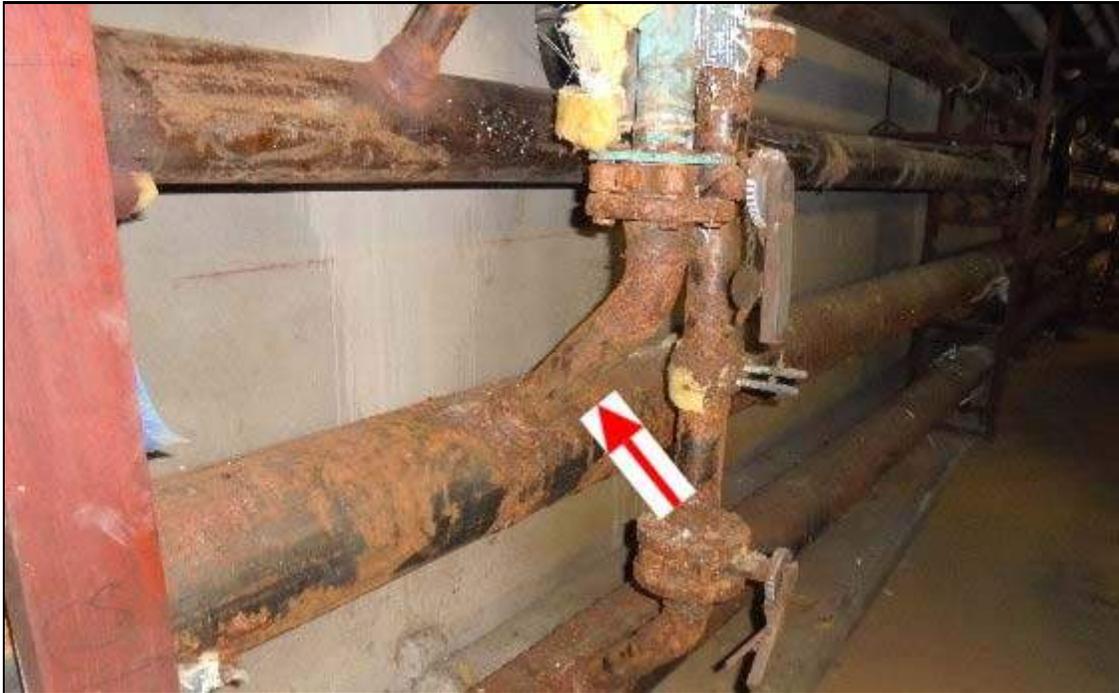
Service: Chill Water
Nominal Pipe Size: 3 in.
Actual Pipe Size: 3.50 in.
Schedule/Type: Schedule 40
Material: Carbon Steel
Construction: Welded
Flow: Supply To Building
Pipe Pressure: 60 PSIG
Temperature: 65 Deg. F.
Pipe Orientation: Diagonal
Test Site I.D.: T-CHW-3-128
Site Drawing Number: n/a
Depth Allowance: 0.000 in.
Test Pattern: Random Points

Placed In Service: June 1, 1985
Date of Test: December 30, 2016
Time In Service: 31.6 Years
Original Wall Thickness: 0.216 in.
Minimum Allowable Thickness: 0.100 in. (0.022)
Minimum Thickness Based Upon: Default Minimum Value
Standard Deviation: 0.014 in. / **High to Low Range:** 0.056 in.
Minimum Theoretical Wall Thickness: 0.139 in.
Pitting Index: 19.3% - Significant Pitting Activity
Notes: None

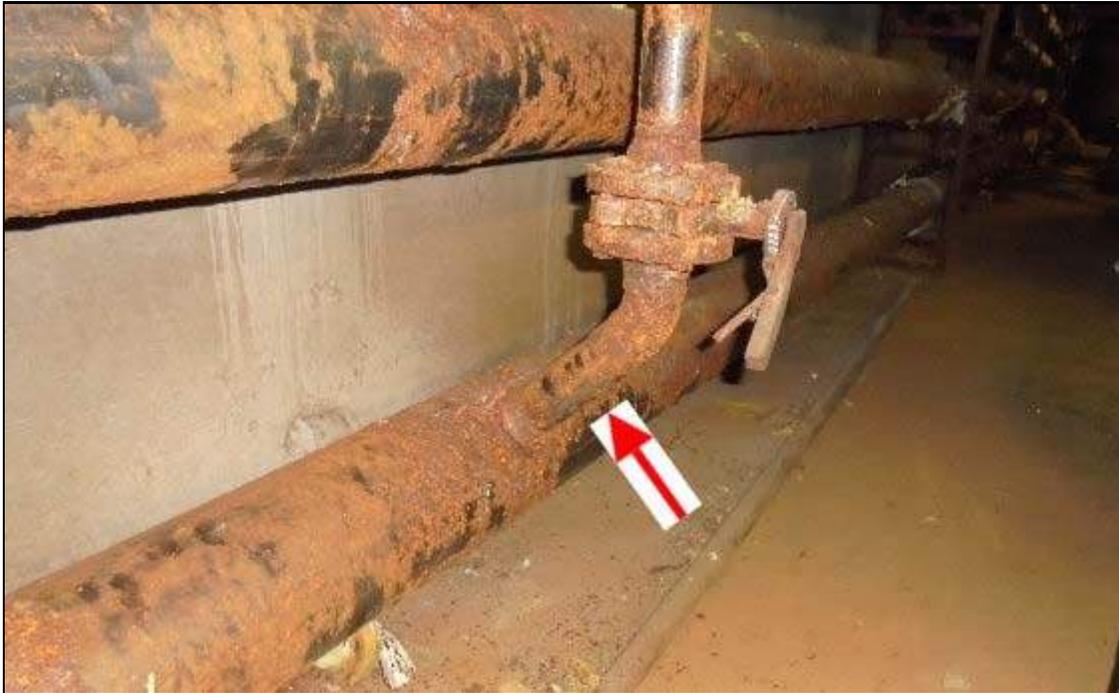
Photo File #: phl-1-139.jpg
 Detail: Pipe Location / Condition
 Orientation: Side View

Service: Chill Water
 Nominal Pipe Size: 3 in.
 Actual Pipe Size: 3.50 in.
 Schedule/Type: Schedule 40
 Material: Carbon Steel
 Construction: Welded
 Flow: Return To HX
 Pipe Pressure: 50 PSIG
 Temperature: 55 Deg. F.
 Pipe Orientation: Diagonal
 Test Site I.D.: T-CHW-3-129
 Site Drawing Number: n/a
 Depth Allowance: 0.000 in.
 Test Pattern: Random Points

Placed In Service: June 1, 1985
 Date of Test: December 30, 2016
 Time In Service: 31.6 Years
Original Wall Thickness: 0.216 in.
Minimum Allowable Thickness: 0.100 in. (0.021)
 Minimum Thickness Based Upon: Default Minimum Value
 Standard Deviation: 0.010 in. / High to Low Range: 0.035 in.
 Minimum Theoretical Wall Thickness: 0.148 in.
 Pitting Index: 14.1% - Significant Pitting Activity
 Notes: None

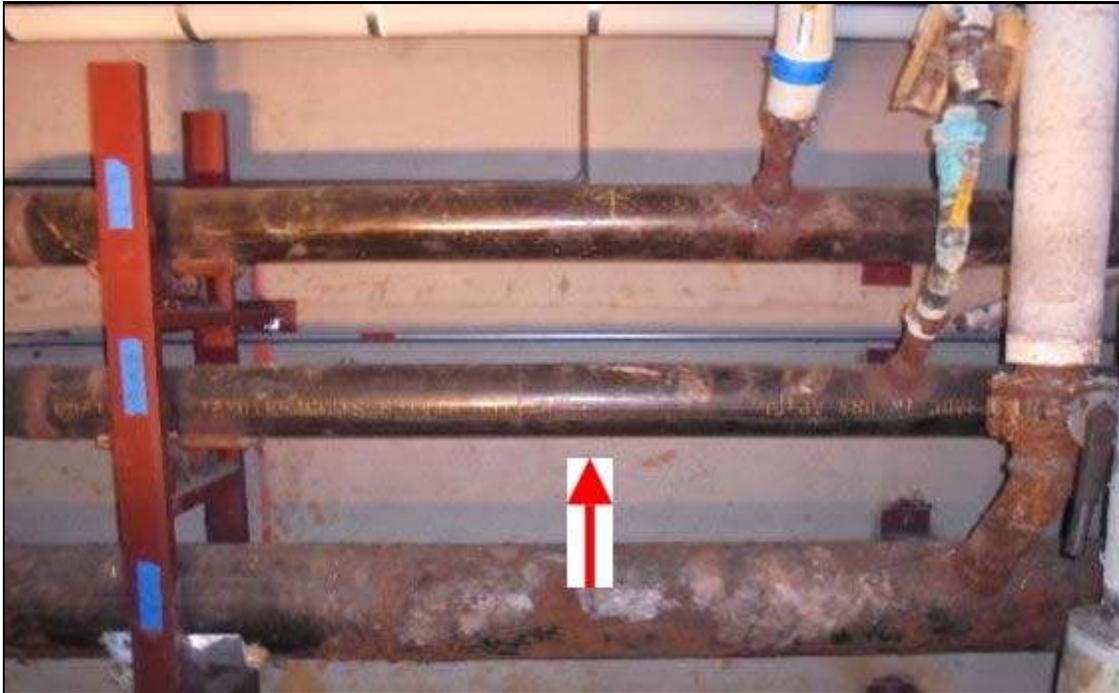
Service: Hot Water Heating
Nominal Pipe Size: 6 in.
Actual Pipe Size: 6.63 in.
Schedule/Type: Schedule 40
Material: Carbon Steel
Construction: Welded
Flow: Return To Boiler
Pipe Pressure: 50 PSIG
Temperature: 130 Deg. F.
Pipe Orientation: Horizontal
Test Site I.D.: T-HWH-6-02
Site Drawing Number: n/a
Depth Allowance: 0.000 in.
Test Pattern: Bottom & Lower Sides

Placed In Service: June 1, 1985
Date of Test: December 30, 2016
Time In Service: 31.6 Years
Original Wall Thickness: 0.280 in.
Minimum Allowable Thickness: 0.125 in. (0.036)
Minimum Thickness Based Upon: Default Minimum Value
Standard Deviation: 0.013 in. / **High to Low Range:** 0.041 in.
Minimum Theoretical Wall Thickness: 0.222 in.
Pitting Index: 8.7 % - Moderate Pitting Activity
Notes: None

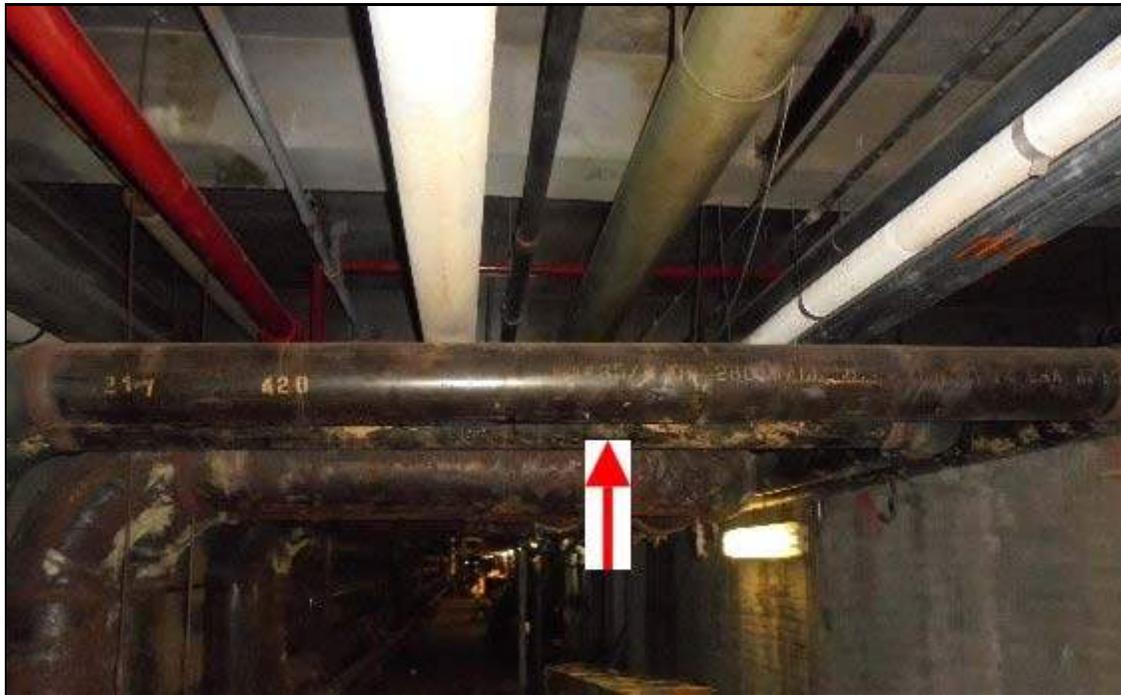
Service: Hot Water Heating
Nominal Pipe Size: 6 in.
Actual Pipe Size: 6.63 in.
Schedule/Type: Schedule 40
Material: Carbon Steel
Construction: Welded
Flow: Supply To Building
Pipe Pressure: 60 PSIG
Temperature: 160 Deg. F.
Pipe Orientation: Horizontal
Test Site I.D.: T-HWH-6-04
Site Drawing Number: n/a
Depth Allowance: 0.000 in.
Test Pattern: Bottom & Lower Sides

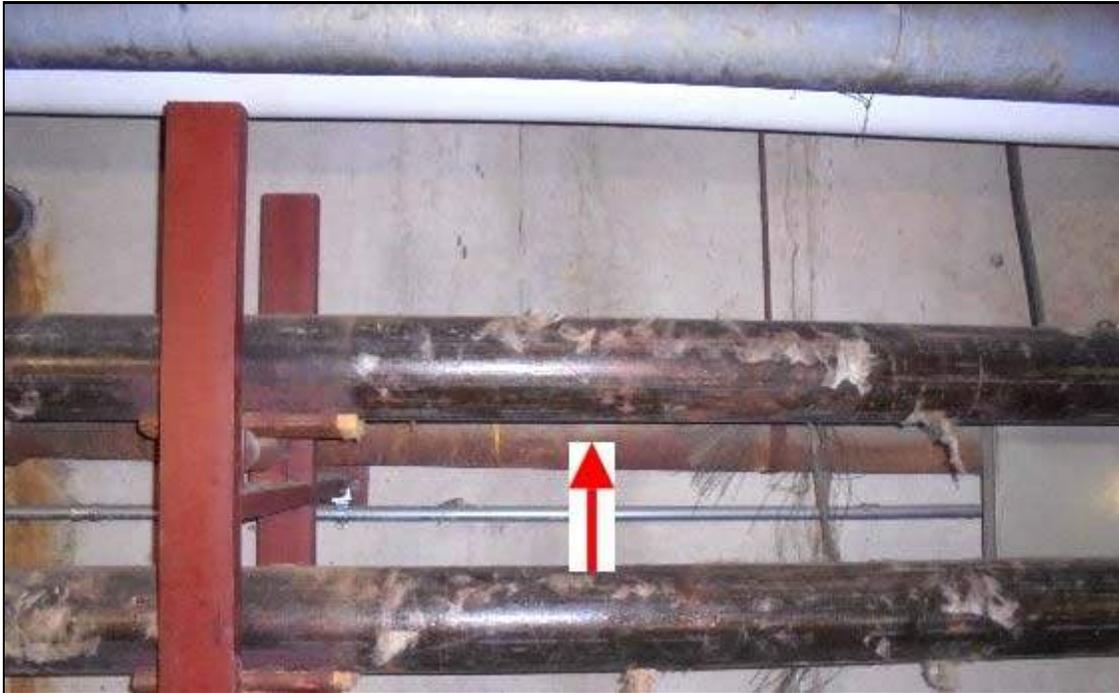
Location No: 40

Photo File #: phl-1-64.jpg
 Detail: Pipe Location / Condition
 Orientation: Side View

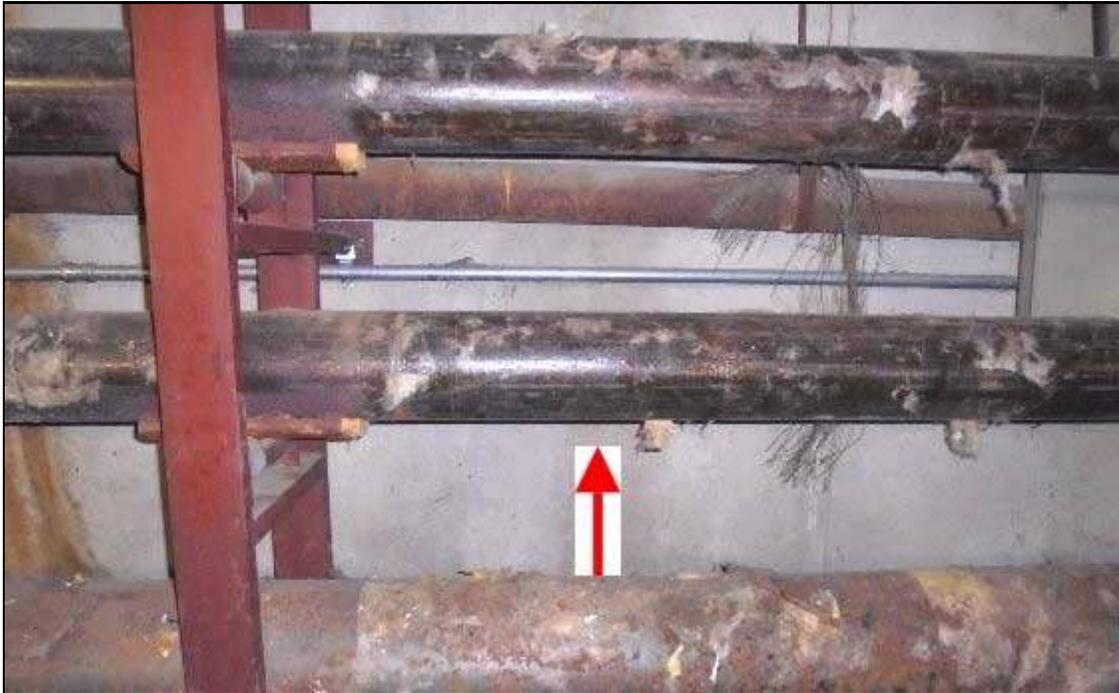
Location No: 41

Photo File #: phl-1-65.jpg
 Detail: Pipe Location / Condition
 Orientation: Side View

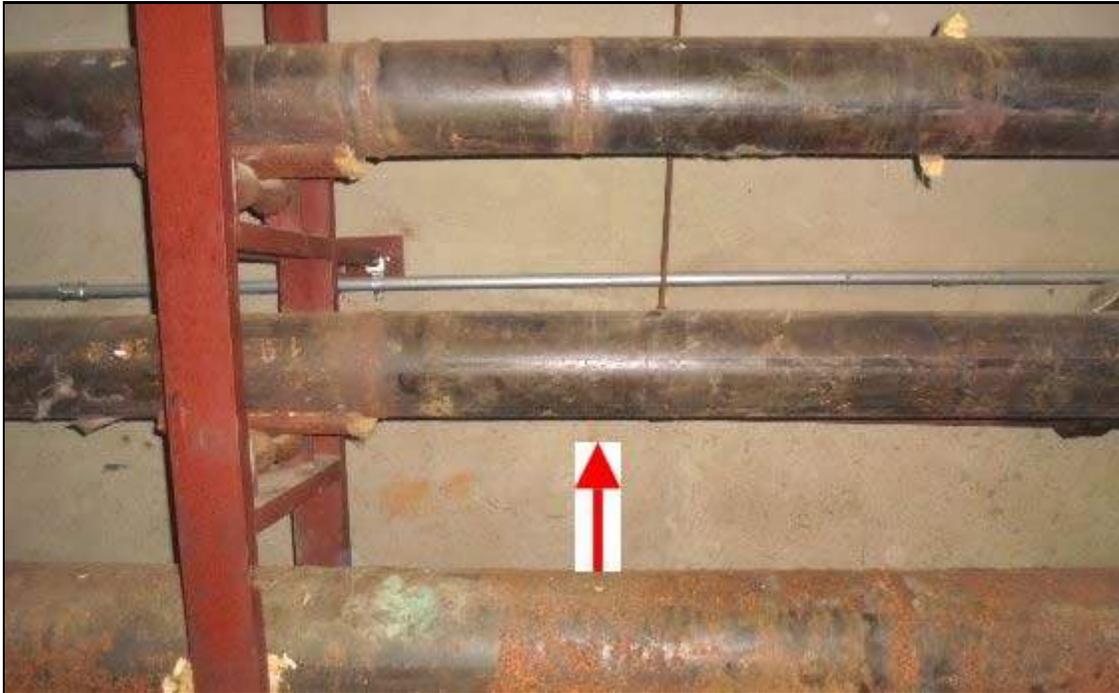
Location No: 45

Photo File #: phl-1-75.jpg
Detail: Pipe Location / Condition
Orientation: Side View

Pipe Identification and Operating Conditions

Service: Hot Water Heating
Nominal Pipe Size: 6 in.
Actual Pipe Size: 6.63 in.
Schedule/Type: Schedule 40
Material: Carbon Steel
Construction: Welded
Flow: Return To Boiler
Pipe Pressure: 50 PSIG
Temperature: 130 Deg. F.
Pipe Orientation: Horizontal
Test Site I.D.: T-HWH-6-16
Site Drawing Number: n/a
Depth Allowance: 0.000 in.
Test Pattern: Bottom & Lower Sides

Placed In Service: June 1, 1985
Date of Test: December 30, 2016
Time In Service: 31.6 Years
Original Wall Thickness: 0.280 in.
Minimum Allowable Thickness: 0.125 in. (0.036)
Minimum Thickness Based Upon: Default Minimum Value
Standard Deviation: 0.012 in. / **High to Low Range:** 0.040 in.
Minimum Theoretical Wall Thickness: 0.231 in.
Pitting Index: 9.4 % - Moderate Pitting Activity
Notes: None

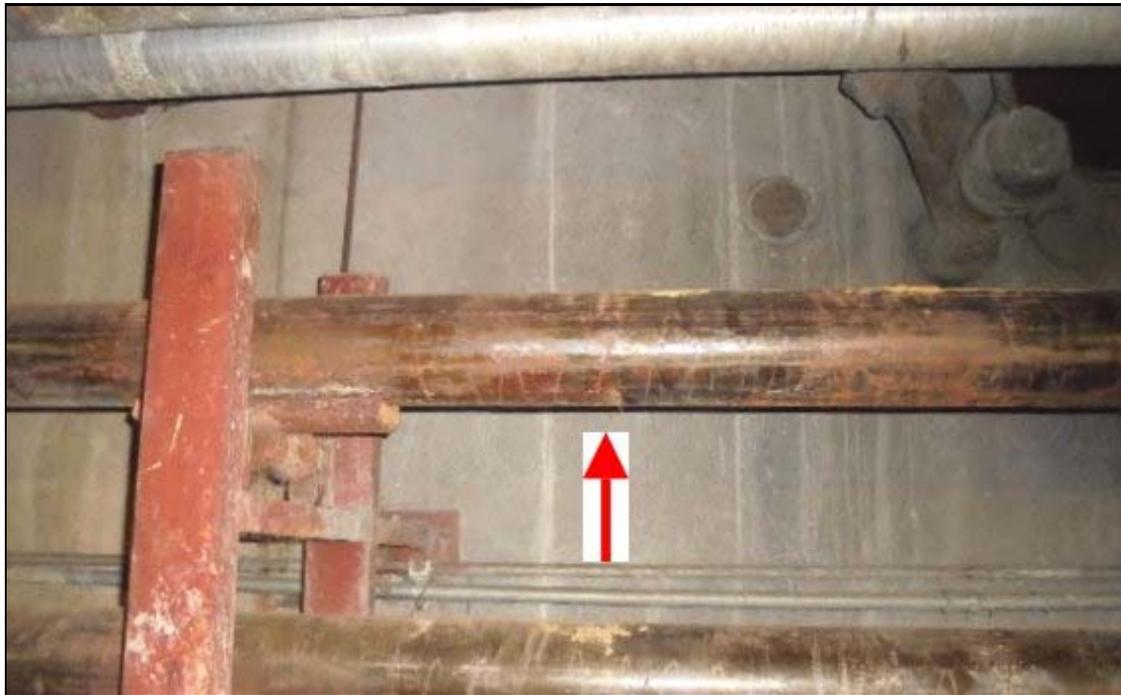
Pipe Identification and Operating Conditions

Service: Hot Water Heating
Nominal Pipe Size: 5 in.
Actual Pipe Size: 5.56 in.
Schedule/Type: Schedule 40
Material: Carbon Steel
Construction: Welded
Flow: Supply To Building
Pipe Pressure: 60 PSIG
Temperature: 160 Deg. F.
Pipe Orientation: Horizontal
Test Site I.D.: T-HWH-5-17
Site Drawing Number: n/a
Depth Allowance: 0.000 in.
Test Pattern: Bottom & Lower Sides

Placed In Service: June 1, 1985
Date of Test: December 30, 2016
Time In Service: 31.6 Years
Original Wall Thickness: 0.258 in.
Minimum Allowable Thickness: 0.125 in. (0.036)
Minimum Thickness Based Upon: Default Minimum Value
Standard Deviation: 0.016 in. / **High to Low Range:** 0.043 in.
Minimum Theoretical Wall Thickness: 0.185 in.
Pitting Index: 10.9% - Significant Pitting Activity
Notes: None

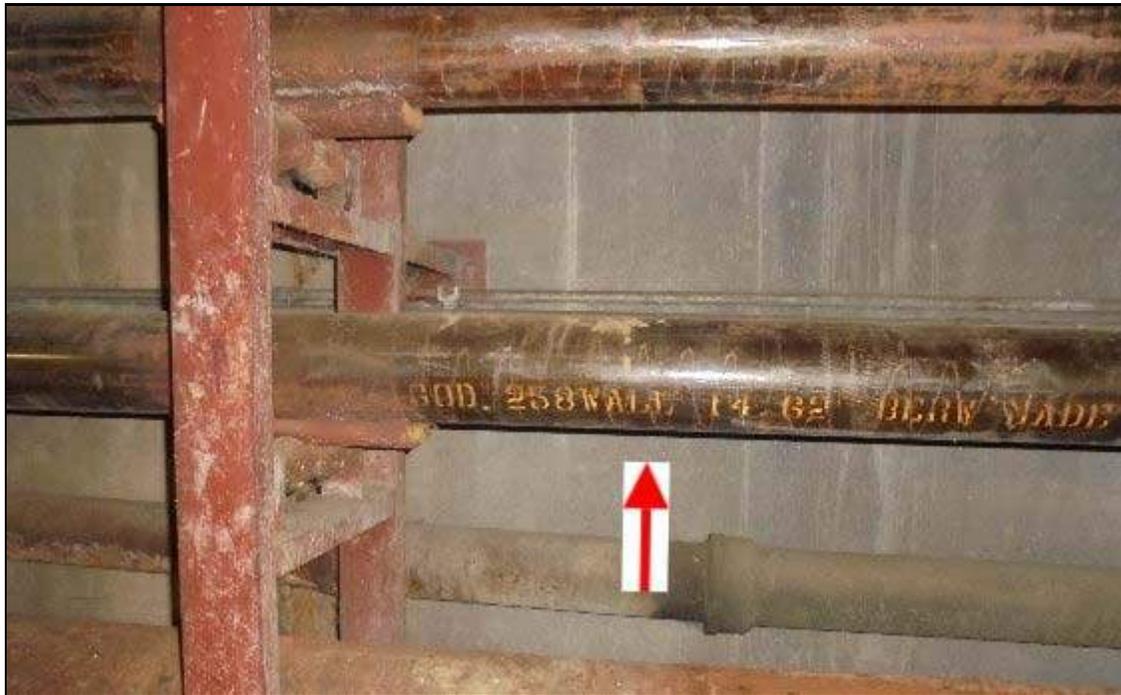
Pipe Identification and Operating Conditions

Service: Hot Water Heating
Nominal Pipe Size: 5 in.
Actual Pipe Size: 5.56 in.
Schedule/Type: Schedule 40
Material: Carbon Steel
Construction: Welded
Flow: Return To Boiler
Pipe Pressure: 50 PSIG
Temperature: 130 Deg. F.
Pipe Orientation: Horizontal
Test Site I.D.: T-HWH-5-18
Site Drawing Number: n/a
Depth Allowance: 0.000 in.
Test Pattern: Bottom & Lower Sides

Placed In Service: June 1, 1985
Date of Test: December 30, 2016
Time In Service: 31.6 Years
Original Wall Thickness: 0.258 in.
Minimum Allowable Thickness: 0.125 in. (0.034)
Minimum Thickness Based Upon: Default Minimum Value
Standard Deviation: 0.015 in. / **High to Low Range:** 0.044 in.
Minimum Theoretical Wall Thickness: 0.200 in.
Pitting Index: 11.3% - Significant Pitting Activity
Notes: None

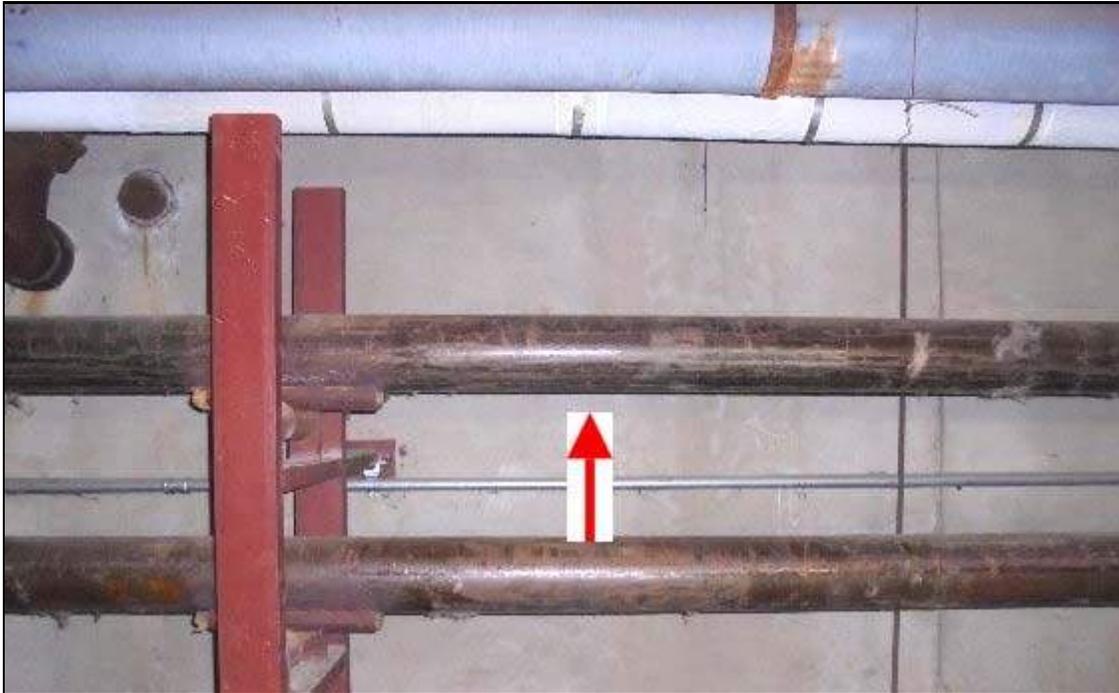
Pipe Identification and Operating Conditions

Service: Hot Water Heating
Nominal Pipe Size: 5 in.
Actual Pipe Size: 5.56 in.
Schedule/Type: Schedule 40
Material: Carbon Steel
Construction: Welded
Flow: Supply To Building
Pipe Pressure: 60 PSIG
Temperature: 160 Deg. F.
Pipe Orientation: Horizontal
Test Site I.D.: T-HWH-5-21
Site Drawing Number: n/a
Depth Allowance: 0.000 in.
Test Pattern: Random Points

Placed In Service: June 1, 1985
Date of Test: December 30, 2016
Time In Service: 31.6 Years
Original Wall Thickness: 0.258 in.
Minimum Allowable Thickness: 0.125 in. (0.036)
Minimum Thickness Based Upon: Default Minimum Value
Standard Deviation: 0.020 in. / **High to Low Range:** 0.070 in.
Minimum Theoretical Wall Thickness: 0.171 in.
Pitting Index: 15.8% - Significant Pitting Activity
Notes: None

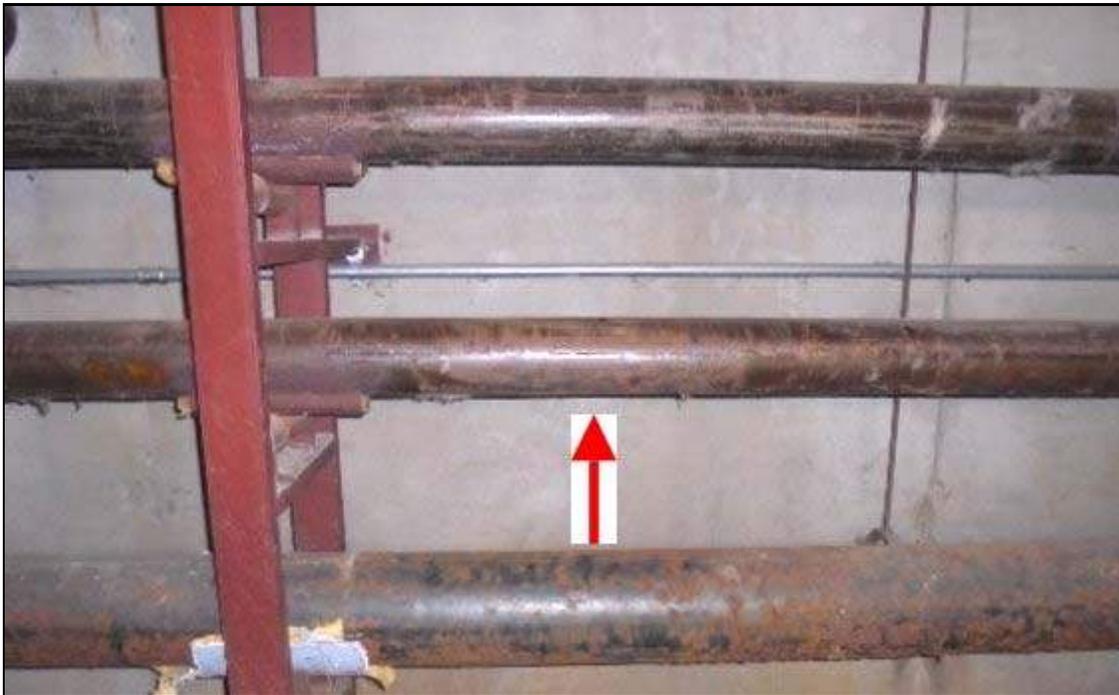
Pipe Identification and Operating Conditions

Service: Hot Water Heating
Nominal Pipe Size: 5 in.
Actual Pipe Size: 5.56 in.
Schedule/Type: Schedule 40
Material: Carbon Steel
Construction: Welded
Flow: Return To Boiler
Pipe Pressure: 50 PSIG
Temperature: 130 Deg. F.
Pipe Orientation: Horizontal
Test Site I.D.: T-HWH-5-22
Site Drawing Number: n/a
Depth Allowance: 0.000 in.
Test Pattern: Random Points

Placed In Service: June 1, 1985
Date of Test: December 30, 2016
Time In Service: 31.6 Years
Original Wall Thickness: 0.258 in.
Minimum Allowable Thickness: 0.125 in. (0.034)
Minimum Thickness Based Upon: Default Minimum Value
Standard Deviation: 0.012 in. / **High to Low Range:** 0.034 in.
Minimum Theoretical Wall Thickness: 0.200 in.
Pitting Index: 7.1 % - Moderate Pitting Activity
Notes: None

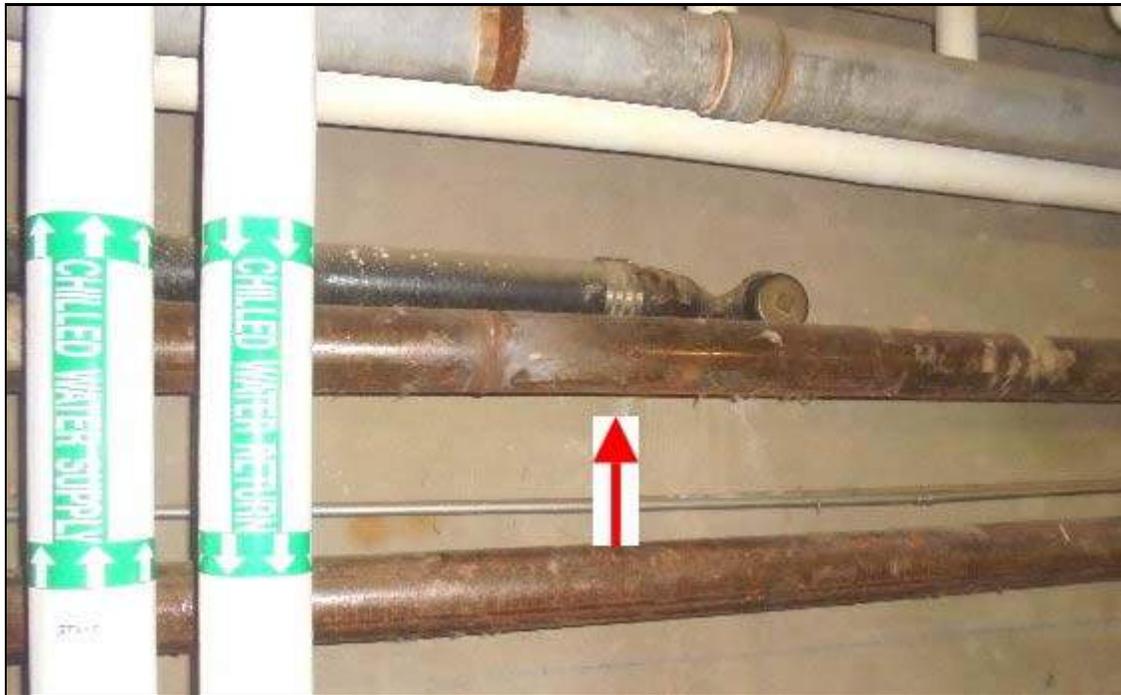
Pipe Identification and Operating Conditions

Service: Hot Water Heating
Nominal Pipe Size: 5 in.
Actual Pipe Size: 5.56 in.
Schedule/Type: Schedule 40
Material: Carbon Steel
Construction: Welded
Flow: Supply To Building
Pipe Pressure: 60 PSIG
Temperature: 160 Deg. F.
Pipe Orientation: Horizontal
Test Site I.D.: T-HWH-5-23
Site Drawing Number: n/a
Depth Allowance: 0.000 in.
Test Pattern: Random Points

Placed In Service: June 1, 1985
Date of Test: December 30, 2016
Time In Service: 31.6 Years
Original Wall Thickness: 0.258 in.
Minimum Allowable Thickness: 0.125 in. (0.036)
Minimum Thickness Based Upon: Default Minimum Value
Standard Deviation: 0.018 in. / **High to Low Range:** 0.055 in.
Minimum Theoretical Wall Thickness: 0.176 in.
Pitting Index: 12.8% - Significant Pitting Activity
Notes: None

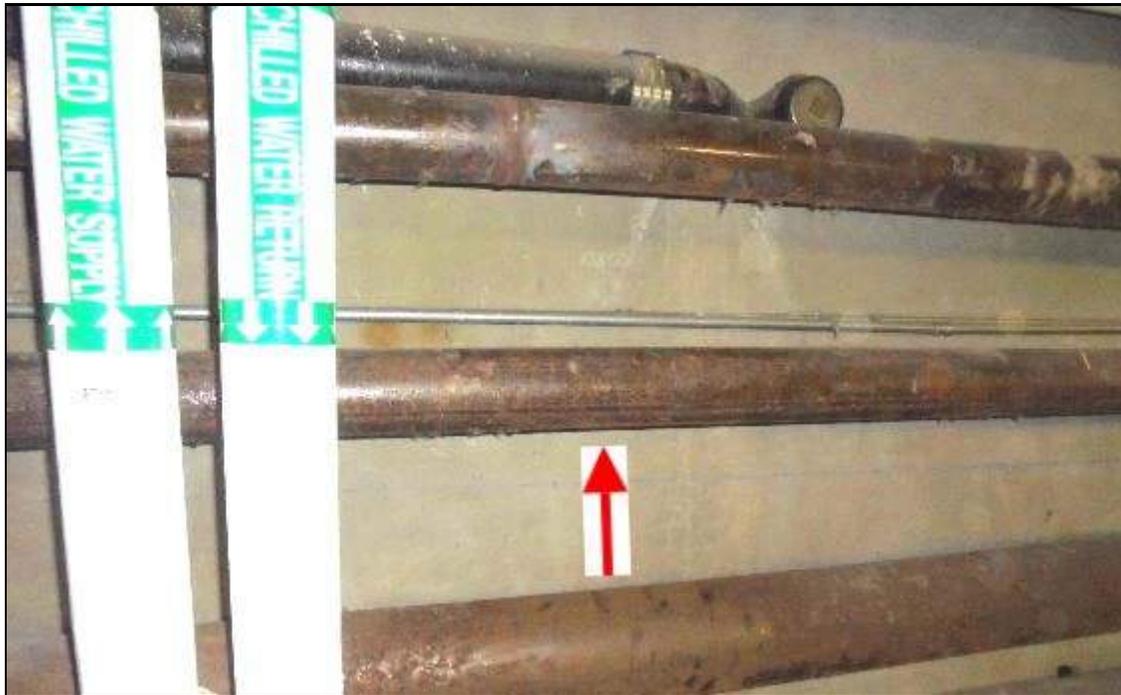
Location No: 51

Photo File #: phl-1-130.jpg
 Detail: Pipe Location / Condition
 Orientation: Side View

Pipe Identification and Operating Conditions

Service: Hot Water Heating
Nominal Pipe Size: 5 in.
Actual Pipe Size: 5.56 in.
Schedule/Type: Schedule 40
Material: Carbon Steel
Construction: Welded
Flow: Return To Boiler
Pipe Pressure: 50 PSIG
Temperature: 130 Deg. F.
Pipe Orientation: Horizontal
Test Site I.D.: T-HWH-5-24
Site Drawing Number: n/a
Depth Allowance: 0.000 in.
Test Pattern: Random Points

Placed In Service: June 1, 1985
Date of Test: December 30, 2016
Time In Service: 31.6 Years
Original Wall Thickness: 0.258 in.
Minimum Allowable Thickness: 0.125 in. (0.034)
Minimum Thickness Based Upon: Default Minimum Value
Standard Deviation: 0.010 in. / **High to Low Range:** 0.031 in.
Minimum Theoretical Wall Thickness: 0.209 in.
Pitting Index: 7.6 % - Moderate Pitting Activity
Notes: None

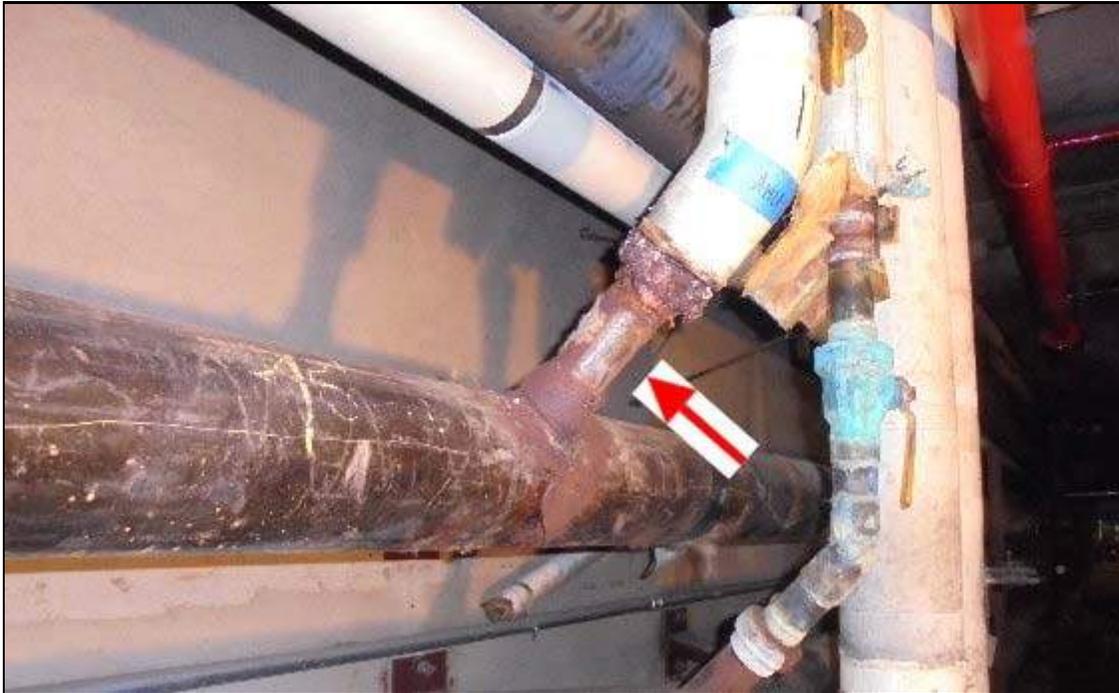
Pipe Identification and Operating Conditions

Service: Hot Water Heating
Nominal Pipe Size: 2 in.
Actual Pipe Size: 2.38 in.
Schedule/Type: Schedule 40
Material: Carbon Steel
Construction: Threaded
Flow: Supply To Building
Pipe Pressure: 60 PSIG
Temperature: 160 Deg. F.
Pipe Orientation: Diagonal
Test Site I.D.: T-HWH-2-03
Site Drawing Number: n/a
Depth Allowance: 0.073 in.
Test Pattern: Random Points

Placed In Service: June 1, 1985
Date of Test: December 30, 2016
Time In Service: 31.6 Years
Original Wall Thickness: 0.154 in.
Minimum Allowable Thickness: 0.095 in. (0.103)
Minimum Thickness Based Upon:
Standard Deviation: 0.010 in. / **High to Low Range:** 0.034 in.
Minimum Theoretical Wall Thickness: 0.098 in.
Pitting Index: 13.9% - Significant Pitting Activity
Notes: Pipe exists 37 mils from the threads, see Addendum.

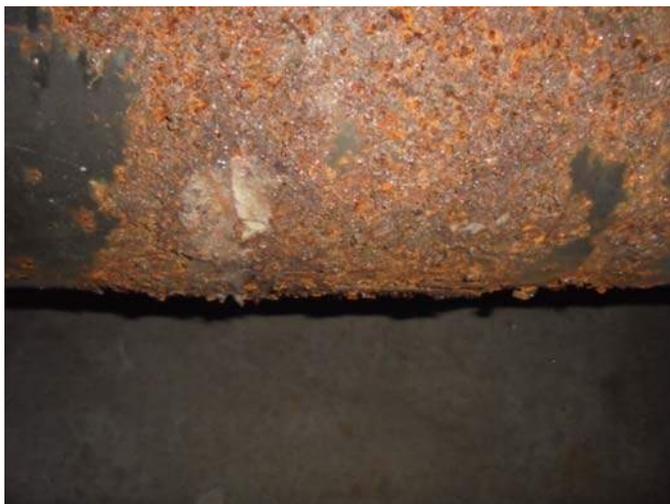
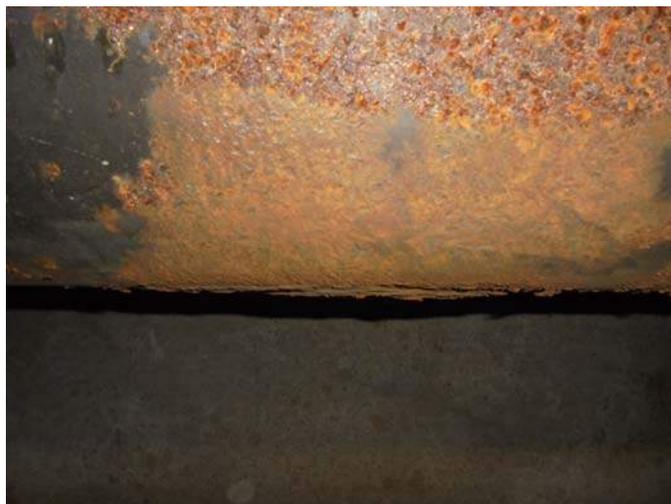
In the photographs below we show an example of chill water pipe having a heavier volume of outer surface rust at the bottom due to condensation accumulating in this area. Its condition represents the concern originally expressed for this piping system. At left we show the pipe condition following removal of the insulation. Surface rust would be classified as light to moderate, with some unaffected areas of bare steel still showing. Below right we show the surface rust removed by wire wheel to reveal mild outer pitting to a depth measured by micrometer at 0.035 in. Although an unnecessary and unexpected loss, such pitting is relatively insignificant against 10 in. schedule 40 pipe having an initial wall thickness of 0.365 in., and a current wall thickness near 0.340 in. Nevertheless, it is still an unnecessary wall loss which will inevitably increase in its severity unless addressed.

With the insulation already removed, rehabilitation of the pipe can be accomplished by removing all heavier rust deposits using a wire wheel, applying a rust reverter to stop further deterioration, applying a top coat of a high solids waterproof paint, and then re-insulating. For chill water systems, 2 in. thick insulation is required. Our experience has shown that fiberglass insulation, the most common form of insulation applied in this area of the country, will inevitably fail - thereby allowing moisture to reach the pipe.

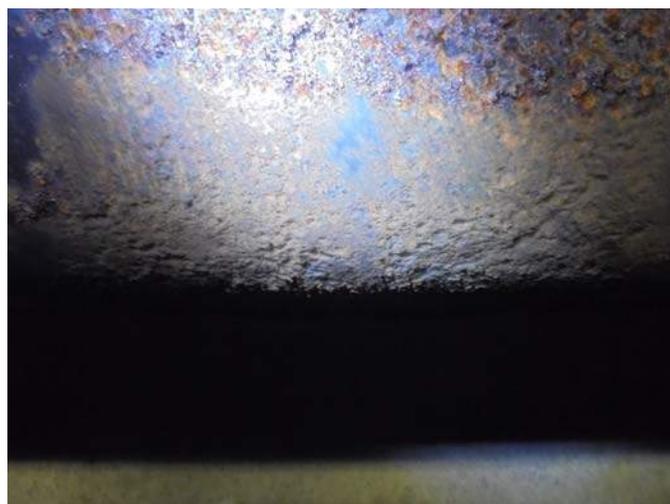
We identified relatively minor surface rust randomly in some areas which, from the above example, can be shown to have had little significant impact against the pipe.

At left, a close-up photograph of the pipe surface better shows the moderate pitting into the pipe, and also that most of this heavier wall loss exists along the bottom. This defines that a long term condition of waterlogged insulation has existed for this pipe.

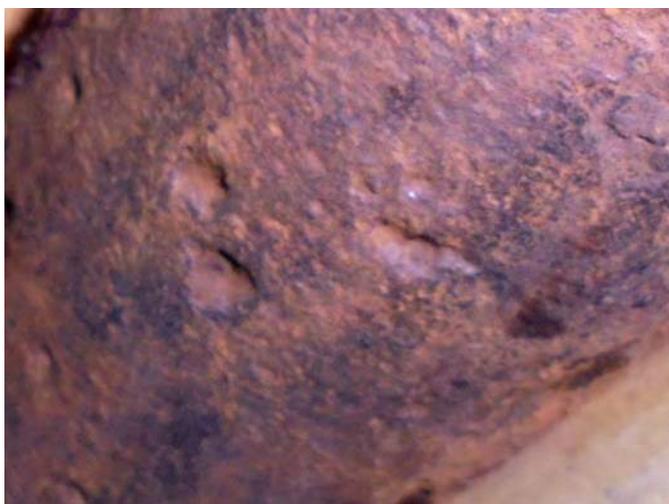
A good illustration to the threat posed by a continuation of this outer surface deterioration is provided by the results of location No. 29 at an example of smaller take-off line to the AHU units. Here, ultrasonic testing identified generally high wall thickness but also random areas of deep surface pitting. This is common to any tee or take-off line often lacking adequate insulation, or having breaks at the seams, thereby allowing moisture to easily infiltrate and damage the pipe.

At left we show a closer view of the take-off line at location No. 29 where deep surface pitting is evident having a depth of near 0.045 in. as measured by a surface depth micrometer. Lesser pitting was identified in most other areas of the chill water system in the range typically of near 0.035 in.

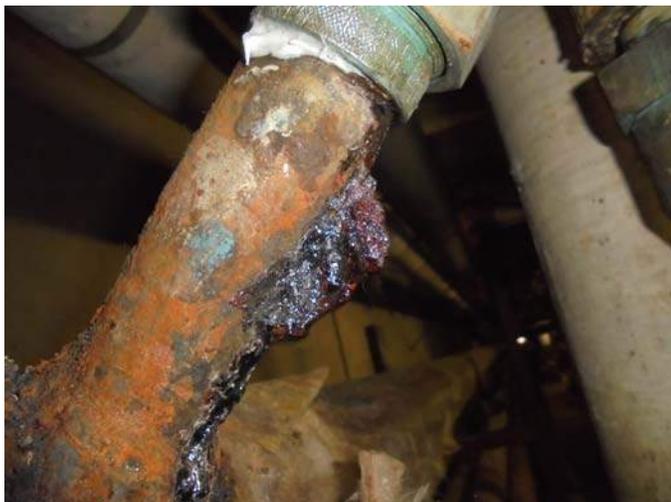
We offer a close-up view of a current pinhole leak in the photo below.

While some results at this smaller take-off pipe are more favorable, the generally lower service life estimates produced, in addition to this obvious threat, suggests that it would be prudent to replace all such take-off pipe sections at this time.

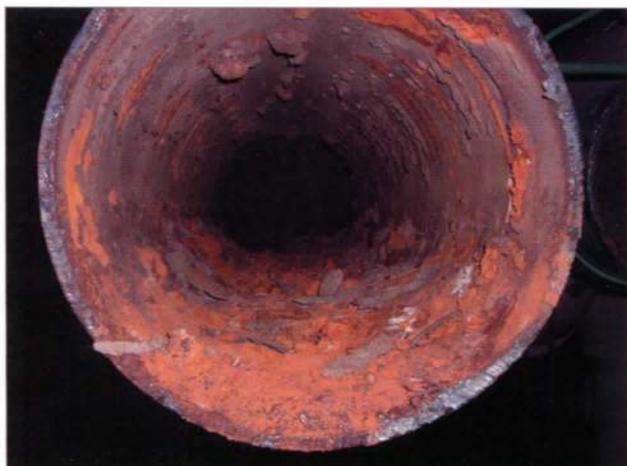
Figure 1. Heavy corrosion deposits along the length of a pipe. Severe pitting was found under the deposits.

Shown in Figure 1, heavy corrosion deposits were found along the entire bottom length of the pipe. Severe pitting under the deposits confirmed UT predictions.

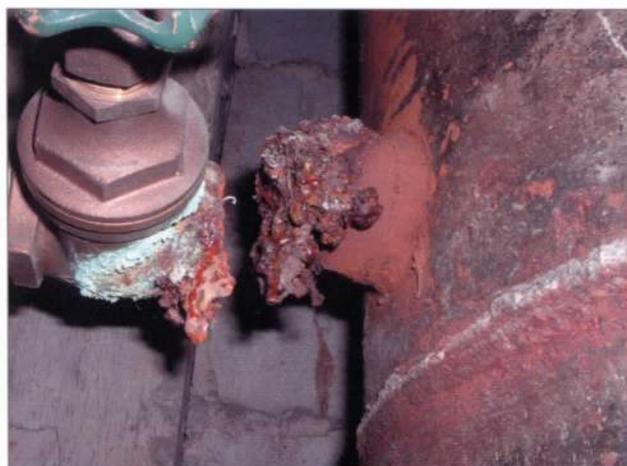
Figure 2. This incidence of corrosion was detected by expanding testing into dead-end areas.

Expanding prior testing efforts by demanding access into the shaftway and to multiple 1 in. abandoned valve connections produced the finding shown by Figure 2.

Pending failure was also found at the adjacent supply riser connection and in other areas of a piping system required to provided uninterrupted 24/7 critical cooling service. Approximately 15 floors of 24 in. condenser return water pipe to the roof existed above this point, with 150 psi of water pressure amazingly held back by only the presence of some rust product.
