BIRD

NETTING

ALL INFORMATION ON THIS DOCUMENT'IS PROPERTY OF THE STATE OF WEST VIRGINIA AND SHALL NOT BE REPRODUCED OR FURNISHED TO OTHERS, IN WHOLE OR IN PART, WITHOUT THE EXPRESS WRITTEN CONSENT	SJ SCALE: AS NOTED	Details: Pointing & Sealant	Masonry Cleaning & Repair Project	West Virginia State Capitol	Charleston, West Virginia	CHARLESTO	DEPARTMENT OF ADMINISTRATION	STATE OF WEST VIRGINIA
WEST VIRGINIA AND SHALL NOT BE OUT THE EXPRESS WRITTEN CONSENT	DATE: 06-08-07	& Sealant	Repair Projec		ginia	CHARLESTON, WEST VIRGINIA	VIIII	WEST V
CAD PATH SEQUENCE: C:\ACAD\SUPPORT\SHEETS\D-SHEET	A-JUI	DRAWING NO:	SHCA PROJ. #: 5827-D			GINIA	DIVISION OF GENERAL SERVICES	IRGINIA

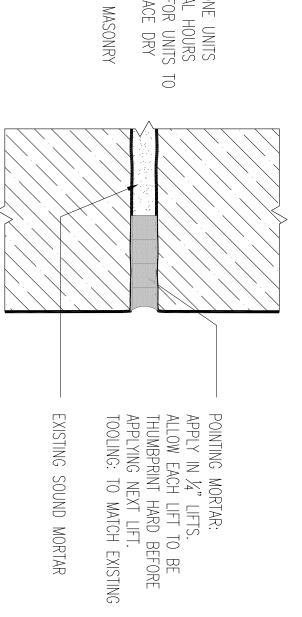
STEP 2: PRE-WETTING OF STONE UNITS - SATURATE STONE UNITS ALLOW SEVERAL HOURS DRYING TIME FOR UNITS T BECOME SURFACE DRY SURFACE DRY MASONRY 10

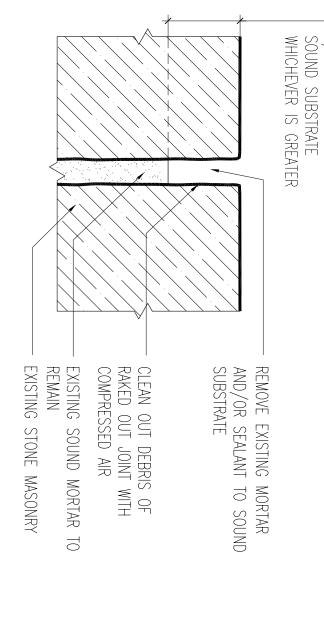
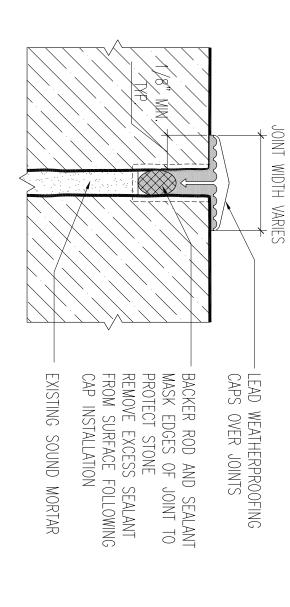
REPOINTING

STEP 3: APPLICATION OF MORTAR

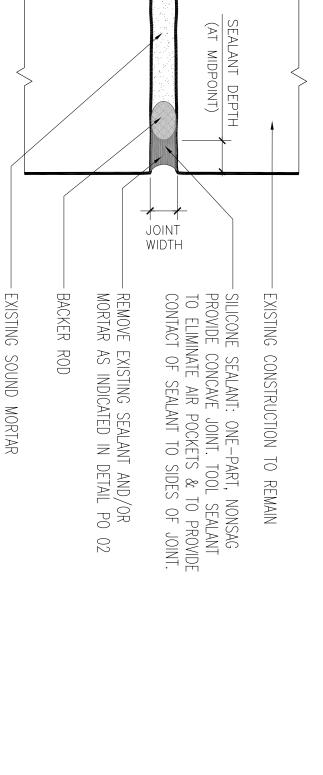
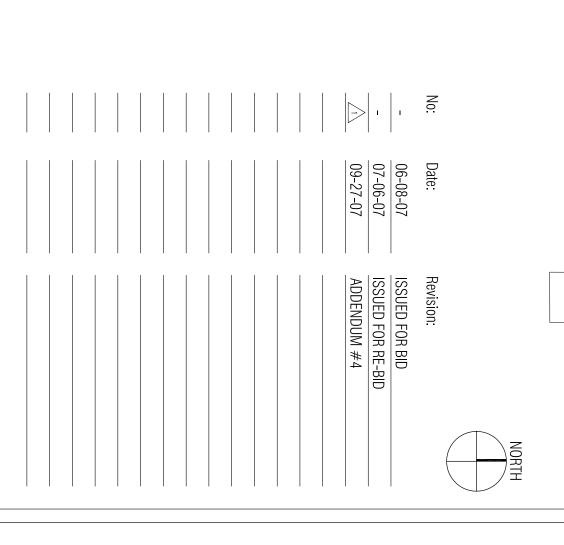
SE 03: SEALANT REPLACEMENT AT V **ERTICAL CORNER CRACK**

SEALANT

DEPTH &

BACKER ROD

DIAMETER SHALL BE

BASED
