Solicitation Description: Open-end contract for a Claims Administrator and Adjustor

Claim Investigation Report

The objective of this evaluation is to determine if the conditions of concern at the claimant's residence are the result of blasting activities for the HAWKEYE CONTRACTING project in .

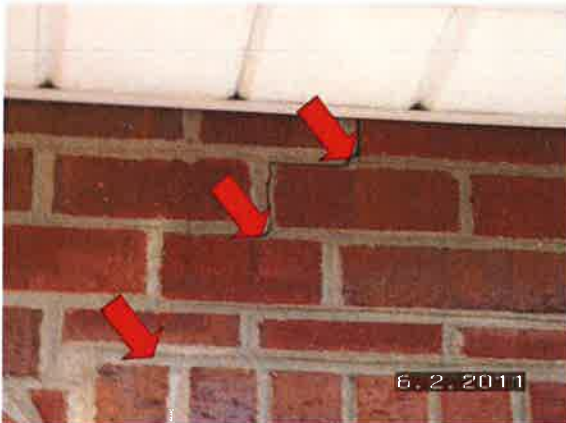
Pre-Blast Photograph No. 9 compared to Post-Blasting Photograph Nos. 8 & 11

Location: Left top of garage door
 Description: Five (5) brick stair step 1/8" to hairline
 General Comments: NO CHANGE from pre to post-blasting level.

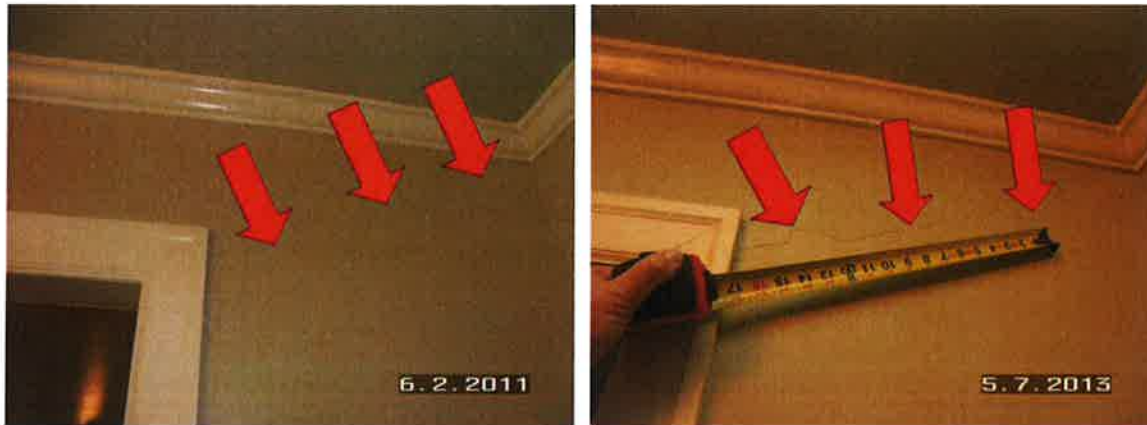
Pre-Blast Photograph No. 41 compared to Post-Blasting Photograph No. 17

Location: Right top of door leading from dining room into Kitchen
 Description: 18” drywall crack by 1/32” to hairline
 General Comments: This defect was re-measured and was exactly 18” by 1/32” to hairline from pre to post-blasting level.

The same is true for the adjacent kitchen and utility room, in which the pre-blasting inspection had DEFECTS previously documented with NO CHANGE in LENGTH or WIDTH on the post-blasting inspection.
