RFQ NUMBER
 GSD096421

LINE	QUANTITY	UOP	CAT. NO.	ITEM NUMBER	UNIT PRICE	AMOUNT
				ADDENDUM NO. 1		
				THIS ADDENDUM IS ISSUED TO:		
				1.) PROVIDE ANSWERS TO ALL TECHNICAL QUESTIONS SUBMITTED PRIOR TO THE DEADLINE FOR TECHNICAL QUESTIONS,		
				2.) PROVIDE THE PRE-BID ATTENDEE SHEET,		
				3.) PROVIDE A COPY OF THE ASBESTOS INSPECTION REPORT WITH DRAWINGS,		
				AND		
				4.) EXTEND THE BID OPENING DATE.		
				BID OPENING DATE IS EXTENDED TO: 12/02/2008		
				BID OPENING TIME REMAINS: 1:30 PM		
				***** END ADDENDUM NO. 1 *****		
0001	1	LS		968-32		
				DEMOLITION/ABATEMENT CASS GRADE SCHOOL

**ASBESTOS INSPECTION REPORT
FORMER CASS GRADE SCHOOL
CASS SCENIC RAILROAD STATE PARK
P.O. BOX 107, WV ROUTE 66
CASS, WEST VIRGINIA 24927**

Re: Executive Summary, Asbestos
Inspection, Former Cass Grade
School Complex.

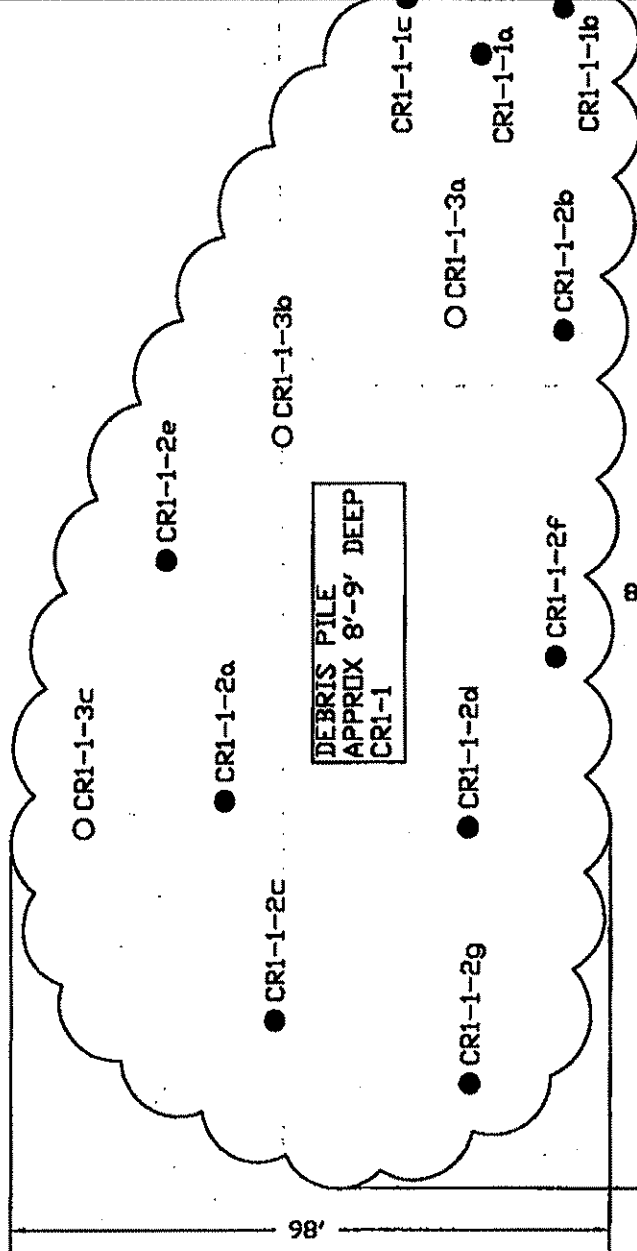
ASBESTOS INSPECTION
APPROX SITE PLAN
OLD CASS GRADE SCHOOL COMPLEX
CASS SCENIC RAILROAD STATE PARK
CASS, WV
3-18-08
NTS

- = APPROX. ASBESTOS BULK SAMPLE LOCATION, ASBESTOS DETECTED > 1%
- = APPROX. ASBESTOS BULK SAMPLE LOCATION, ASBESTOS NOT DETECTED > 1%

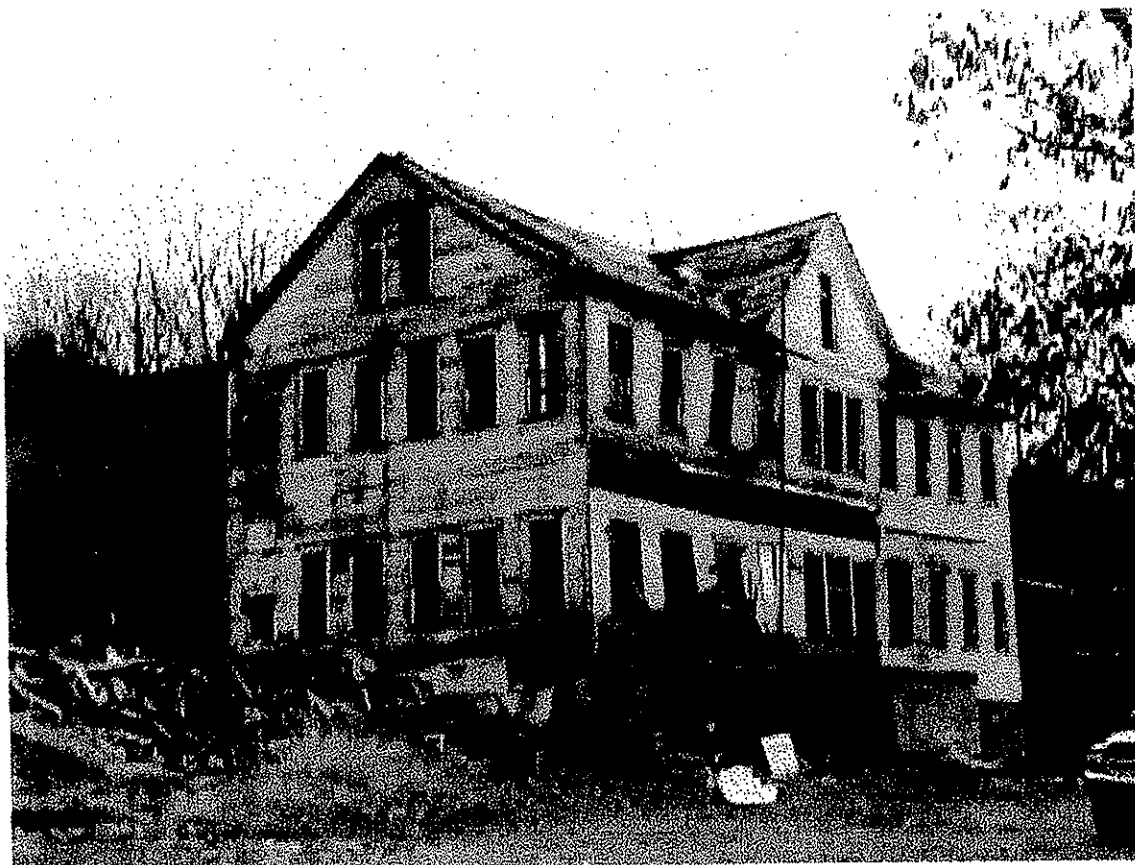
CR1-1
3/17/08

It should be understood that approximately one half of the main building has collapsed and has been "pushed up" in a large debris pile. The remaining section of the main building has partially collapsed (2nd floor collapsed onto 1st floor). Access to the 2nd floor could not be safely performed.

REMAINING SECTION
MAIN BUILDING

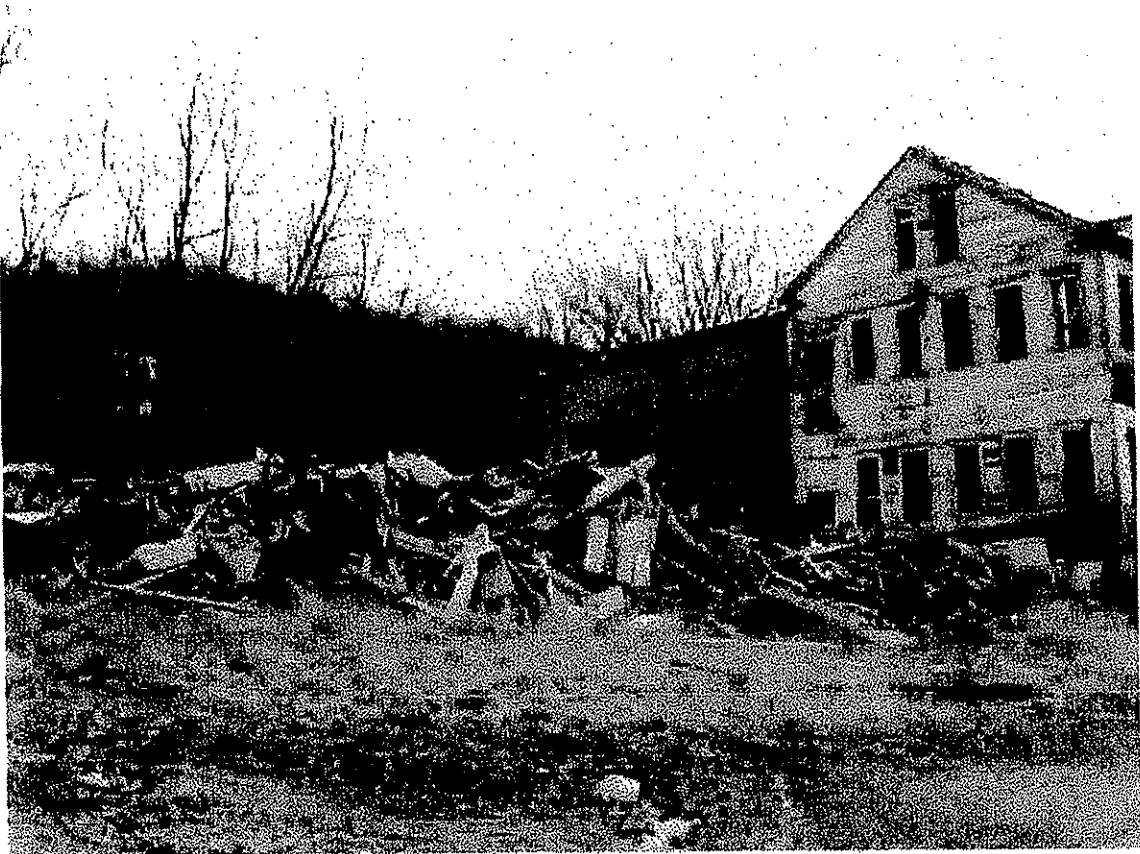
MAIN BLDG. SECTION AND ASSOCIATED DEBRIS PILE
GYMNASIUM
3/17/08

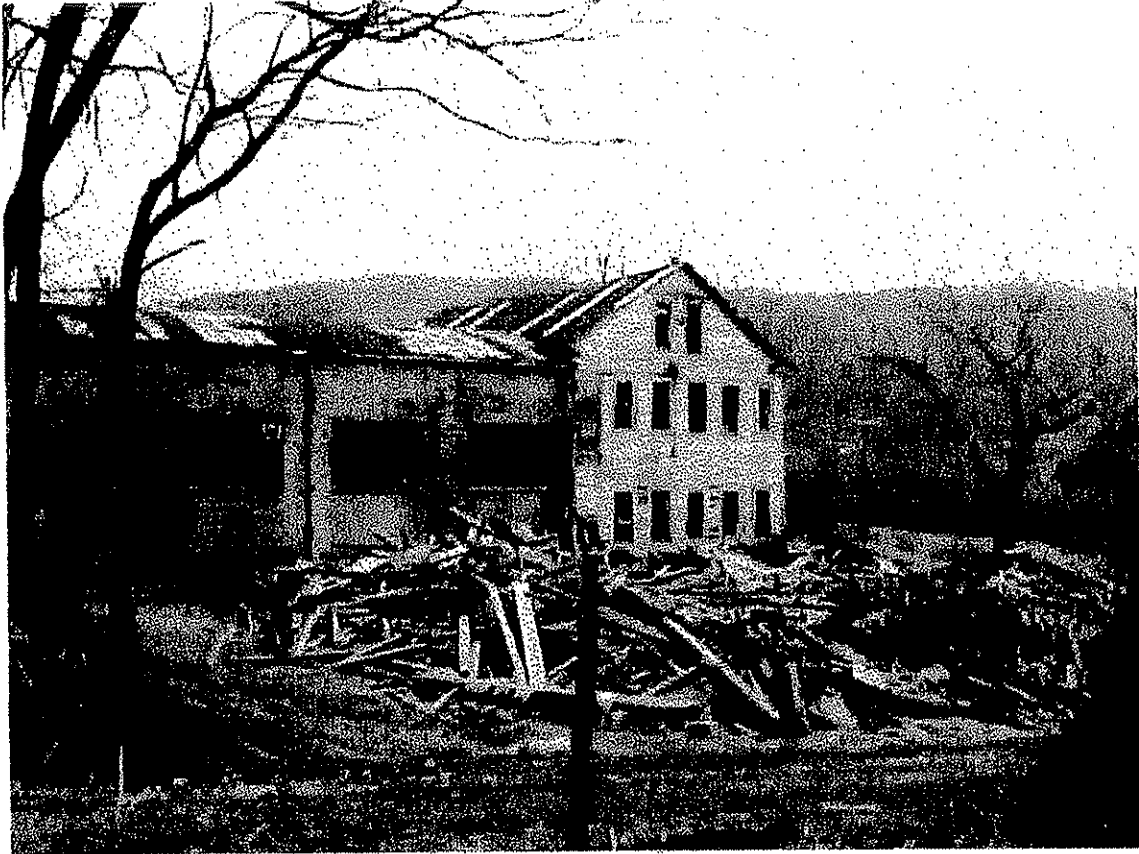
Note: In addition to asbestos-containing plaster, transite panels and pipe insulation may be buried in the debris pile. The ground surface under the debris pile is also considered contaminated, approximately 8000 square feet(ft²).

DEBRIS PILE WITH MAIN BUILDING AND
GYM IN BACKGROUND
3/17/08
