RFQ NUMBER
 DNRB11006

EXPRESSION OF INTEREST
Canaan Valley Resort State Park
Sleeping Unit Replacements and Other Improvements
DNRB 211006

Canaan Valley Resort State Park and Conference Center is located in Davis, WV and currently hosts many activities within the park property, including overnight accommodations at the lodge. The purpose of this report is to summarize structural deficiencies and provide recommendations for structural repairs and general maintenance items for the 5 overnight sleeping facilities surrounding the main lodge. The 5 facilities are Raven Lodge, Wild Goose Lodge, Deer Lodge, Woodcock Lodge, and Beaver Lodge, and will be referred to as such throughout the entirety of this report. As part of this report, an Order of Magnitude Cost Estimate for Structural Repairs has been prepared as well as an Order of Magnitude Cost Estimate for General Maintenance Items.

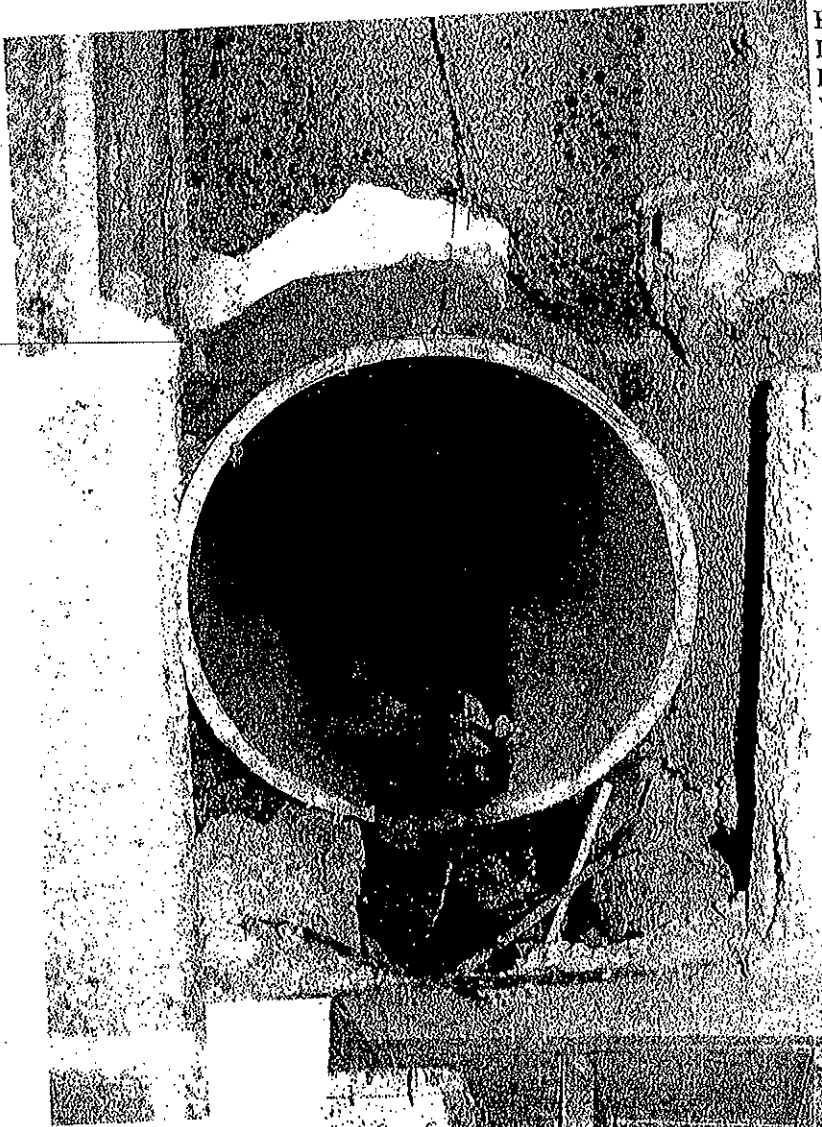
- Missing insulation was observed in numerous locations
- **Crawlspace vents are allowing water to enter the crawlspace** (See Photo 11-Appendix A)
- **Crawlspace vent pipes do not extend through the entire block foundation wall allowing water to dump into the block cores**

Photo 11. Crawl Space Vent
Does Not Extend in Past Interior
Face of Exterior Block Wall—
Water Comes in and Fills Block
Wall Cores

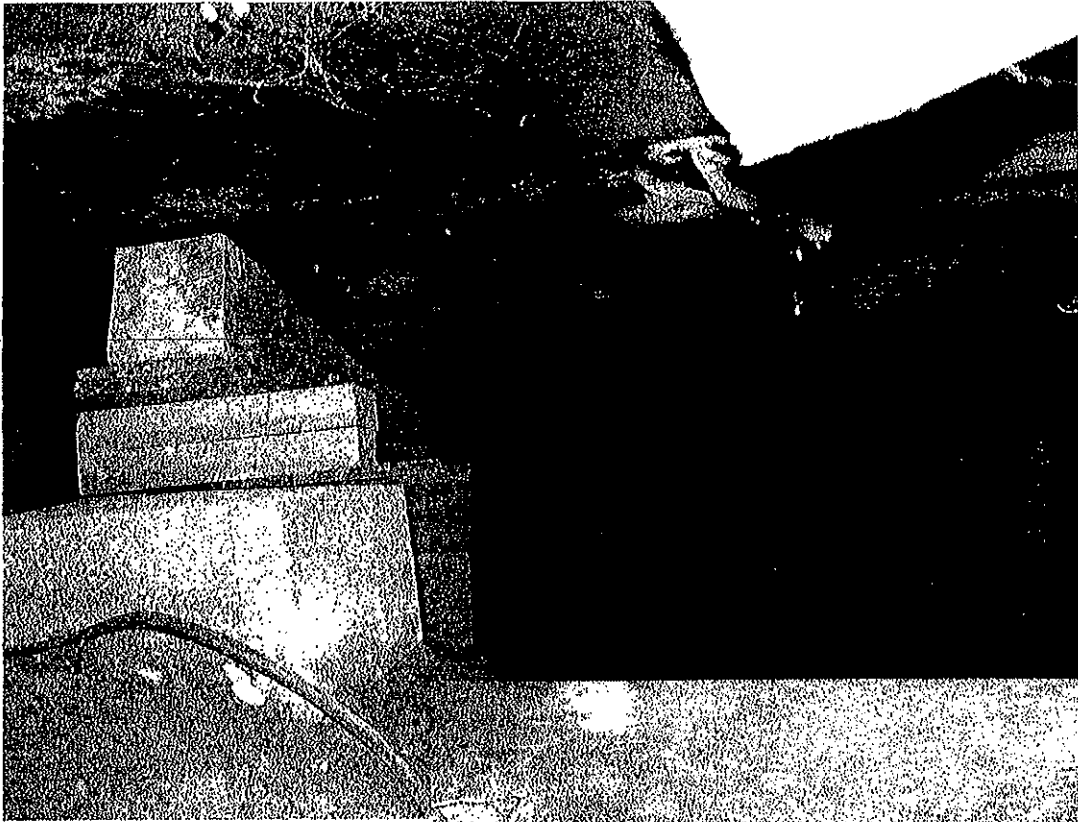
- Supplemental framing has been added below the telephone equipment room (See Photo 49-Appendix A)
- **The foundation walls and firewall appear to be unreinforced** (See Photo 75-Appendix A)

Photo 49. Additional Support Placed Directly Below Telephone Equipment Room

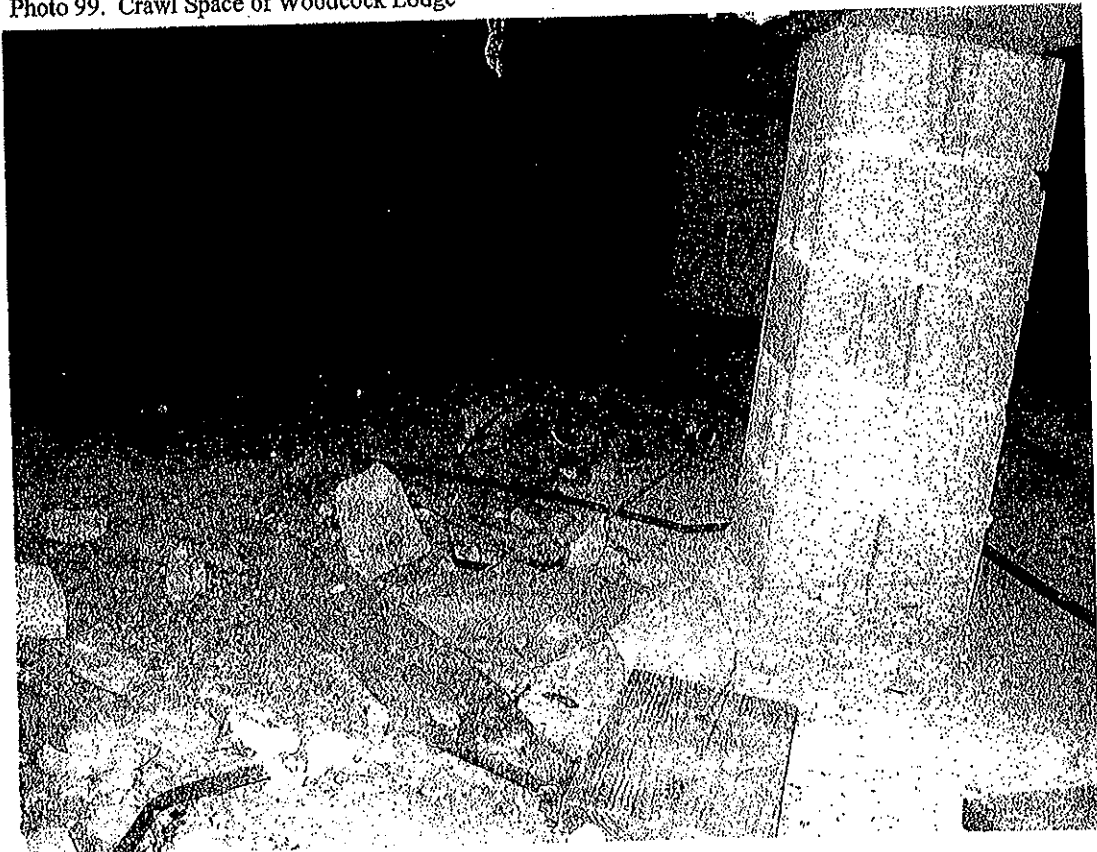
- The crawlspace was noticed to be damp (See Photos 90, 91, and 99-Appendix A)
- **Mold/algae growth in the crawlspace is suspected**
- **The foundation walls and firewall appear to be unreinforced** (See Photo 101-Appendix A)
- **The depth of the frost wall for the sidewalk and the foundations for the columns supporting the balcony are not below the frost line****
- Areas of missing vapor barrier to the bottom side of the first floor framing were noticed (See Photos 90 and 99-Appendix A)
- Missing insulation was observed in numerous locations (See Photos 90 and 99-Appendix A)

Photo 100. Another View of Crawl Space of Woodcock Lodge
